Reference	SSM71420
Models	LR2 / L359 Range Rover Evoque / L538
Title	Primary door seals coming adrift
Category	Body
Last modified	27-Jan-2014 00:00:00
Symptom	110000 Sealing
Content	<p>Issue: The primary door seals come adrift from the body at the bottom of the door aperture.</p> <p>Cause: The cause is being investigated and information is required to help establish root cause.</p> <p>Action: Please raise an EPQR detailing the measurements as shown in the attachment</p>

Door seal adrift

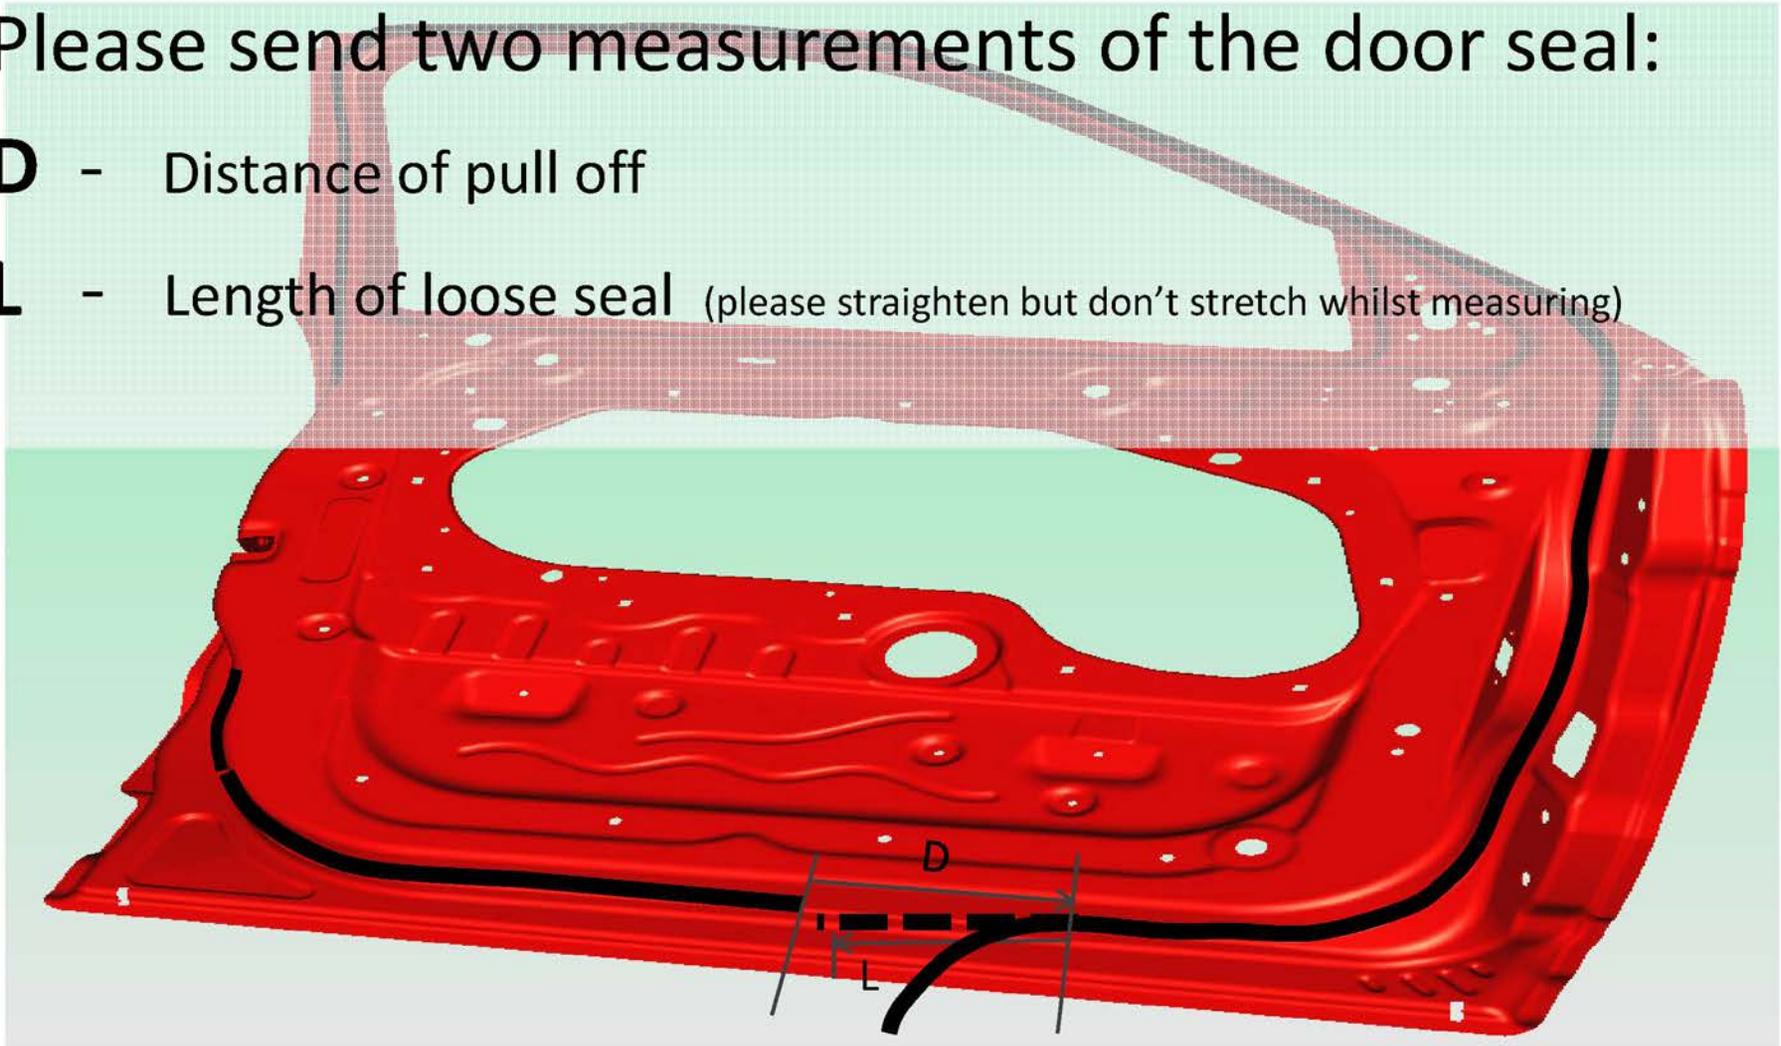
Please send two measurements of the door seal:

D - Distance of pull off

L - Length of loose seal (please straighten but don't stretch whilst measuring)
