TECHNICAL BULLETIN LTB00679NAS2 26 SEP 2014

SECTION: 415-01

Loss Of Global Positioning System (GPS) Signal

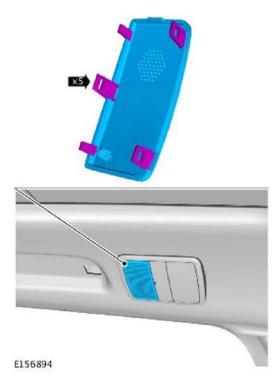
Remove the interior lamp cover.

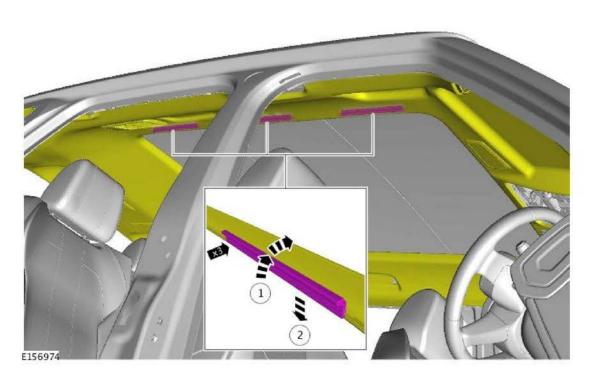
14.

Detatch the headliner retainers as shown.

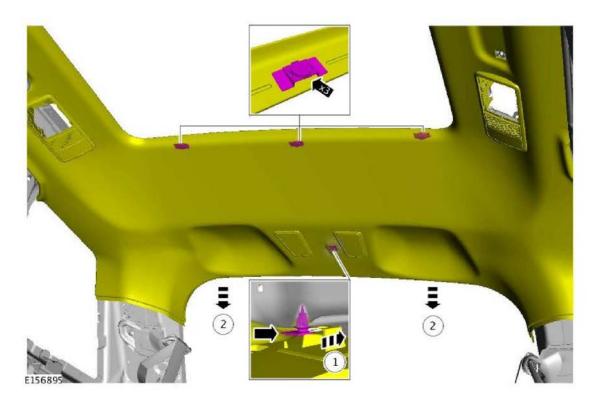
Remove the headliner retaining clips as shown.

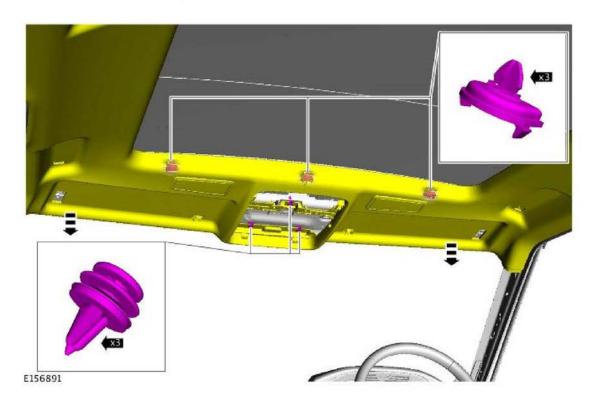
16. Remove the headliner retaining clips as shown.

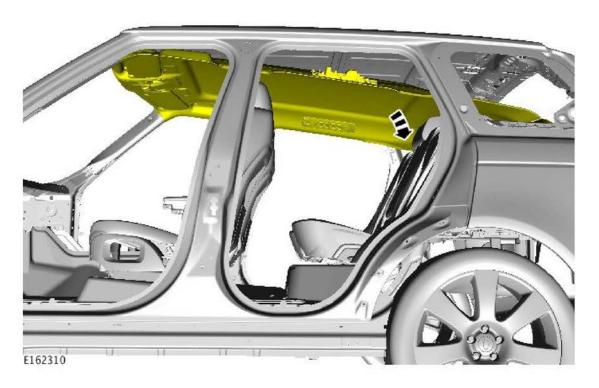
Lower the headliner.
