TECHNICAL BULLETIN
LTB00692NAS1
12 SEP 2014

SECTION: 417-00

Front / Rear Lamp Condensation - Information Only

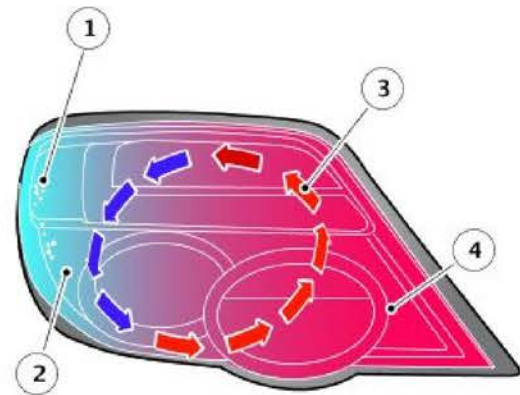
E170120

1. Condensation or moisture can be more noticeable during the months of spring and autumn when there is a likelihood of a higher moisture content in the air. It can occur when there is a temperature difference on either side of the lens surface. This can often be seen in the evening and morning sunshine or when cold water makes contact with a warm lamp lens. When a lamp is warmed unevenly by the sunshine the surface area in direct sunlight will be approximately 10°C higher than the remainder of the lamp. When warm air circulates within the lamp and makes contact with the colder surfaces moisture can appear on the lens as water condenses out of the warmer air. Condensation may occur when washing a vehicle with cold water on a warm day or when the lamps are warm and vice versa. This is the same phenomena as with the formation of dew on the surface of a glass window pane.

2. The illustration shows the following.

1. Moisture formation
2. Cool surfaces
3. Air circulation
4. Warm surfaces

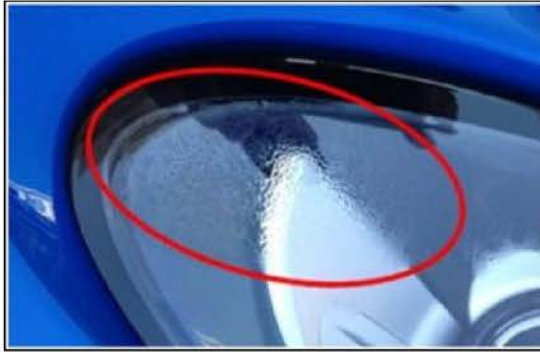
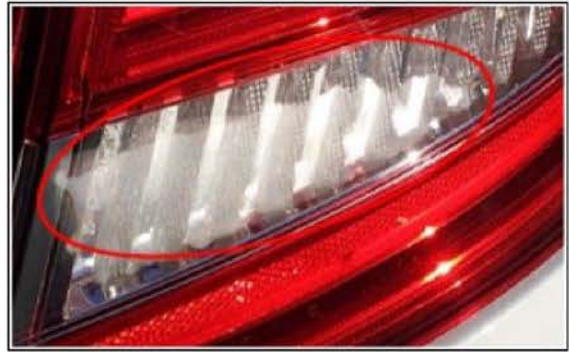
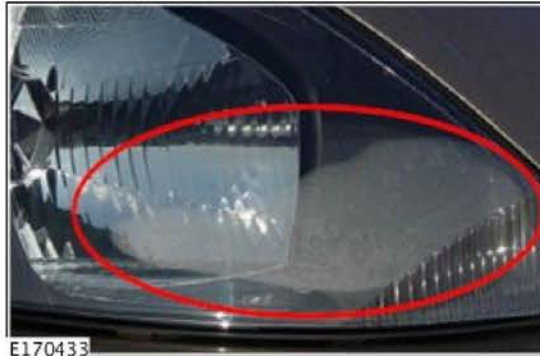
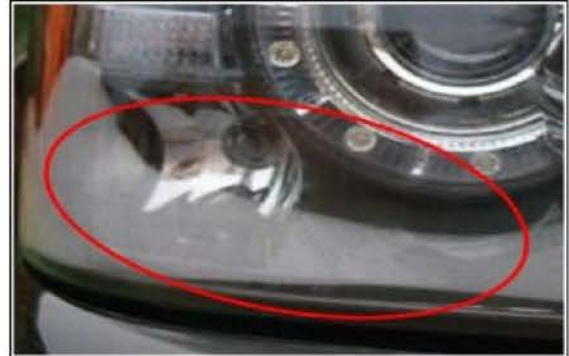
E170433

These are examples of normal exterior lamp condensation. This would NOT be covered by Warranty and the lamp should not be replaced.

3. No visible streaks, drip marks or droplets in the condensation mist.

Action: A lamp that exhibits condensation should be evaluated after a drying time where all the functions have been operated for a minimum of 30 minutes. If the condensation has started to clear during this time, it indicates that the lamp sealing has NOT been breached and will eventually clear. The lamp must NOT be replaced.

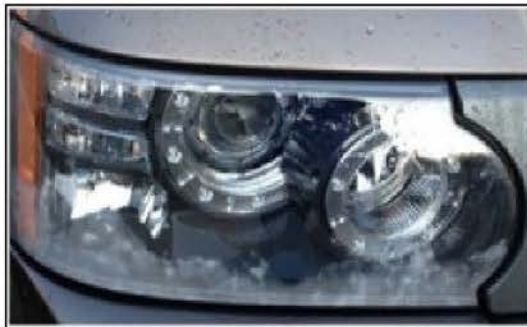
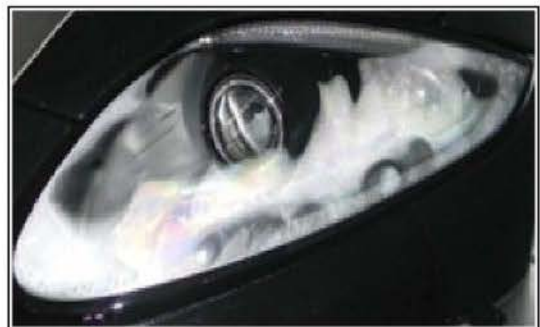
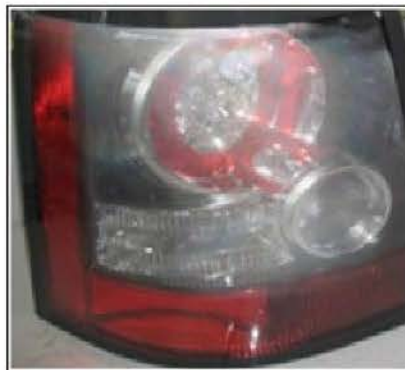
E170434

4. Condensatio
mist that
does not
obstruct the
view of the
lamp interior

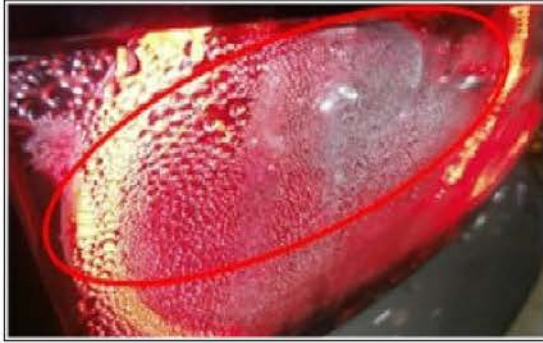
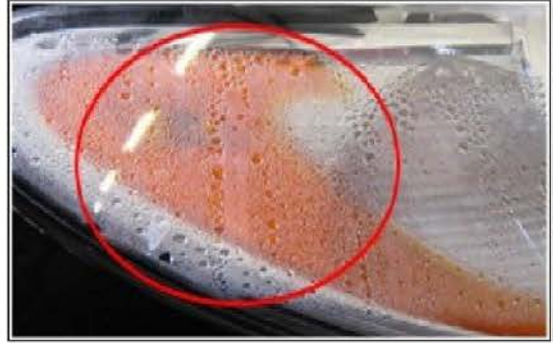
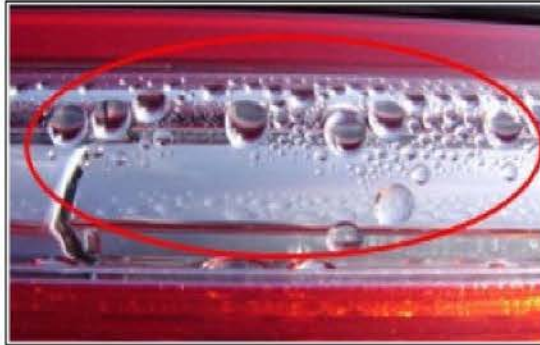
E170435

These are examples of abnormal exterior lamp condensation that may be covered by Warranty. Warranty may be accepted providing the lamp does not exhibit any visible signs of external damage.

5. Large
water
droplets.

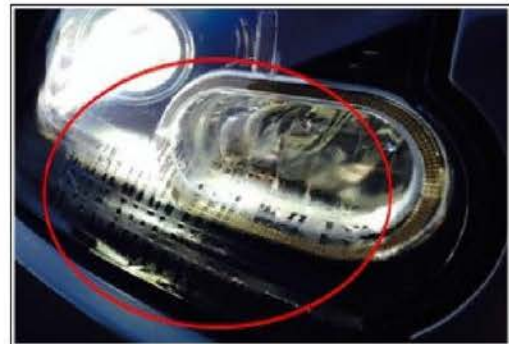
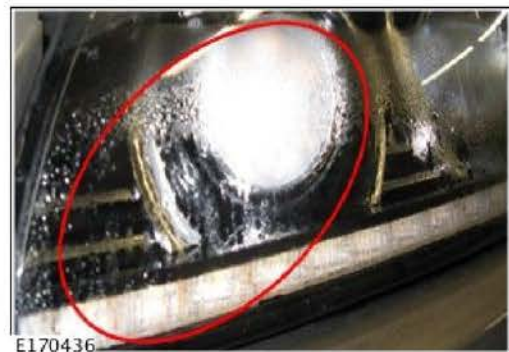
E170436

6. Drip marks or streaks in the condensation.

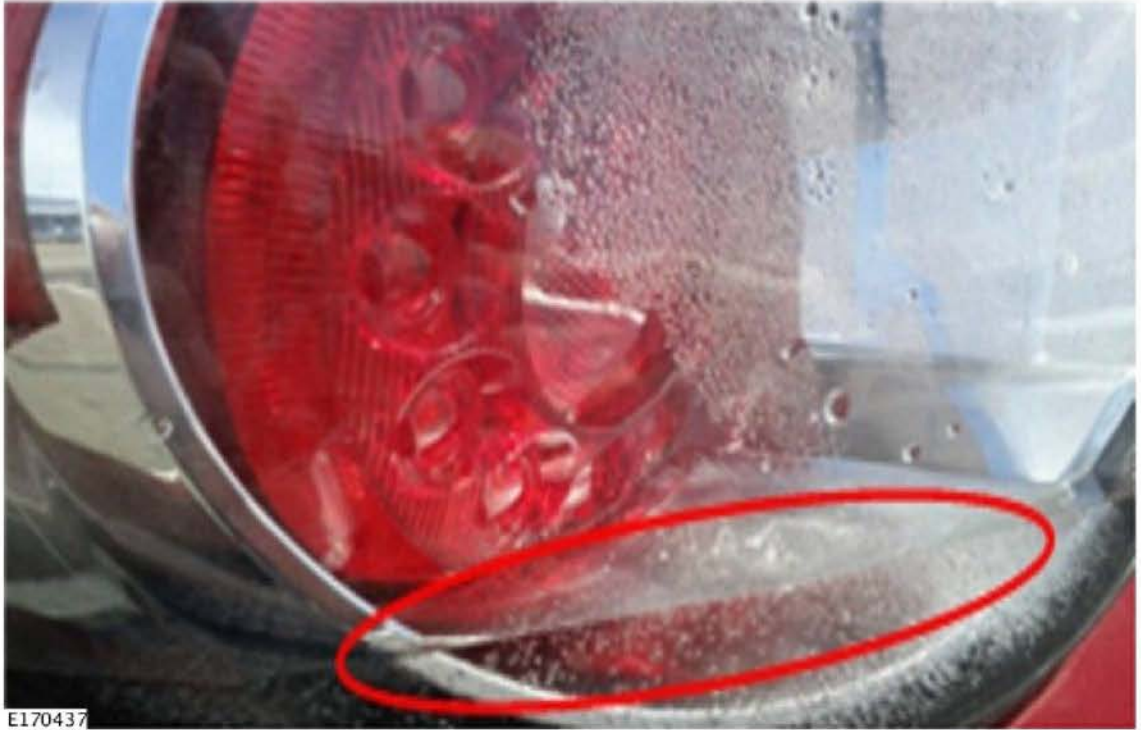
E170437

**NOTE:** Pools of water and high levels of condensation would indicate that the lamps sealing has been compromised. Check for damage and inspect the condition of caps and breathers.

7. Standing water within the lamp.

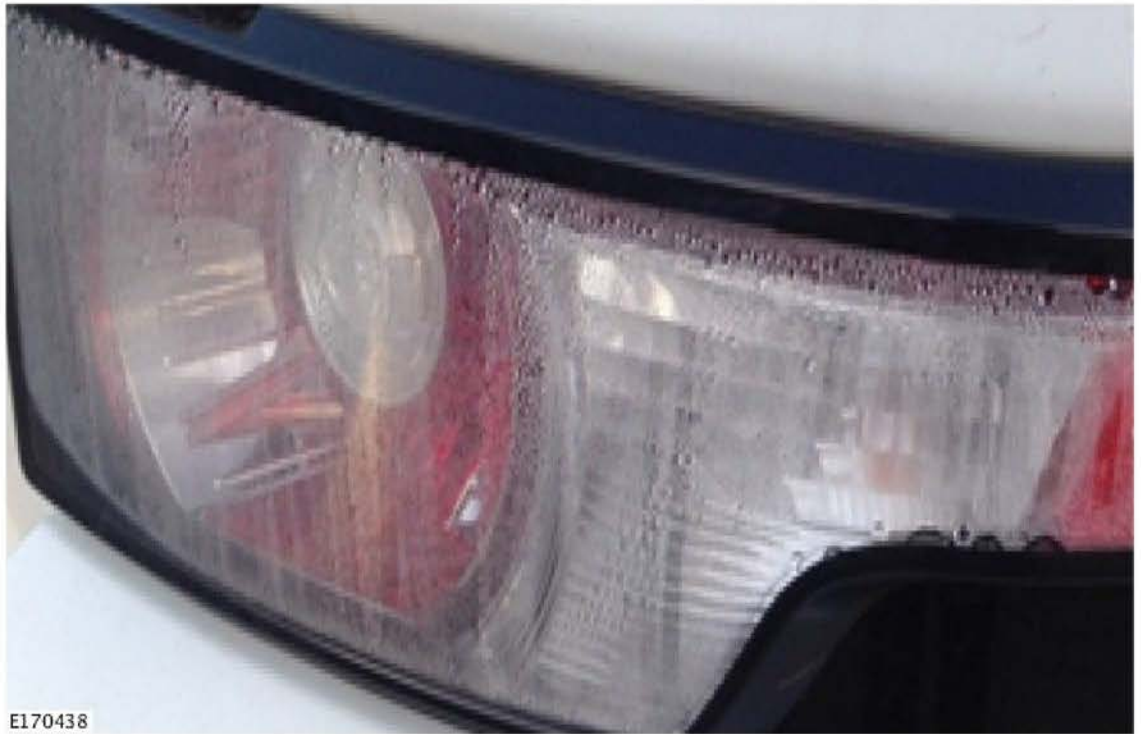
E170438

8. A thick mist covering the lens with water droplets.
