TECHNICAL BULLETIN
Q404NAS2
16 SEP 2014

Service Action: Fixed Side Step 'Rattle' Noise / Trim Loose

Range Rover Sport (LW)

Range Rover (LG)

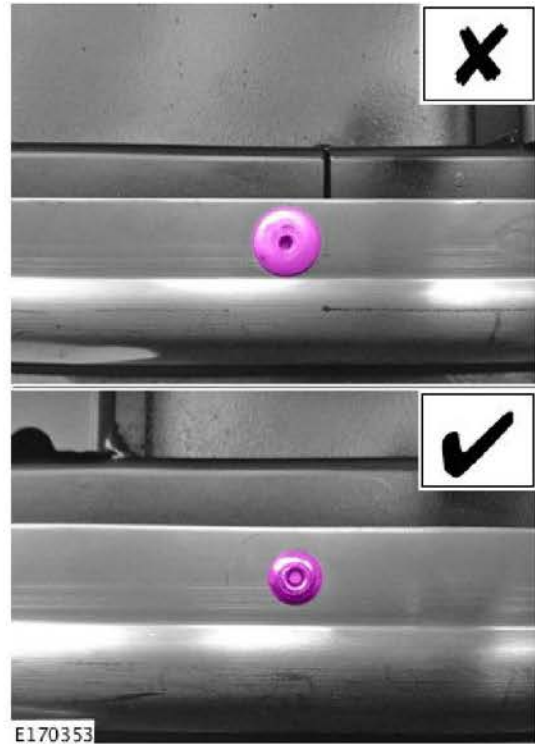
**NOTE: Make sure that the side steps have not already been reworked. The graphic shows the difference between old style**

anodized rivet ('X') and the new style stainless steel rivet ('tick').

Inspect the left-hand and right-hand side step bright finish trim rivets.

- If the stainless steel rivets are fitted ('tick'), no further action required.
- If the anodized rivets -- NOT stainless steel -- are fitted ('X'), continue to the next step.

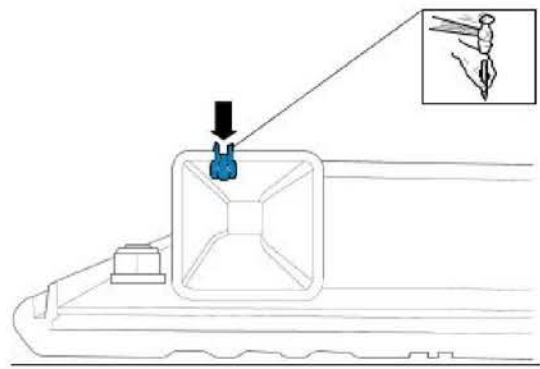
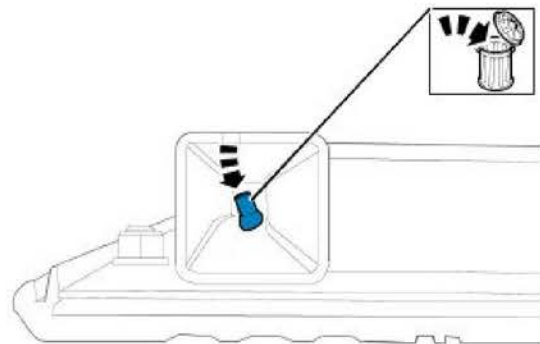
E165653

**NOTE: Make sure all the rivets are removed from the side step; failure to perform this may cause a rattle.**

Remove and discard the rest of the 10 rivet inserts.

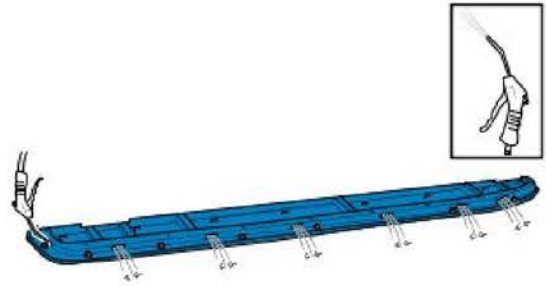
E165654

**NOTE: Make sure all the rivets are removed from the side step; failure to perform this may cause a rattle.**

Using a suitable tool, remove all the excess material from the rivet removal.

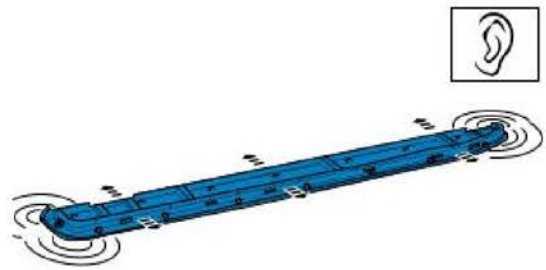
E165655

**NOTE: Make sure all the rivets are removed from the side step; failure to perform this may cause a rattle.**

Shake the side step to make sure there is no material inside the step after drilling.
