TECHNICAL BULLETIN  
Q407NAS1  
26 SEP 2014

Service Action: Rear Right-Hand Seat Cushion Blower Motor

**Range Rover (LG)**  
**Model Year:** 2014  
**VIN:** EA154724-EA177794

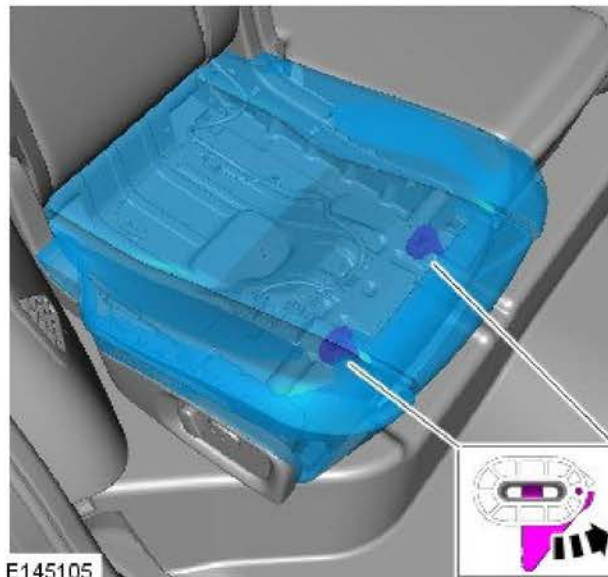
1. Position the rear right-hand seat into the fully forward position; raise the seat and the calf-rest.
2. Remove the rear right-hand seat cushion.

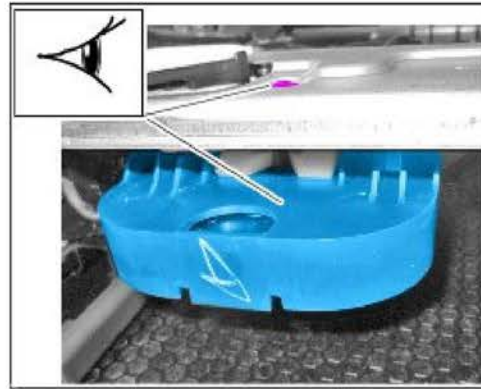
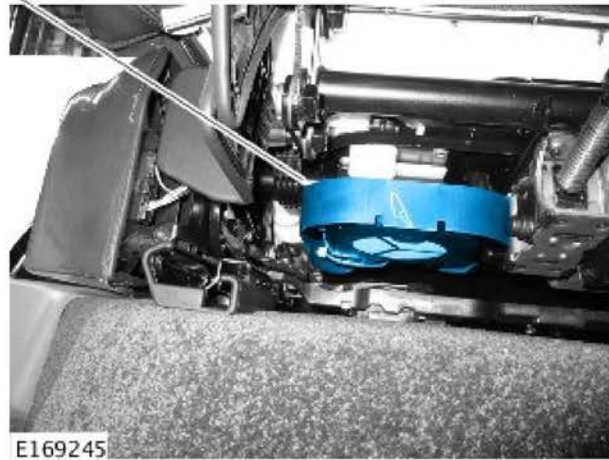
**3.** Visually inspect and feel for any signs of damage or drill marks on the rear right-hand seat cushion blower motor.

- If there are any signs of damage or drill marks or the rear right-hand seat cushion blower motor is non-functional, continue to Step 4.
- If there are no signs of damage or drill marks and the rear right-hand seat cushion blower motor is functional, continue to Step 5.

**4.** Install a new rear right-hand seat cushion blower motor (see TOPIx Workshop Manual, section 501-10B)
