TECHNICAL BULLETIN  
LTB00618NAS3  
15 OCT 2014

**'Click' / 'Rattle' Noise From Engine Compartment When Driving**

**Range Rover Sport (LW)**

**Range Rover (LG)**

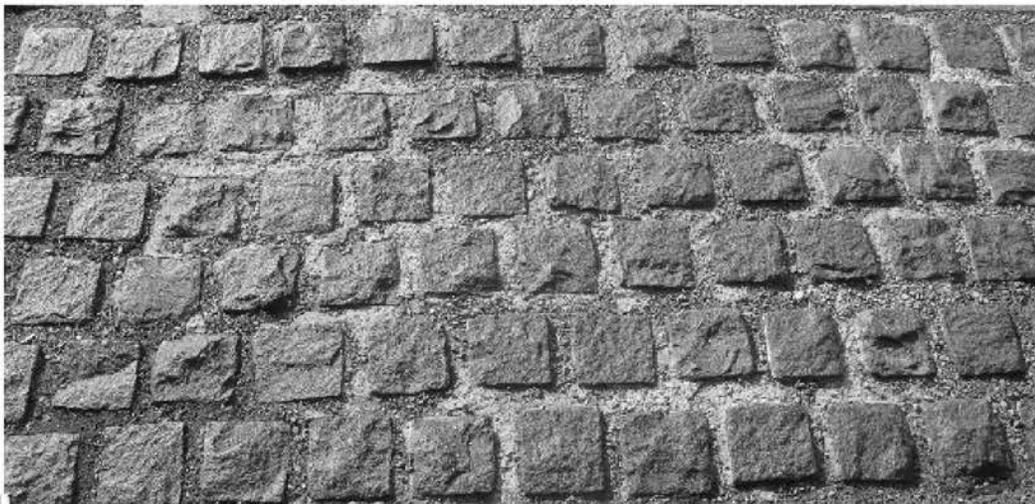
E15961

1. Typical road surface that can generate the 'rattle' sound.

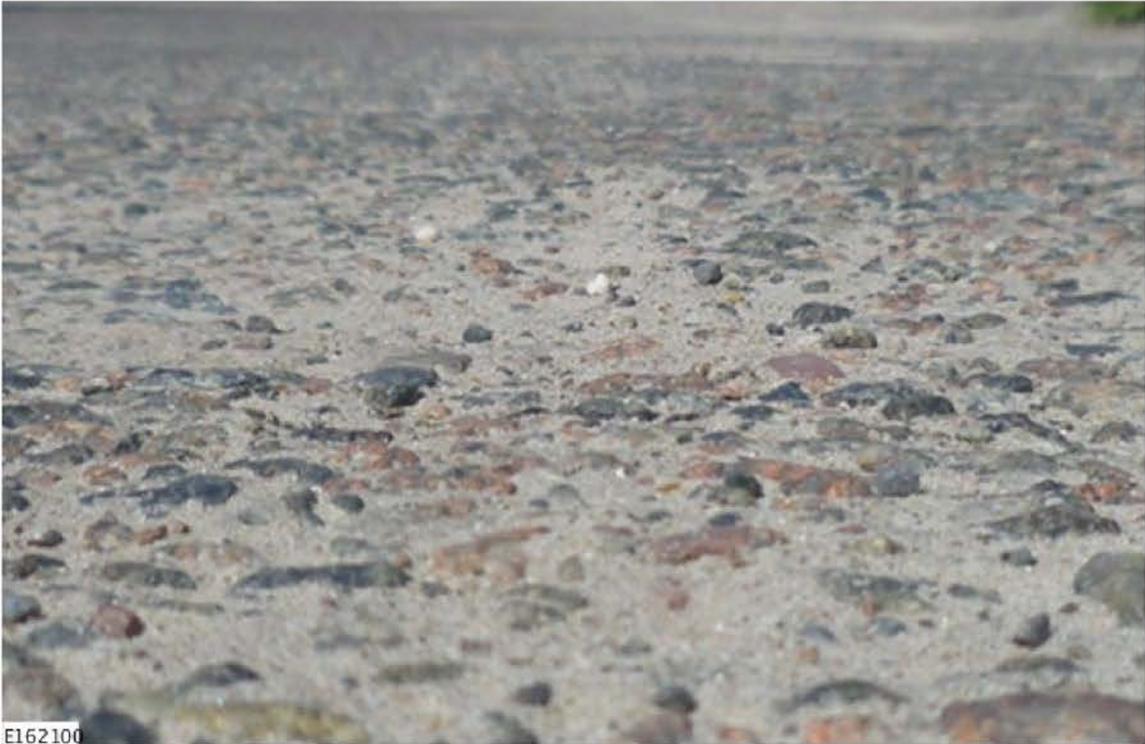
E162100

2. Typical road surface that can generate the 'rattle' sound.
