TECHNICAL BULLETIN
LTB00695NAS1
21 OCT 2014

Vibration in 7th/8th Gear at High Speed

Range Rover Sport (LW)

Model Year: 2014

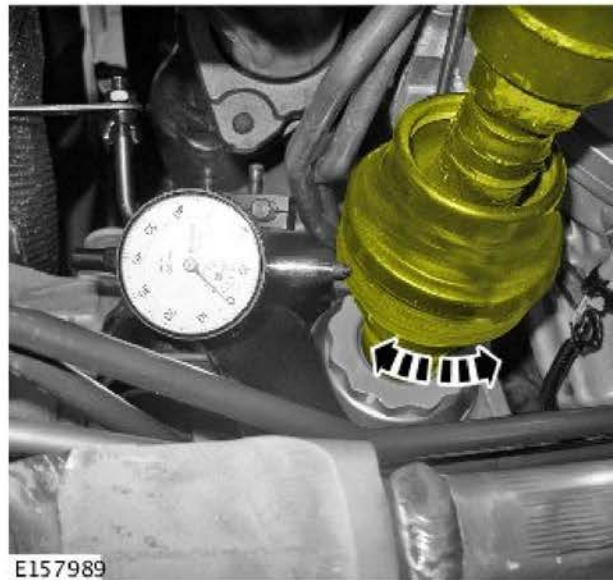
5. Hold one of the front wheels in position and rotate the other to measure the Total Indicator Reading (TIR) of the joint head.

- Record the TIR value.

Repeat Step 5, making adjustments as necessary, until Total Indicator Reading (TIR) is as close to zero as possible (must be less than 0.15mm TIR).

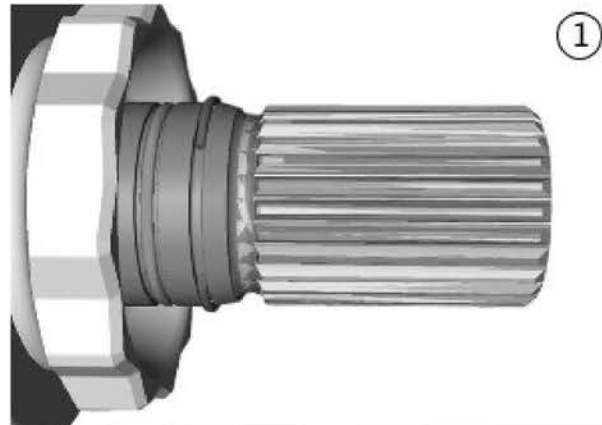
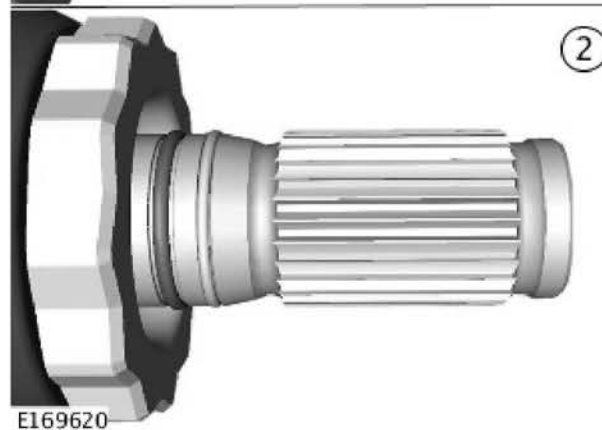
E169620

Identify the currently fitted front differential pinion type:

- (1) Old type
- (2) Modified type

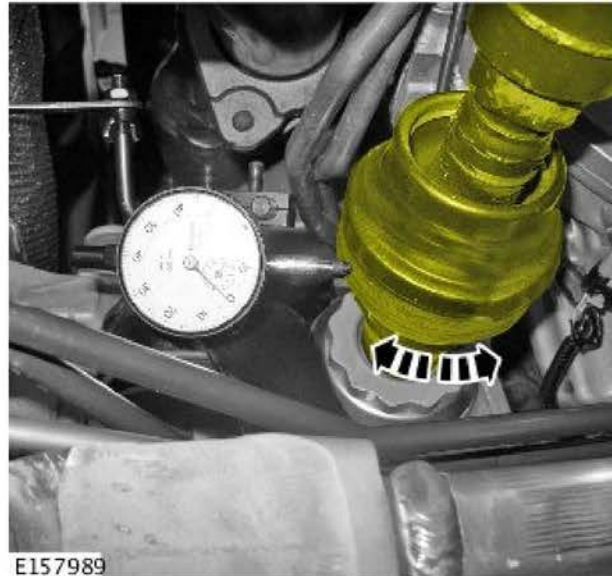
Hold one of the rear wheels in position and rotate the other to measure the Total Indicator Reading (TIR) of the joint head.

- Record the TIR value.

Repeat Step 18, making adjustments as necessary, until TIR is as close to zero as possible (must be less than 0.15mm TIR).

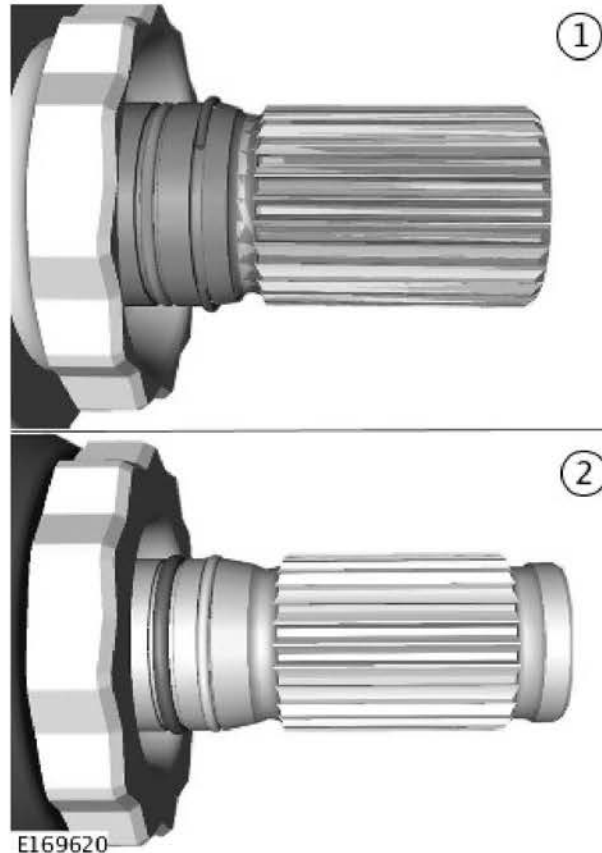
As identified in Service Instruction 'A', step 8:

- (1) 'Old' type
 - If the vehicle is fitted with the 'Old' type (1) front differential pinion, continue to step 2.
- (2) 'Modified' type
 - If the vehicle is fitted with the 'Modified' type (2), continue to step 3.

If vibration still present after performing Service Instruction 'A' and the vehicle is fitted with the 'Old' type (1) front differential, replace the front differential and the front driveshaft with the latest production parts to reduce eccentricity at coupling (see TOPIX Workshop Manual, section 205-03).

If vibration still present after performing Service Instruction 'A' and the vehicle is fitted with the 'New' type (2) front differential, replace only the front driveshaft with the latest production parts to reduce eccentricity at coupling (see TOPIX Workshop Manual, section 205-03).
