TECHNICAL BULLETIN
Q425NAS1
30 OCT 2014

Service Action: 9 Speed Automatic Transmission Calibration

Range Rover Evoque (LV)

Model Year: 2014-2015
VIN: EH815019-FH974024

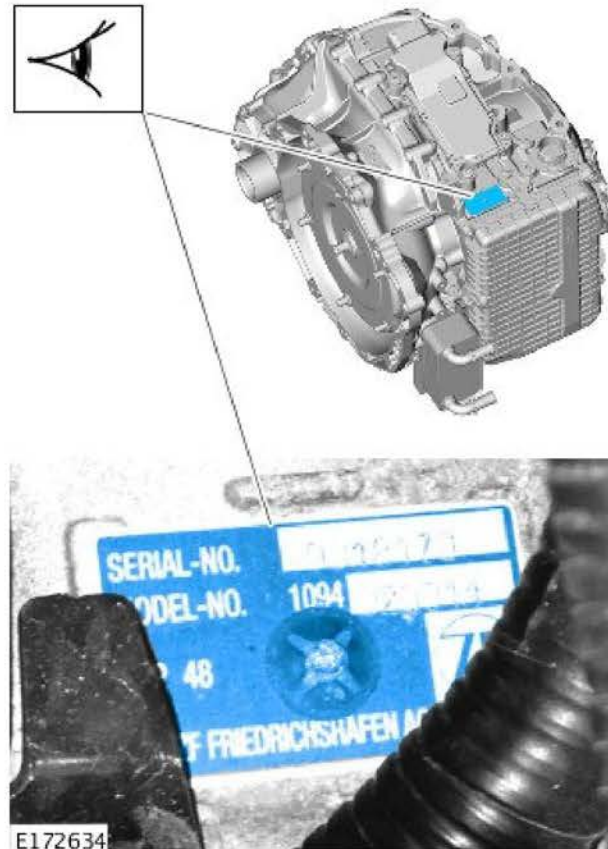
NOTE: During the software update, SDD will prompt you for the transmission serial number. This can be found by looking between the engine and the air filter housing (a lamp may be required for this operation).

Using a suitable lamp, note the transmission serial number on the repair order.
