Reference	SSM72050
Models	Range Rover / L405 Range Rover Sport / L494
Title	L405/L494 Front Air Spring and Damper – Removal and Installation
Category	Chassis
Last modified	31-Oct-2014 00:00:00
Symptom	304000 Suspension System
Attachments	Missaligned Airspring.pdf

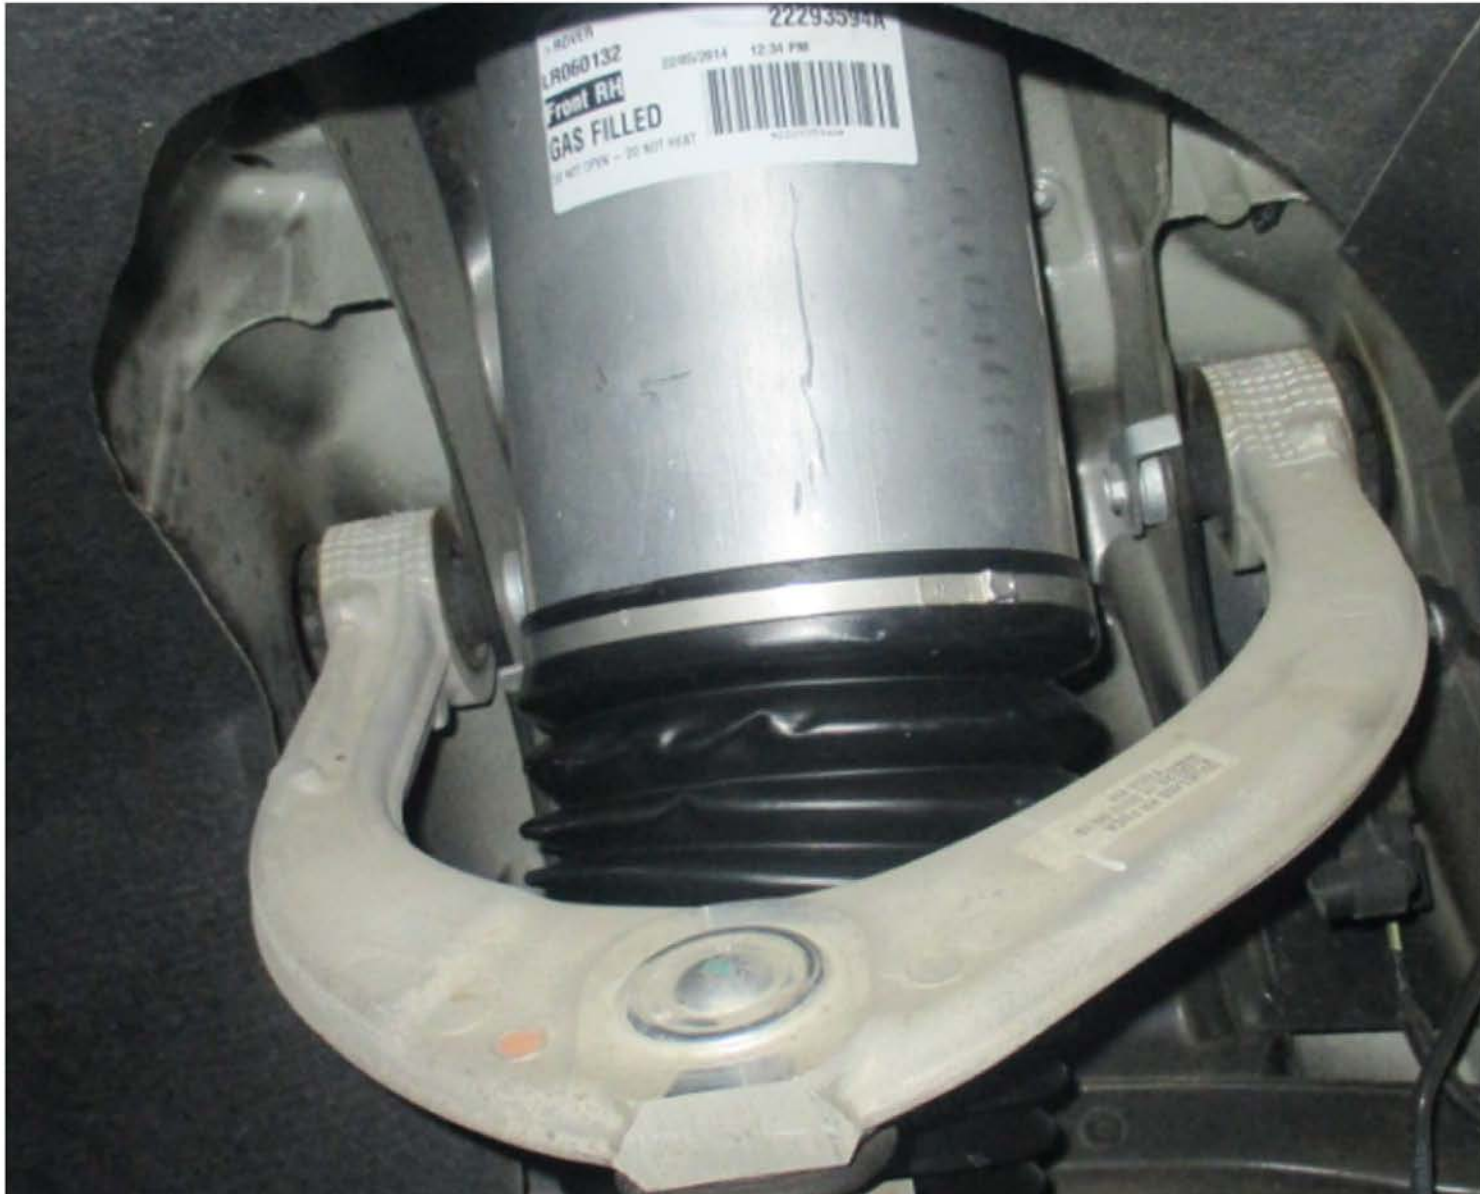
Following replacement of front Air Struts (for example performing LTB604v3/SSM71942) Dealers / Customer may report a noise or a vehicle lean error state. On investigation the front Air Spring is found to be misaligned and damaged. See attached photo

Inflation of Air Suspension Air Springs with the vehicle on the ground (not on a wheel free lift) can cause misalignment and creasing of the Air Bag. The inflation pressures acting on the creased Air Bag can cause permanent damage.

Misaligned Airspring

Please follow the updated TOPIx workshop manual installation procedure - 204-01: Front Suspension - Shock Absorber and Spring Assembly (60.21.01) (60.30.25/99), ensuring that the air spring is inflated, before the vehicle is lowered onto its wheels.

Always handle the Air Strut assembly it by the metallic parts of the component only! Failure to follow this instruction may result in damage to the component
