TECHNICAL BULLETIN
LTB00648NAS1
17 NOV 2014

Harness Repair Terminal Block C44-R2

Range Rover (LG)

Model Year: 2013

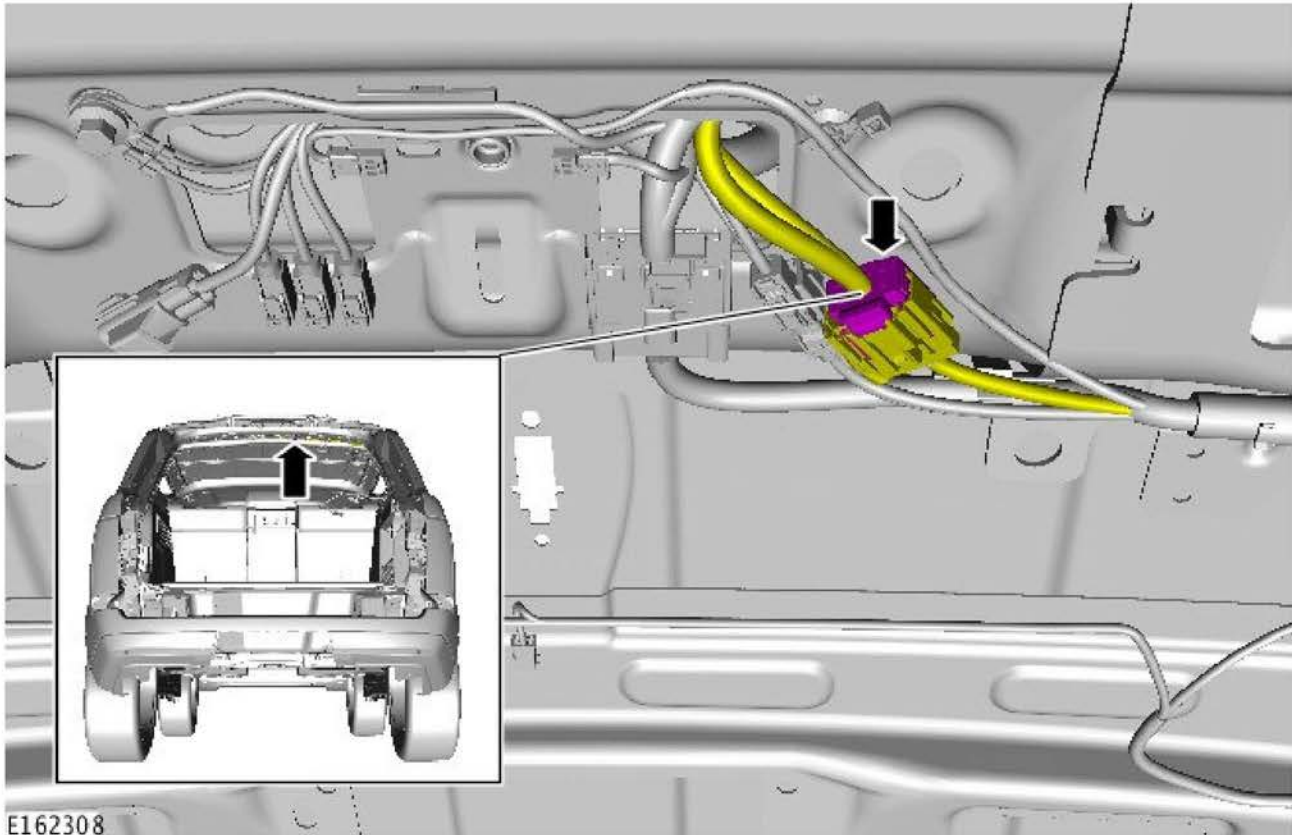
E162308

Cause: These may be caused by terminal block C44-R2 pins 10, 17, 18, and/or 21 having poor continuity.

18. Disconnect the electrical connector C44-R2 from C44-R1.

19. Remove the terminals in the positions 10, 17, 18, and 21 and carry out a pin drag test with each corresponding terminal of connector C44-R1.

- If any of the terminals show no sign of resistance to movement during the test, continue to step 20.
 - If any of the terminals offer a small amount of resistance, refit the original terminals to connector C44-R2 and carry out a continuity test across the two connectors.
- If the joint has good continuity, continue with further diagnosis with reference to TOPIx and SDD.
