TECHNICAL BULLETIN  
Q255NAS2  
10 NOV 2014

Service Action: Water Induced Misfire / Restricted Performance

**Range Rover Evoque (LV)**

**Model Year:** 2012-2013  
**VIN:** CH000447-DH769903

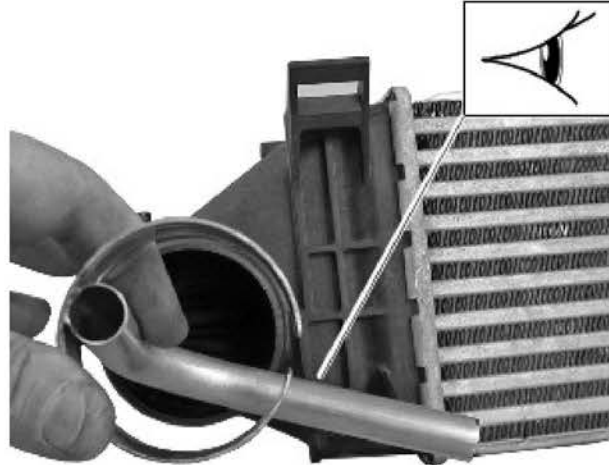
E149136

Note the required orientation of the venturi prior to installation.

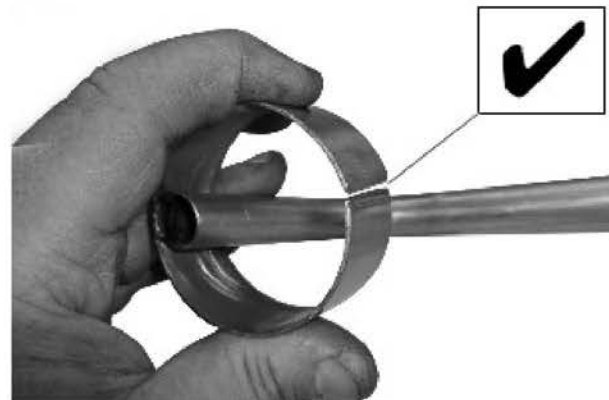
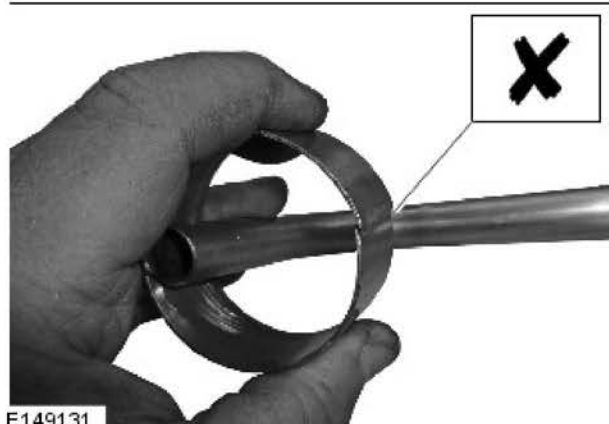
E149131

**CAUTION: The venturi ring will need to be slightly compressed during installation. Make sure that the ring is not compressed so that the ends of the ring overlap. Failure to follow this instruction may result in damage to the vehicle.**

Note the acceptable deformation of the venturi ring prior to installation.

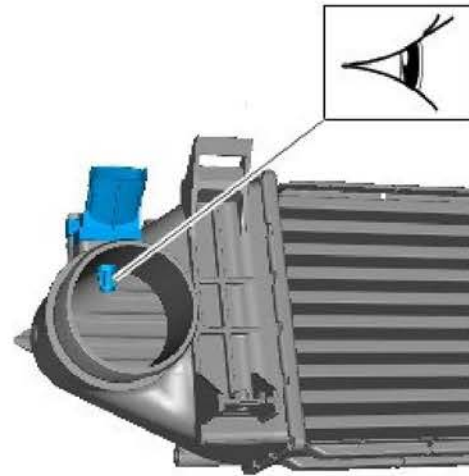
E149137

**CAUTION: Make sure that the sensor is not damaged during the installation of the venturi.**

Note the position of the sensor.

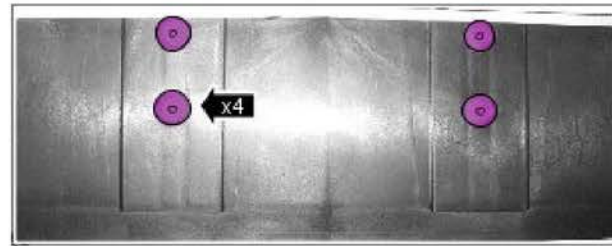
E152334

**CAUTION: Make sure that upper section of the Charge Air Radiator grille is secured with all four (4) rivets before attempting to rotate the assembly. Failure to follow this instruction may result in the dislodging of the rivet(s), resulting in**

damage to the component.

Secure the Charge Air Radiator grille.

- Install the Charge Air Radiator grille to the Charge Air Radiator with the wider section at the top of the Charge Air Radiator.
- Install four (4) rivets to the upper section of the Charge Air Radiator grille.
- Rotate the assembly and install four (4) rivets to the lower section of the Charge Air Radiator grille.
