TECHNICAL BULLETIN
Q255NAS3
24 NOV 2014

Service Action: Water Induced Misfire / Restricted Performance

Range Rover Evoque (LV)

Model Year: 2012-2013
VIN: CH000447-DH769903

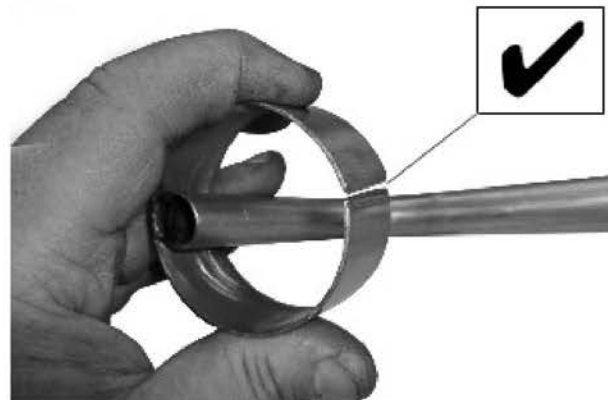
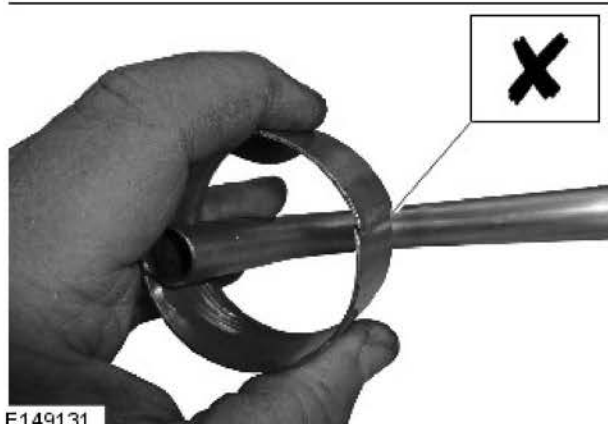
E149131

Note the acceptable deformation of the venturi ring prior to installation.

**CAUTION: The venturi ring will need to be slightly compressed during installation. Make sure that the ring is not compressed so that the ends of the ring overlap. Failure to follow this instruction may result in damage to the vehicle.**

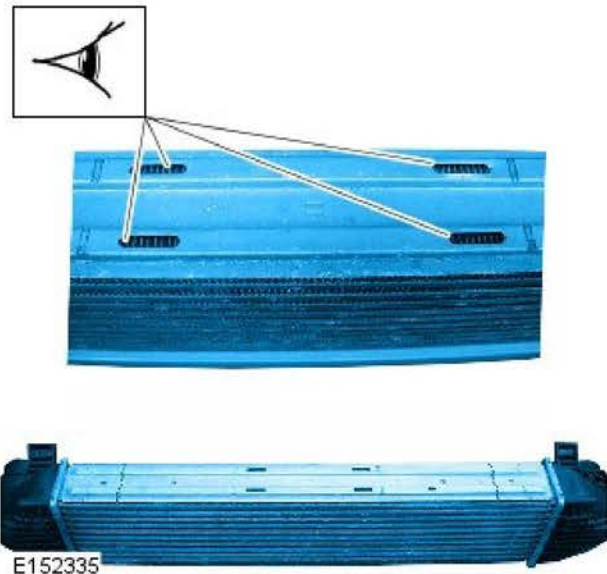
E152335

Identify the eight (8) slots on the Charge Air Radiator.
