TECHNICAL BULLETIN  
Q418 UPS6614-3bNAS1  
19 NOV 2014

Update Prior to Sale: Panoramic Roof Opening Panel / Blind Switch Function

**Range Rover Sport (LW)**

**Range Rover (LG)**

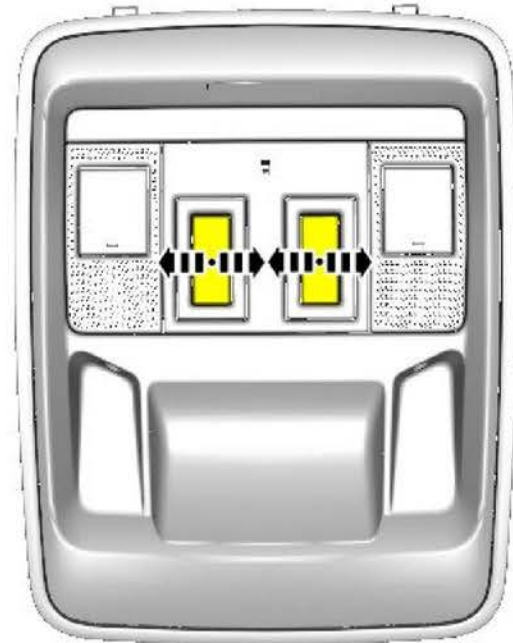
E171780

1. Inspect the front overhead console roof opening panel and roof opening blind switches for side-to-side movement.
  - If faulty, the switches will feel loose and move side to side in the console.

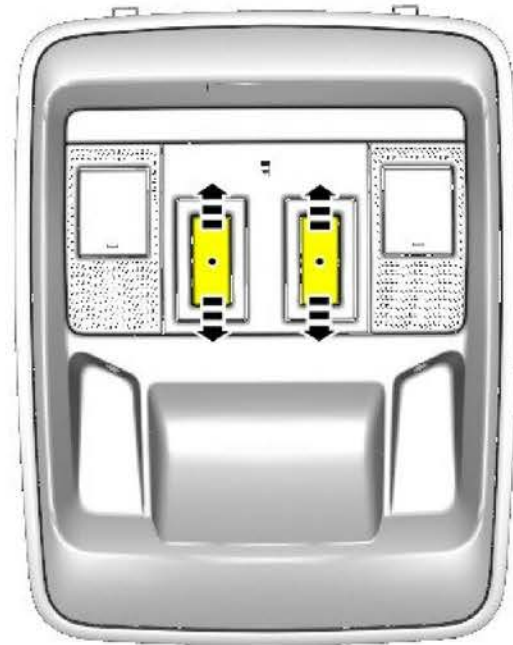
E171778

2. Inspect the front overhead console roof opening panel and roof opening blind switches for positive operation and any abnormal noises when operated.
  - If faulty, a switch will lack a positive 'click' and may also 'squeak' when operated.

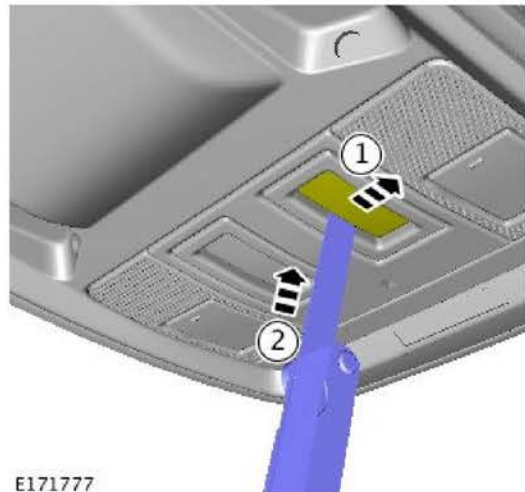
E171777

If any side-to-side movement is found in step 1 and either switch is not secure in the front overhead console, use a plastic feeler gauge to measure the movement of the switch(es) in the front overhead console.

- Side-to-side movement  $\leq 0.5\text{mm}$ : no further action required.
- Side-to-side movement  $> 0.5\text{mm}$ : continue to step 4.

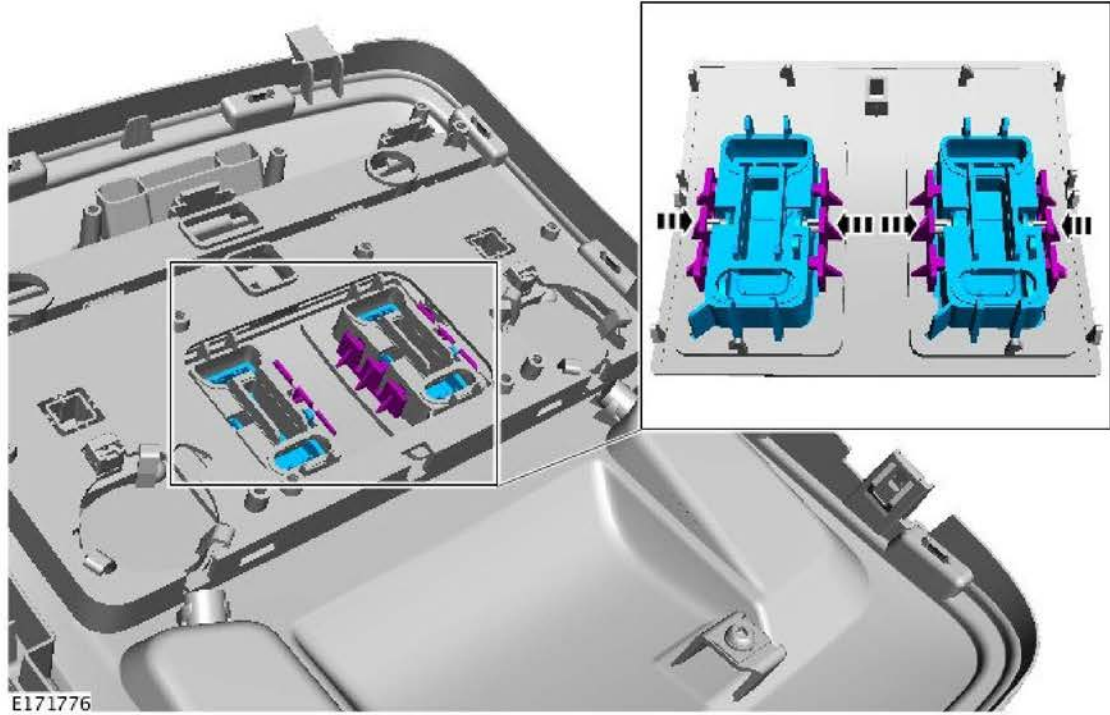
7. Inspect the switch retaining clips, making sure all the clips are fully engaged.
