TECHNICAL BULLETIN
Q425NAS3
14 NOV 2014

Service Action: 9 Speed Automatic Transmission Calibration

Range Rover Evoque (LV)

Model Year: 2014-2015
VIN: EH815019-FH974024

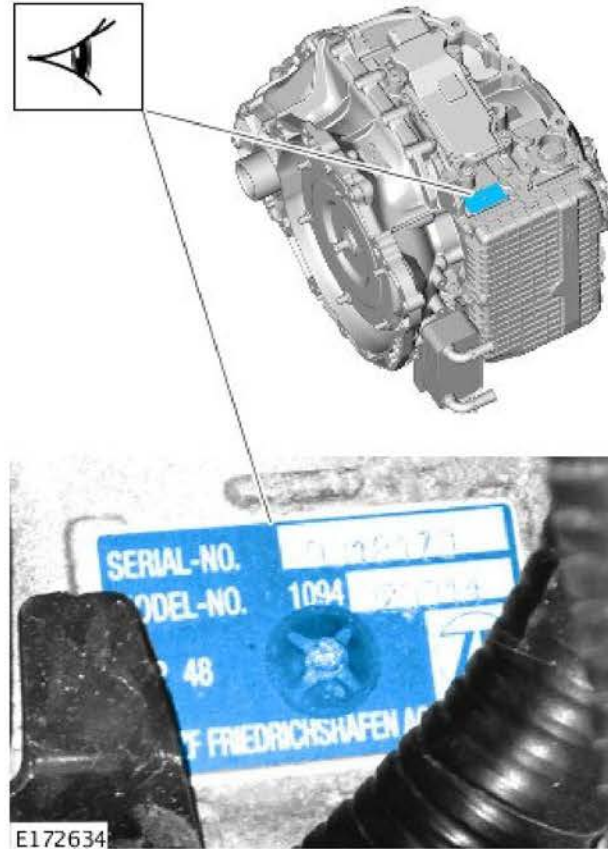
NOTE: During the software update, SDD will prompt you for the transmission serial number. This can be found by looking between the engine and the air filter housing (a lamp may be required for this operation).

Using a suitable lamp, note the transmission serial number on the repair order.
