| Reference | SSM72108 |
| Models | LR4 / L319 |
| Title | 2015 LR4 Instrument Cluster Message Center Display Concern |

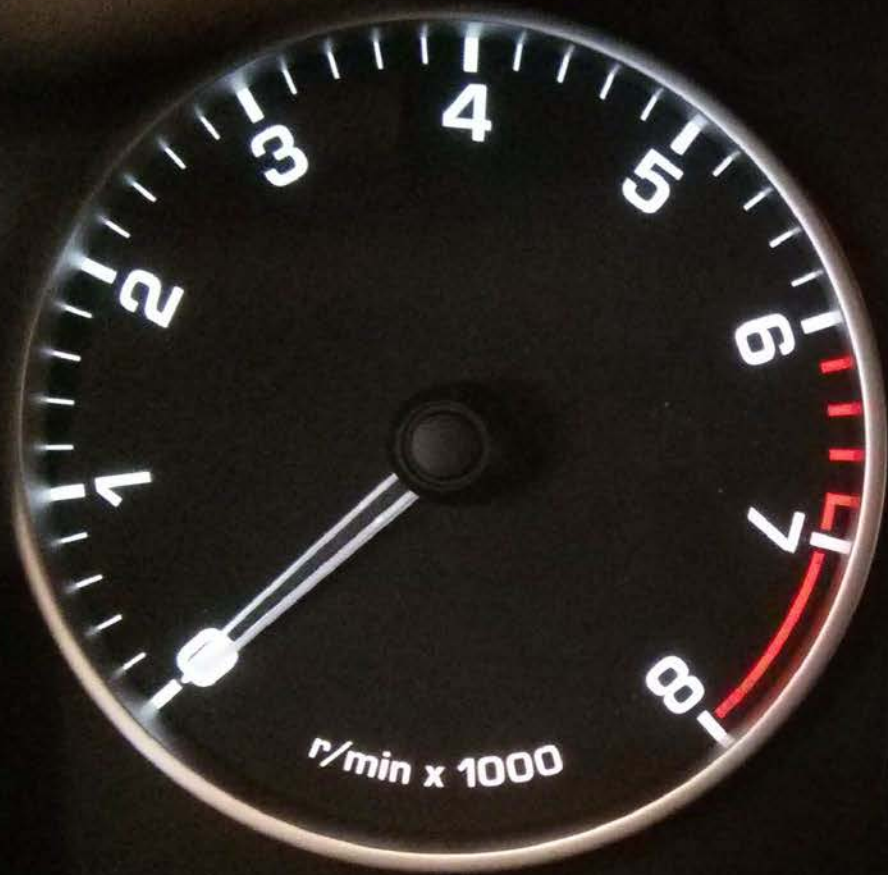
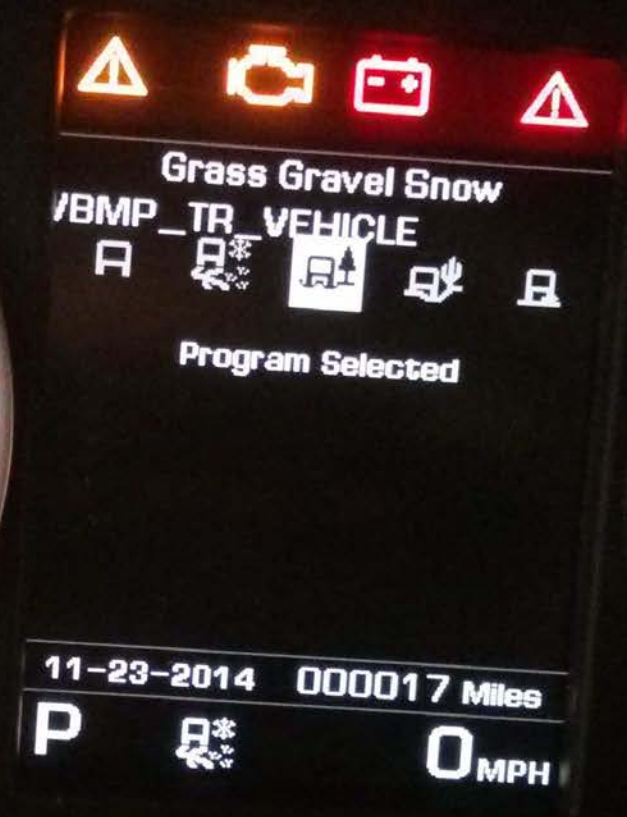
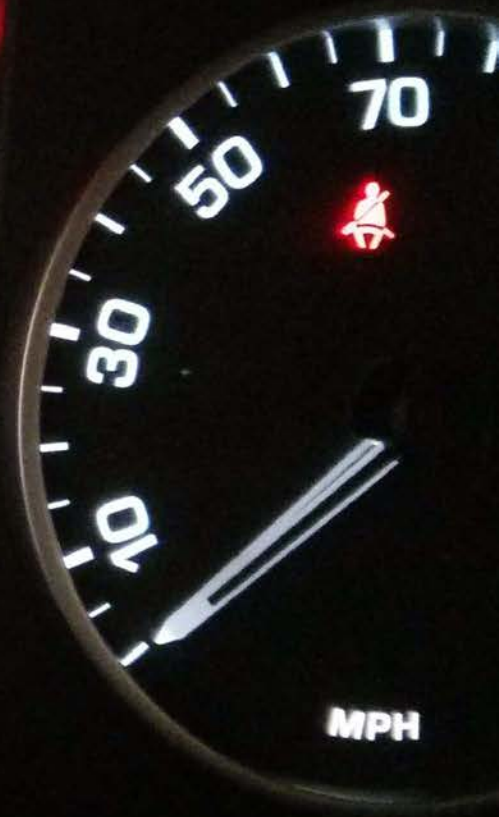
A customer may state their Terrain Optimisation display in the Instrument Cluster Message Center does not correctly match the actual terrain mode which has been selected. Also the text in the Instrument Cluster Message Center, for the selected terrain mode, does not display correctly. "/BMP\_TR\_VEHICLE" is displayed instead of the correct corresponding text for the selected terrain mode.

Instrument Cluster software fault for the "*English US*" language selection.

For further clarification a photo has been attached showing the described concern.

New Instrument Cluster software is being developed and will be released as soon as possible. A further communication will announce the new software, when it becomes available.

As an interim solution, the customer may select "*English UK*" from the Instrument Cluster display menu as follows:

*Main Menu > Display Settings > Language*

Until further notice it is recommended that the UK English language instrument cluster option is selected as a PDI default prior to vehicle delivery and that customers are advised to retain that language option to prevent display concerns.
