| <b>Reference</b> | SSM72083 |
| <b>Models</b> | Range Rover Evoque / L538<br>LR4 / L319<br>Range Rover Sport / L494<br>Range Rover / L405 |
| <b>Title</b> | Twin Solenoid(TS) starter motor diagnosis |

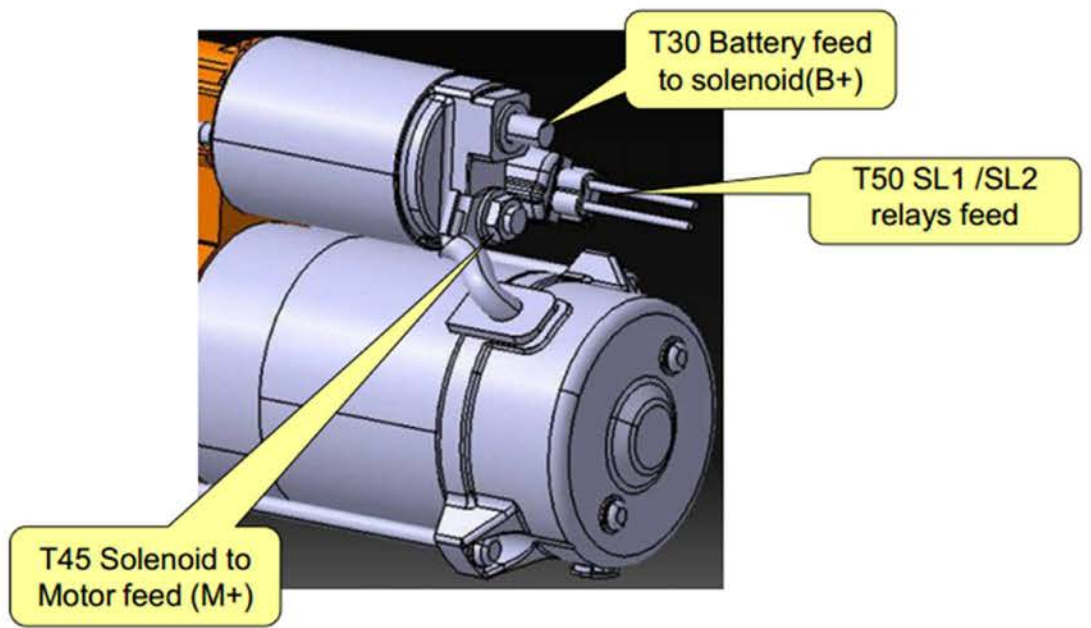
b) Check the connection at the T30 terminal (B+), **see attachment**
