Michael A. Berardi
Director
Service Engineering Operations
Ford Customer Service Division

August 20, 2015

SUBJECT: **DELIVERY HOLD - Customer Satisfaction Program 15B21 – Supplement #2**
Certain 2015 Model Year Edge Vehicles
A-Pillar Water Leak Inspection and Repair

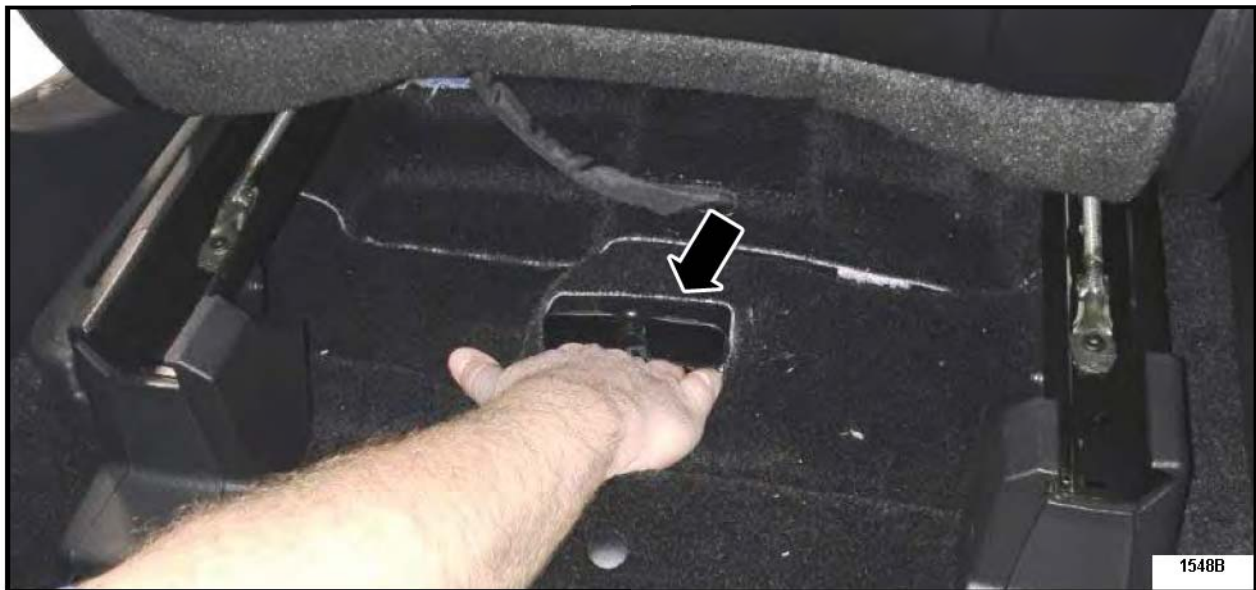
FIGURE 1

- c. Move both front seats to full forward position. From rear seat area, reach in through the holes in the carpet below the rear seat climate control ducts on the floor and feel for water or evidence of moisture on the floor pan sheet metal. See Figure 1.

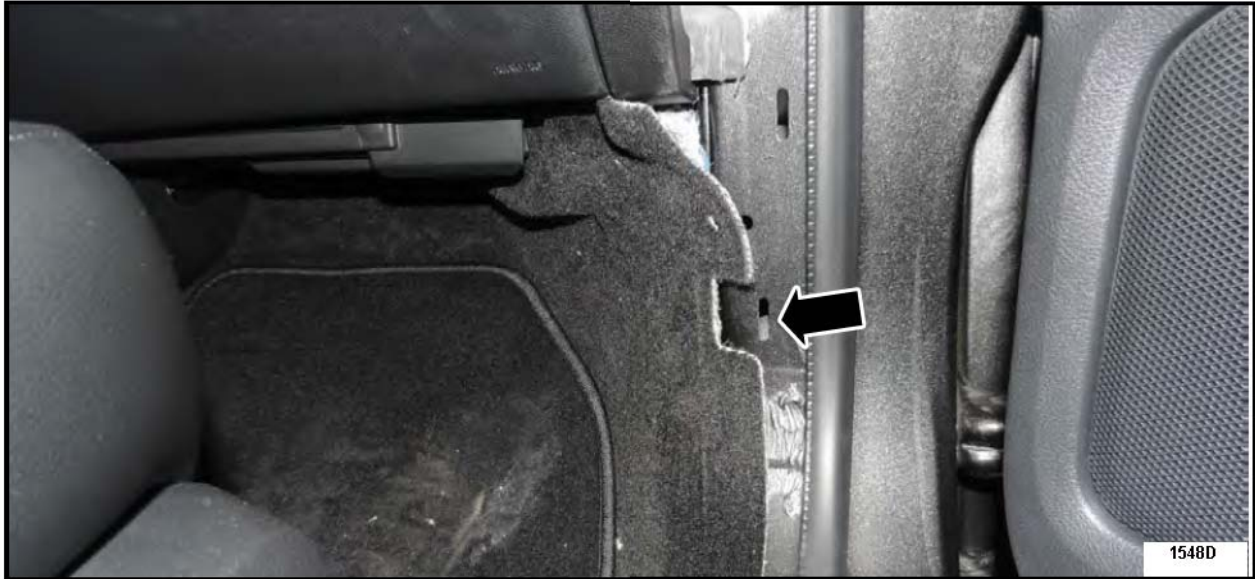
FIGURE 6

7. Using a cotton swab or a piece of paper/cardboard, check for the presence of standing water and visually check for the evidence of water/dampness in the lower A-pillar on both the LH and RH sides of the vehicle through the interior cowl trim panel lower attaching clip retainer opening. See Figure 6.
8. Pull back the carpet and padding on the floor next to the LH and RH A-pillar areas and check for water/dampness.
- **Is standing water, moisture or a mildew/musty odor present?**
 - YES** – Proceed to Wet Vehicle Repair Procedure (Attachment V).
 - NO** – The vehicle did not experience a water leak. Continue to Upper A-pillar Sheet Metal Seam Sealing Procedure to complete repairs.

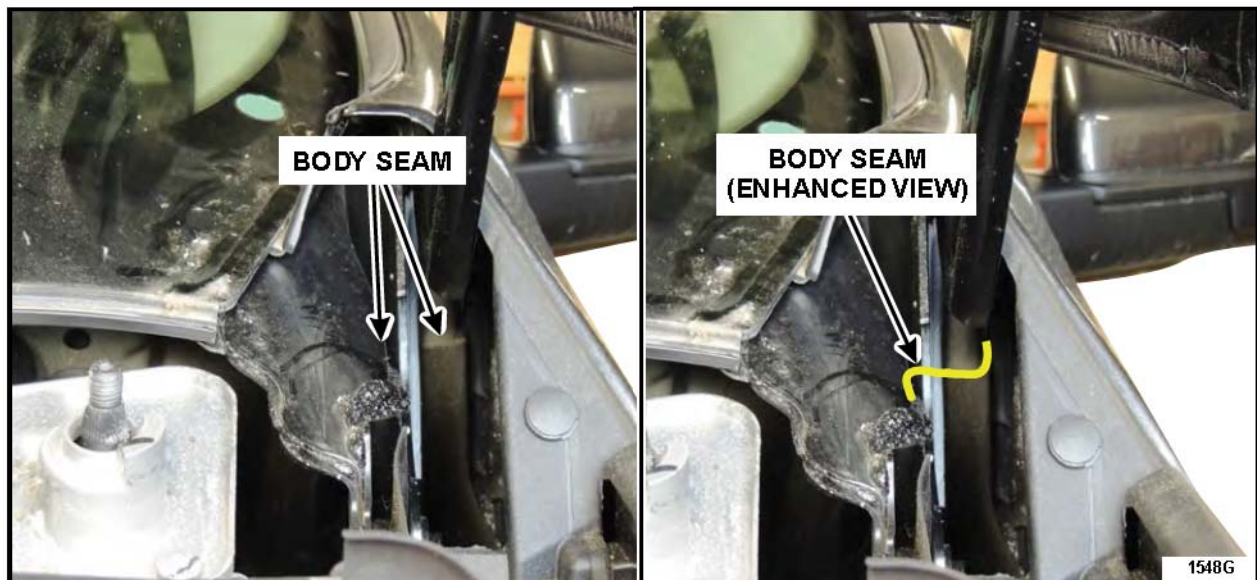
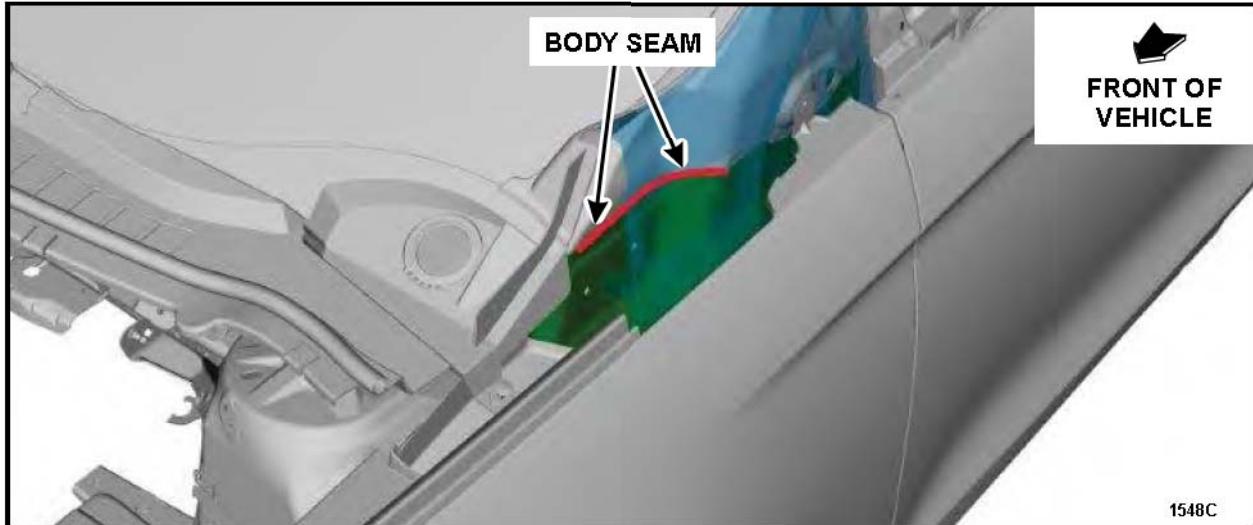
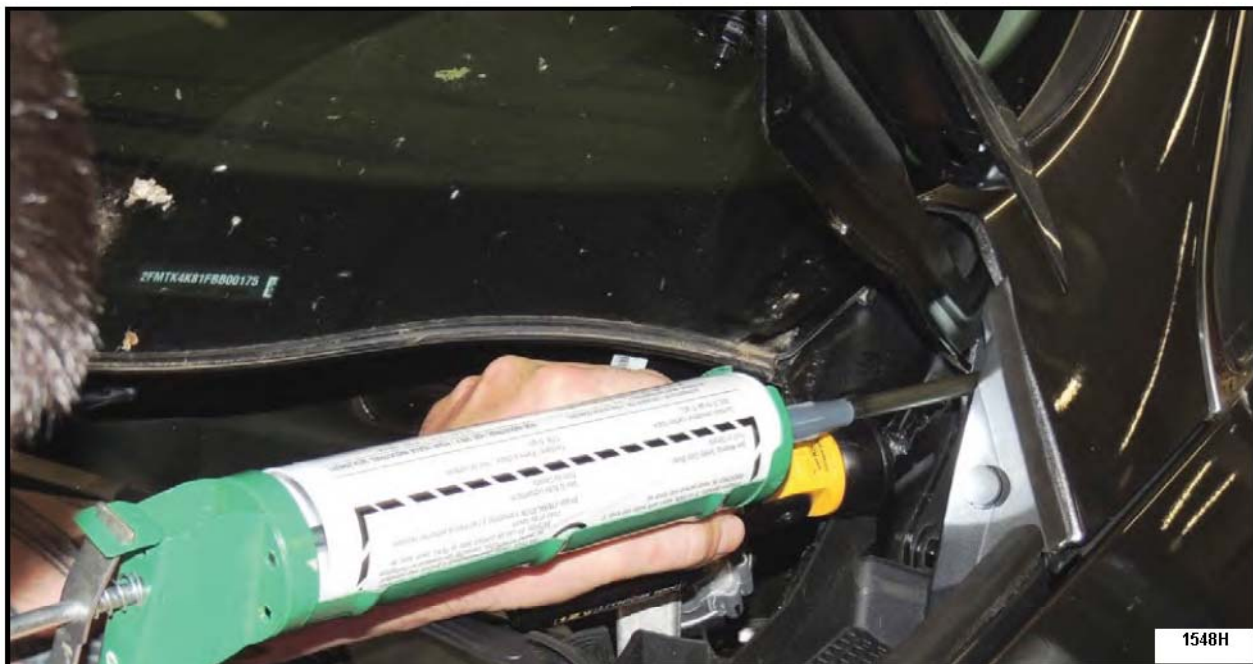
FIGURE 9

3. Open the hood and locate the body seam that runs behind the hood hinge at the base of the exterior A-pillar on both the RH and LH sides of the vehicle. See Figures 9 and 10.

4. Use a flashlight to locate the body seam that runs behind and along the side of the LH and RH hood hinges. Apply a bead of sealer to the body seam. See Figures 9, 10 and 11.

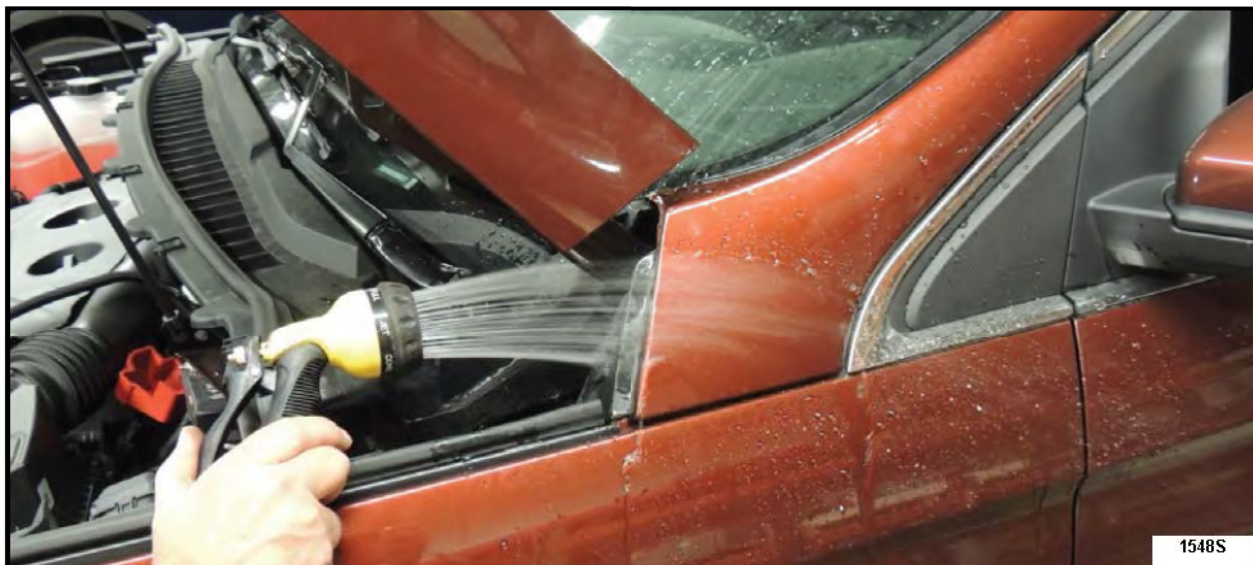
FIGURE 13

- NOTE:** Observe the LH and RH lower A-pillar area while water testing the vehicle.

- If water is leaking into the A-pillar(s) dry with compressed air and apply additional seam sealer to repair area. Repeat step to verify repair as needed.

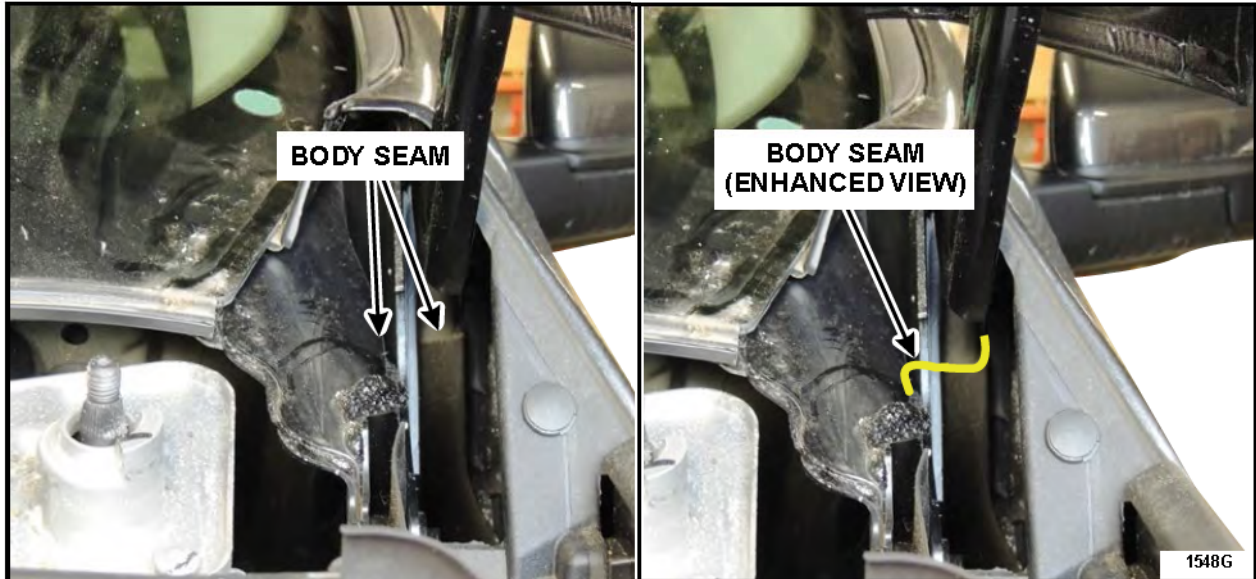
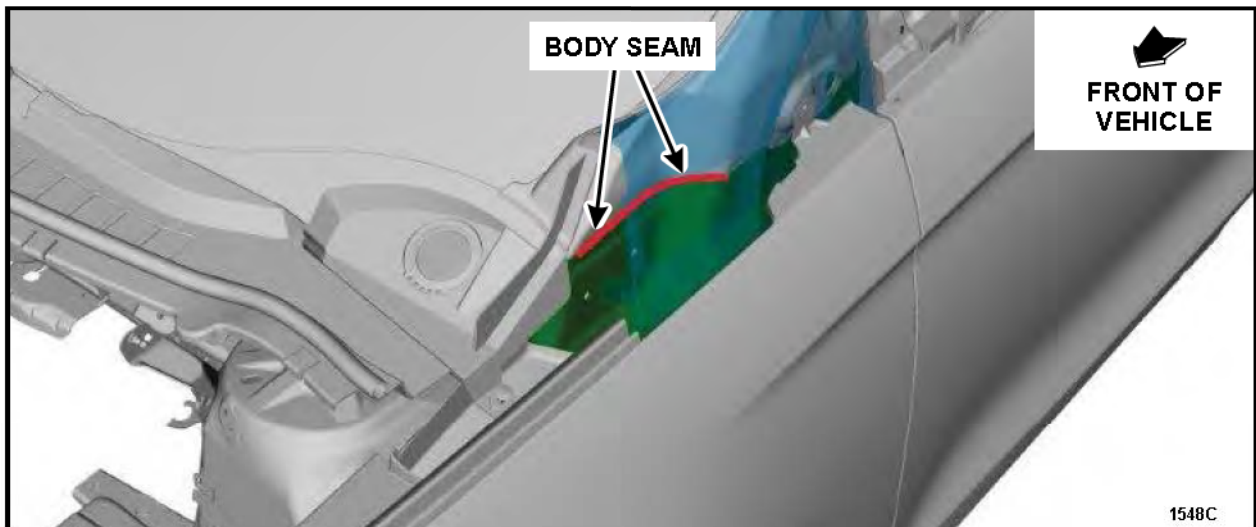
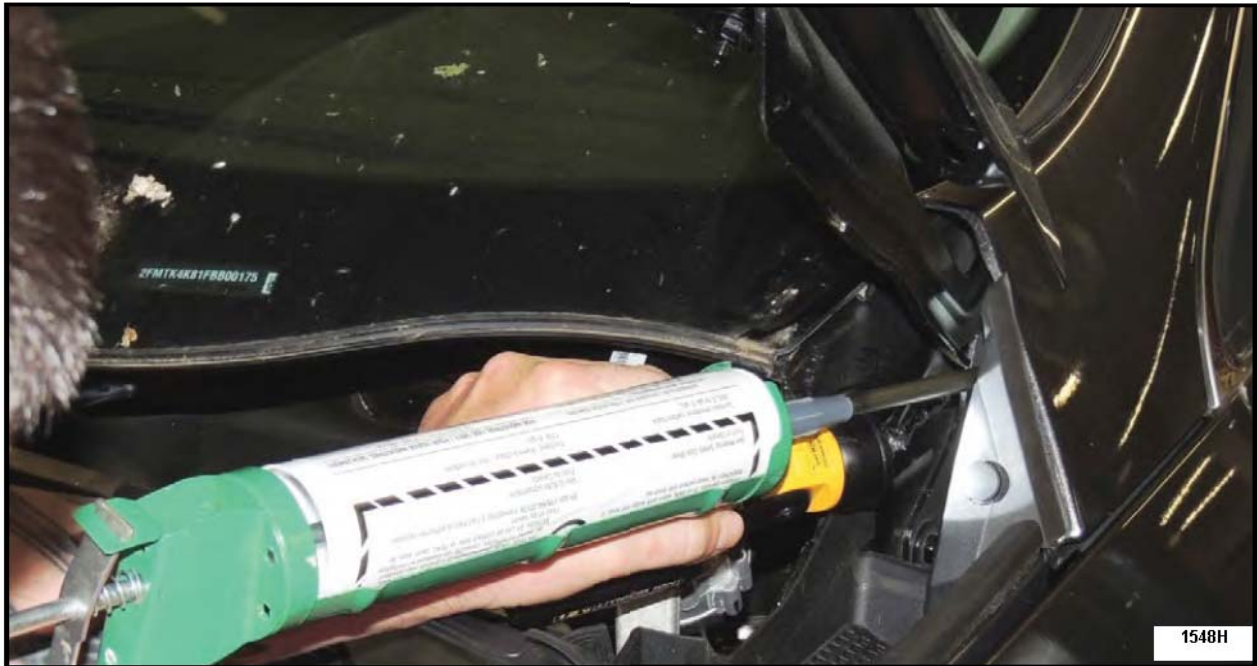
FIGURE 9

11. Open the hood and locate the body seam that runs behind the hood hinge at the base of the exterior A-pillar on both the LH and RH sides of the vehicle. See Figures 9 and 10.

12. Use a flashlight to locate the body seam that runs behind and along the side of the LH and RH hood hinges. Apply a bead of sealer to the body seam. See Figures 10, 11 and 12.
