ARTICLES CONTAINED IN THIS ISSUE

12 WHITISH DISCOLORATION / DEPOSITS ON FRONT DOOR PANELS, 2012MY AND LATER IMPREZA AND XV CROSSTREK®, 2015 WRX AND STI

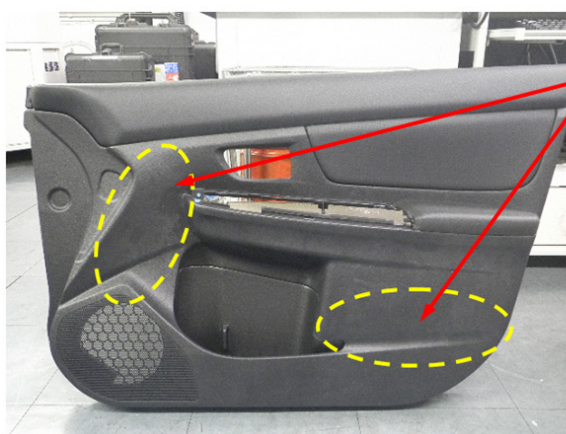
If you receive a customer concern of a whitish discoloration found on the front interior door trim panels, it is most likely a by-product of the scratch prevention agent used in the front door trim material. If the vehicle has been in storage for a period of time or unused with all the windows closed, a lack of air circulation in the cabin can cause deposits to form on the front door trim panel surfaces in the areas shown in the photo below.

Common areas for the whitish deposits to accumulate.

Use a clean detailing cloth wet with plain water to remove the deposits. After the surface dries, confirm all the deposits have been removed. Should any deposits remain, repeat the process again. Make sure the cloth is wet as using a dry cloth can damage the surface of the trim panel.

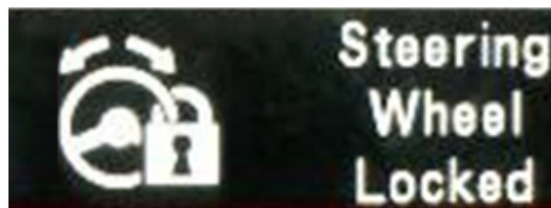
Should you receive a customer concern of no crank or no response from the push-button start button, make sure the steering column is not locked. The information display on the combination meter may also show the warning indicator shown. For example: on a key-start vehicle, the key may not turn in the ignition if there is excess pressure being placed on the steering lock. In those cases, the steering wheel needs to be turned side to side to release the ignition lock and start the car (see Section 3: "Instruments & Controls" of the applicable Owner's Manual). The same holds true for push-button start vehicles except, since there is no key to turn, if the steering lock has excess pressure placed on it, there will be no starter response when pressing the start button. In addition, the operation indicator on the button itself will flash green (for a maximum of 15 seconds). Just as on a key-start vehicle, the steering wheel must be turned side to side to release the pressure on the ignition lock allowing the starter motor to operate. The steps to take should this occur on a push-button start equipped vehicle are: press the brake pedal down firmly, verify the green operation indicator on the start button is flashing then rock the steering wheel side to side while pressing the start button. This condition is a normal operating characteristic and no attempt should be made to repair it. If the customer reports the indicator on the start button is a color other than green when the condition occurs, diagnose the concern following the troubleshooting section of the applicable Service Manual.

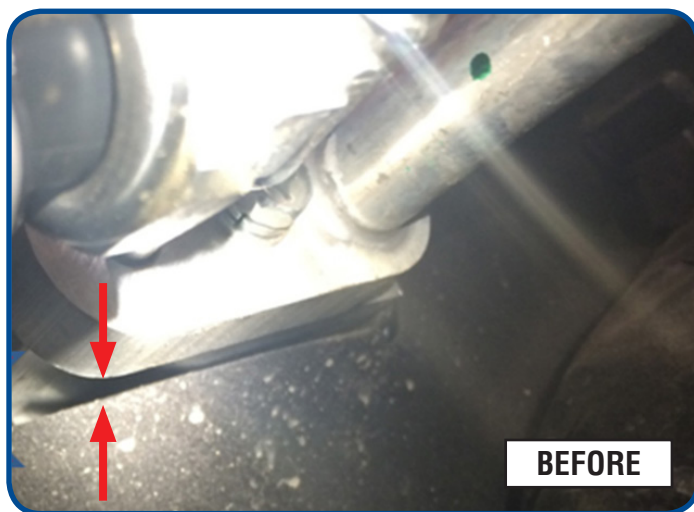
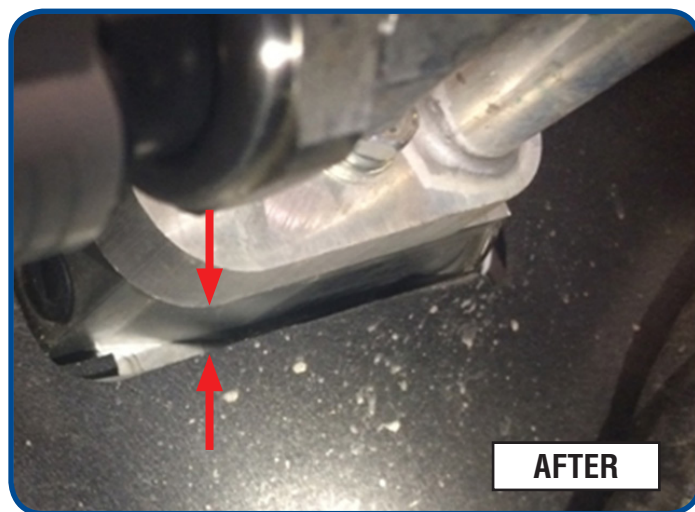
The Techline has received a small number of concerns regarding a rattling sound which seems to be coming from the right side of the dash / behind the glove box area. This information is not model / model year specific. In some cases, the sound is easily duplicated with the engine at idle, transmission in gear and under high electrical load condition (A/C on, headlights and other accessories on, etc.). Confirmed cases have shown contact between the expansion (TXV) valve assembly and the bulkhead at the pass-through area as shown in the “before” and “after” photos below. The A/C system piping is aluminum and can easily become bent or displaced if precautions are not taken when working in this area of the engine bay. Take care to not lean on / against or otherwise move this piping when working on or trying to gain access to other components in the immediate area. Otherwise, the expansion valve assembly may end up out of position resulting in a rattling sound and potential customer comeback situation. In this case, a careful “repositioning” was all that was required to provide the additional clearance needed to eliminate the sound.
