## ROADSTER 2015 Transmission Wiring Harness Incorrect Routing - Pinched Harness (F3 SE6)\_000109799\_MES61Y015S05\_en

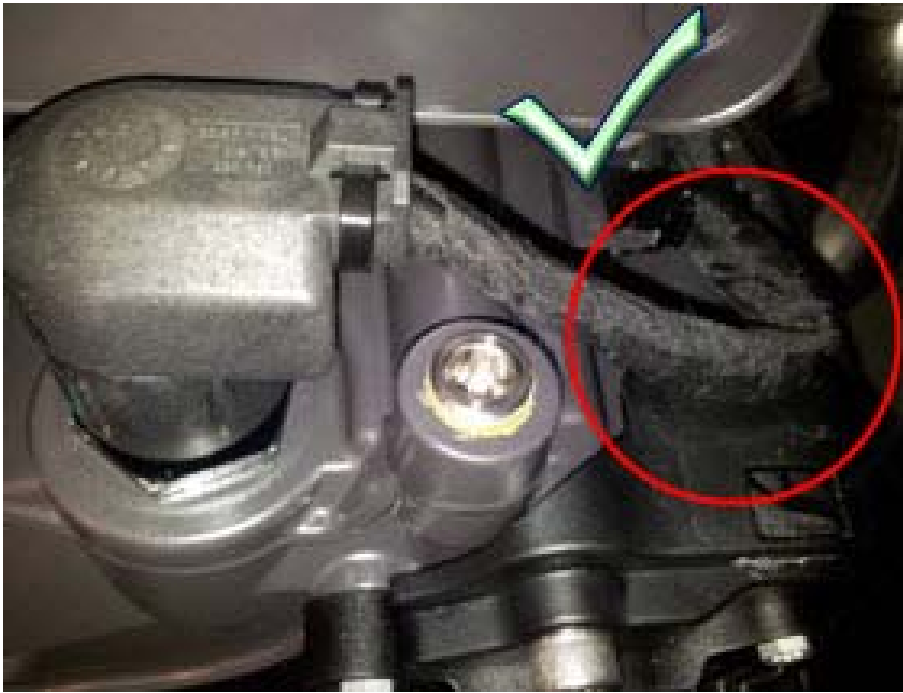
Front top harness correct routing

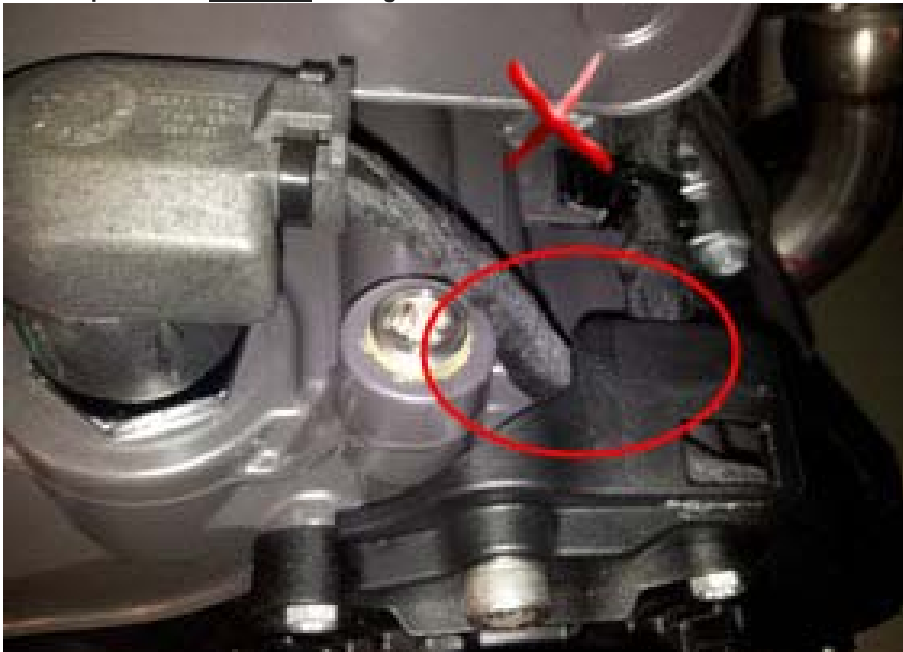
Front top harness incorrect routing

If upper or lower harness has the incorrect routing:  
Unscrew partially the plastic cover screws.  
Reposition wiring harness as specification per correct routing illustrations above..  
Tighten back plastic cover screws at 10 Nm +/- 2 Nm.

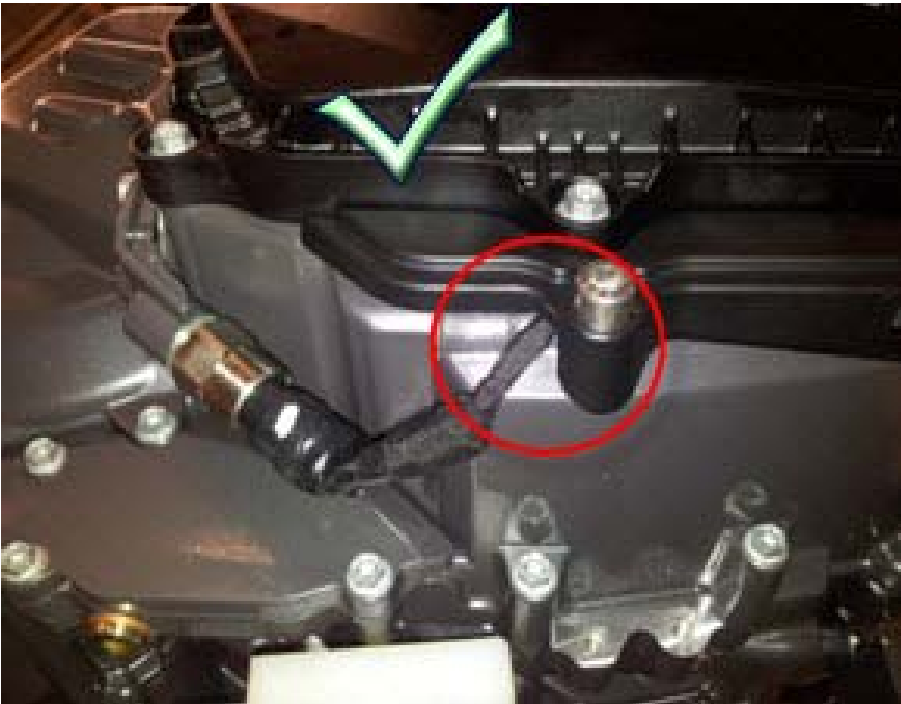
Bottom rear harness correct routing

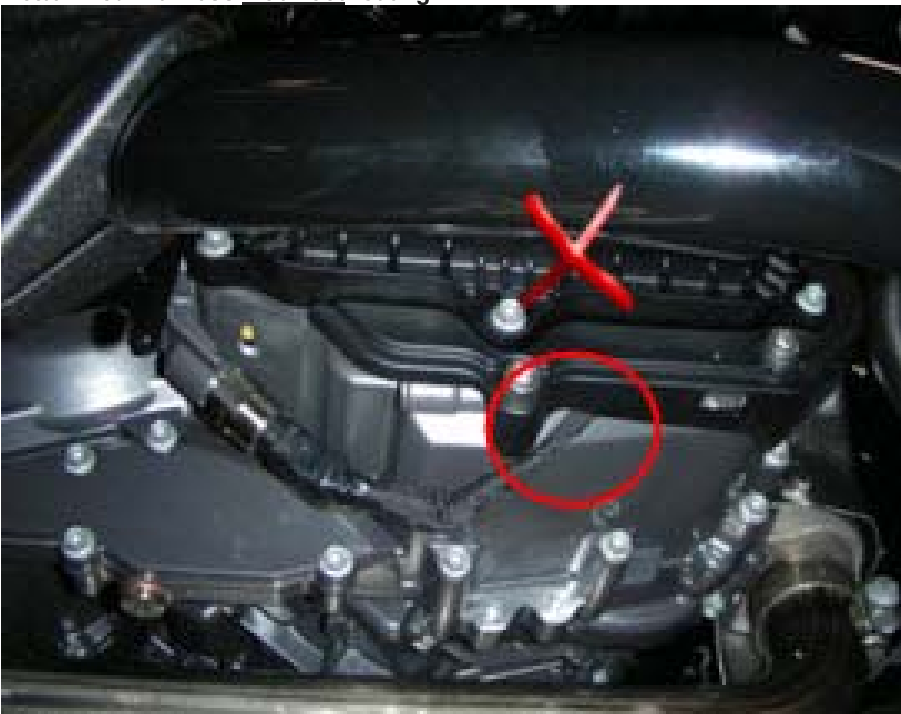
Bottom rear harness incorrect routing
