Engine Harness Relocation  
MP7 US2015  
CXU, GU, LEU, MRU

## PI0865, Engine Harness Relocation

(December 2015)

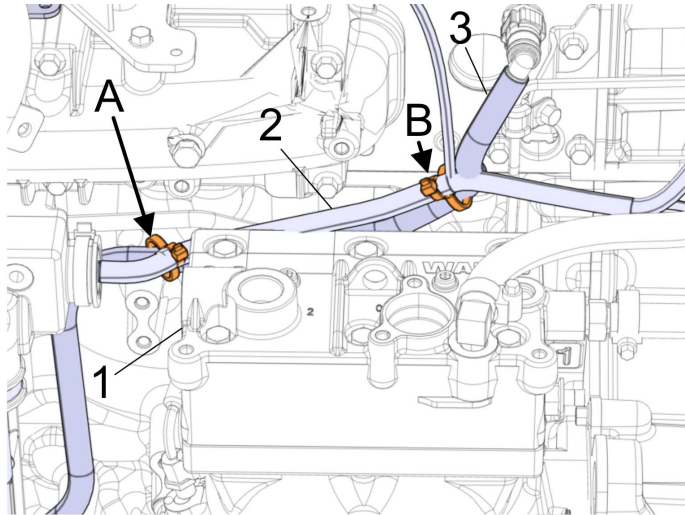
W3107068

The engine harness on MACK MP7 US2015 engines built between March 1, 2015 and August 31, 2015 may be making contact with the air compressor head and rubbing through. It will be necessary to relocate the harness in this area. If wire damage is noted during the harness relocation, reference FSB 373-022 for the repair instructions and continue with the harness relocation after the repairs are done.

- 1. Air Compressor
- 2. Engine Harness
- 3. Cylinder Head Fuel Line

- 9 Relocate the engine harness (2) and install double tie retainers (part number 20885496) as shown (A and B) to secure harness to cylinder head fuel line (3). Ensure harness is not touching air compressor. Make sure the ties are snugged tight.

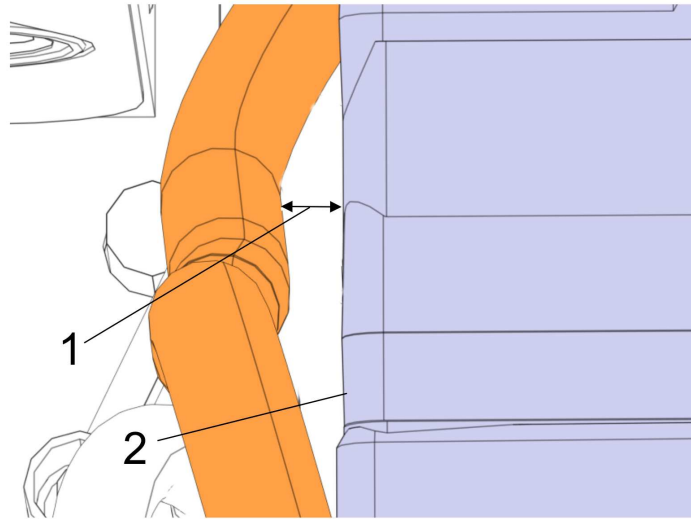
W2107161

Front View

- 1. Clearance
- 2. Air Compressor
