MODEL  
**2016MY  
Sorento (UMa)**

NUMBER  
**PS401 (REV 1, 08/21/2015)**

**SUBJECT: INTERMITTENT NO SOUND FROM HEAD UNIT**

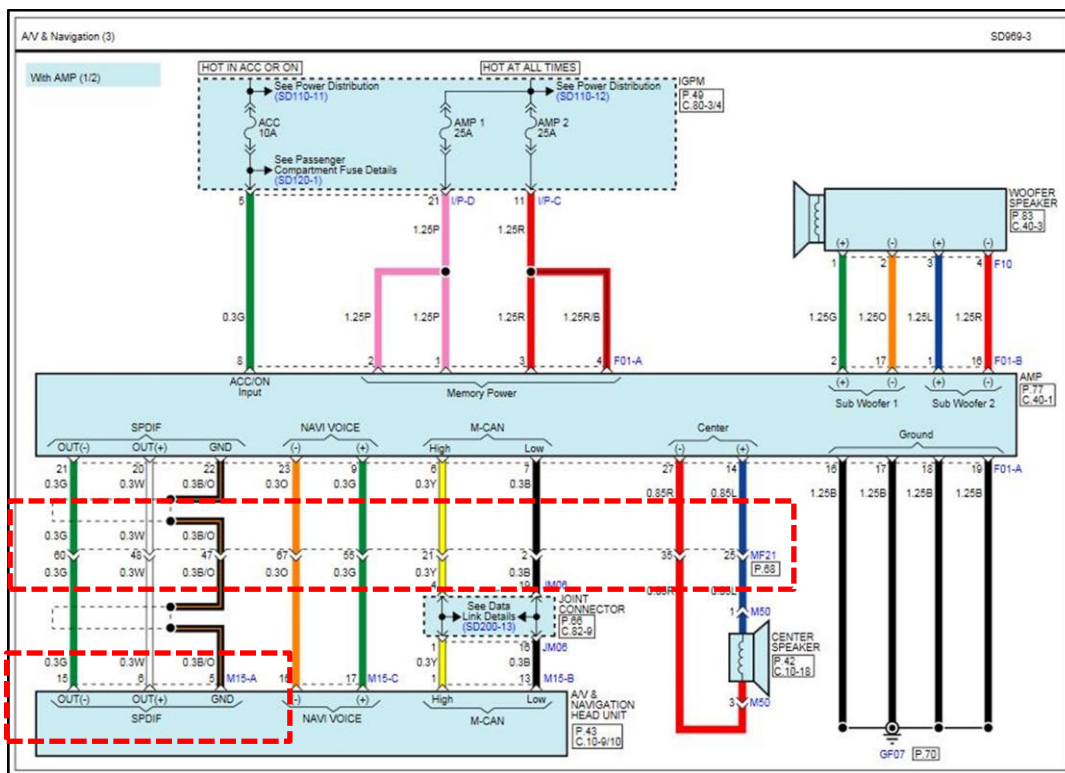
On some 2016MY Sorento (UMa) vehicles equipped with AVN 4.0 navigation head units, customers may complain of the audio system having no sound, intermittently. This condition may be caused by loose pin(s) on connector M15-A (see diagram) behind the head unit and/or on connector MF-21 on the passenger side kick panel. Follow the procedure outlined below to resolve the concern.

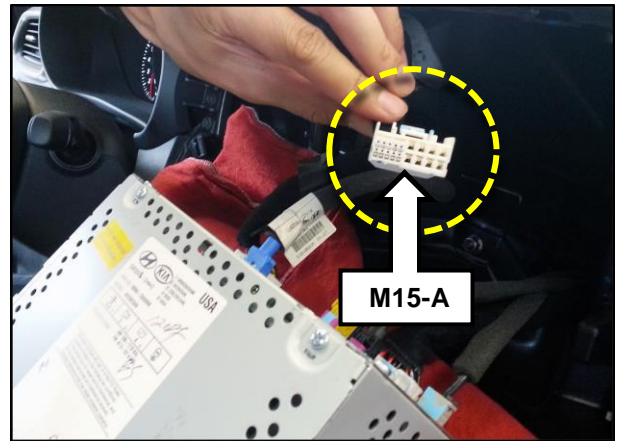
3. Remove all connectors from the back of the head unit. **NOTE: Connector M15-A is shown for reference.**
