GROUP Electrical	MODEL 2012~2013MY Optima (QF/TF)
	NUMBER PS422	DATE July 2015

SUBJECT: ABS HECU REPLACEMENT DUE TO HESITATION CONCERNS

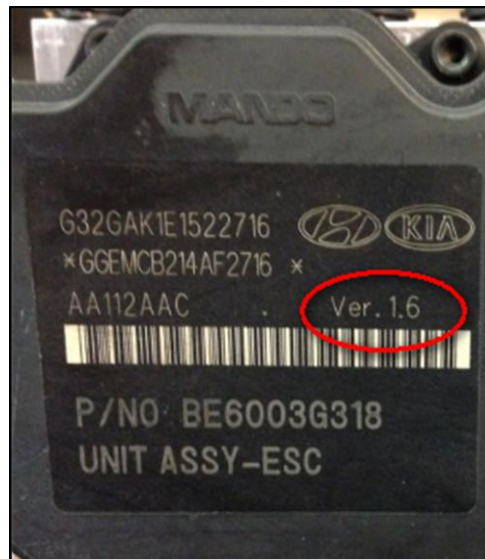
When addressing customer concerns regarding hesitation from the vehicle on hard acceleration, test drive the vehicle to verify the concern. Prior to test driving the vehicle, eliminate common Electronic Stability Control (ESC) trigger factors such as excessive or unevenly worn tires and slippery road conditions. If during hard acceleration testing the ESC light illuminates on the dash and abnormal hesitation is experienced, replace the ABS Hydraulic Electronic Control Unit (HECU) with a module containing the latest S/W version, as shown in the table and image below. **NOTE: always verify latest applicable P/N information using EPC.**

Configuration	Part Number	Old S/W Version	New S/W Version
ABS HECU w/o EPB equipped	58920 2T550	1.4	1.5
ABS HECU with EPB equipped (SXL only)	58920 4C550	1.6	1.7
