MODEL
2011-2013MY
Sorento (XM)

NUMBER
042

TECHNICAL SERVICE BULLETIN

SUBJECT: FRONT STRUT BEARING REPLACEMENT

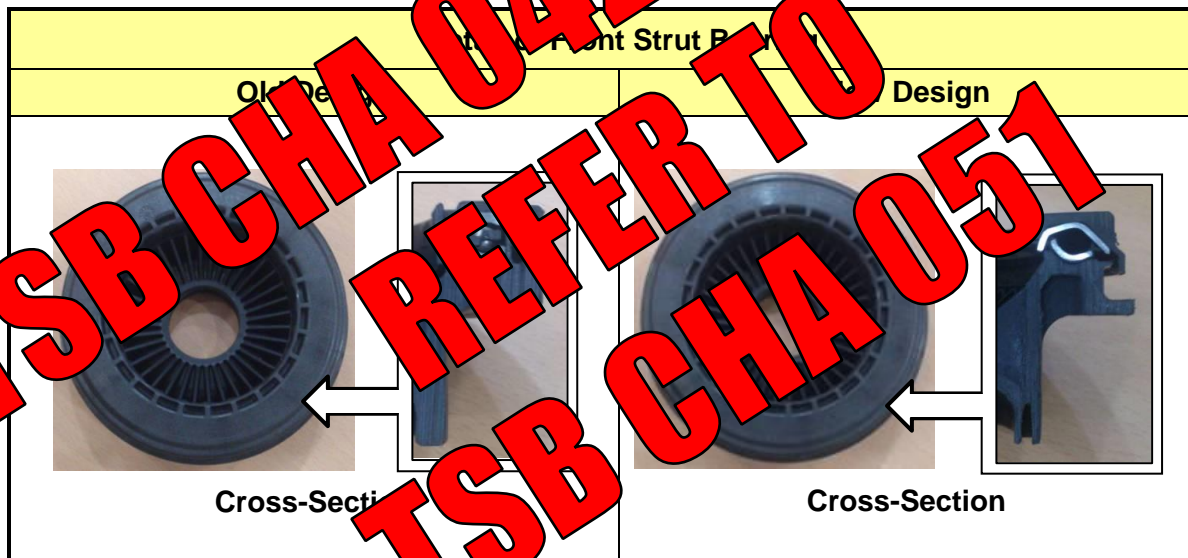
This bulletin provides the procedure for replacing the front strut bearing on some 2011-2013MY Sorento (XM) vehicles, produced from October 26, 2010 through February 21, 2013, which may exhibit a creaking noise emanating from the front of the vehicle when turning the wheel, quickly, at slow speeds. This concern may be caused by corrosion of the front strut bearing due to water or debris entry and is more commonly found in regions where heavy amounts of road salt are used for de-icing in the winter months. Follow the procedure outlined in this bulletin to replace both front strut bearings to resolve the concern.
