Program Bulletin

CUSTOMER SATISFACTION PROGRAM

SUBJECT: Rear Axle Grinding Noise, Vibration - Inspect Rear Axle

MODELS: 2011-2012 Chevrolet Express
2011-2012 Chevrolet Silverado, Suburban 2500 Series
2011-2012 GMC Savana
2011-2012 GMC Sierra, Yukon XL 2500 Series
Equipped with a 10.5" Rear Axle

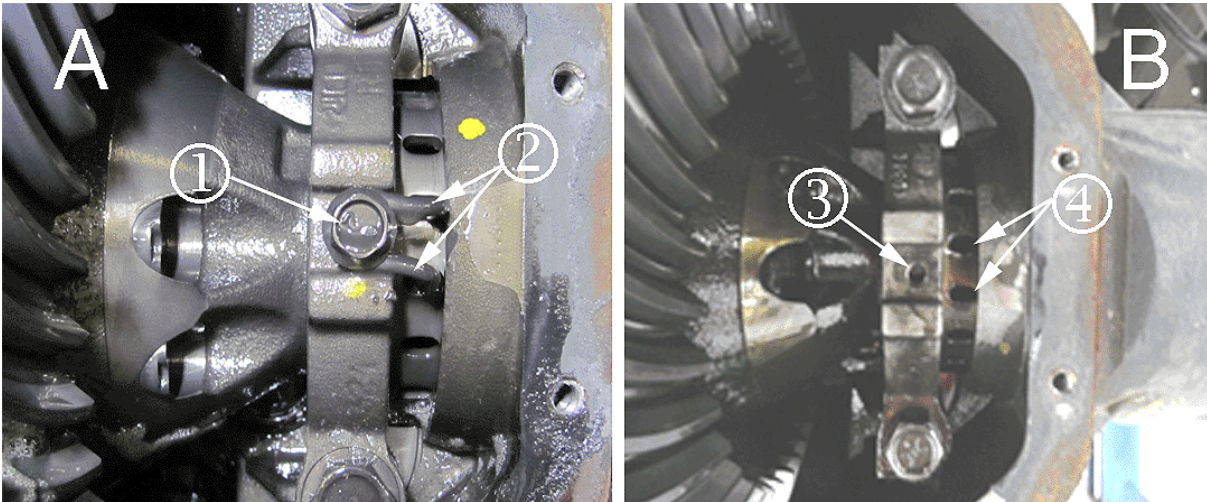
2790899

Adjuster Bolt (1) and (2) Clip Present. (B) Adjuster Bolt and Clip Not Present (3) and (4).

10. Determine if the passenger side (right) adjuster bolt (1) and clip (2) are present.
 - If the passenger side adjuster bolt and clip are present (A), remove the adjuster bolt and clip. Discard only the clip. Refer to illustration. Proceed to Step 11.

- If the passenger side adjuster bolt and clip are NOT present (B), replace the drive pinion, ring gear, differential side bearings, adjuster bolt and adjuster clip. Refer to *Differential Replacement (10.5 Inch Axle)* in SI. Proceed to Step 14 after replacing the drive pinion, ring gear, pinion bearings and differential side bearings. Refer to illustration.

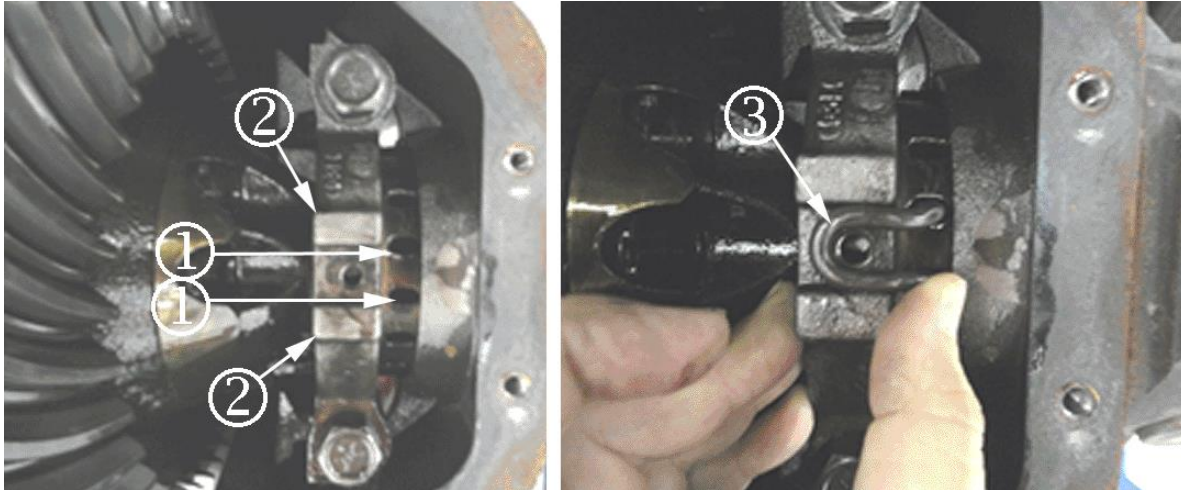
2790908

Visually inspect the adjuster nut slot alignment (1) and then use a new adjuster clip (3) to verify slot alignment. The adjuster clip (3) must be seated between the cap bolt ribs (2) and into the adjuster nut holes as shown in illustration.

11. Inspect the adjuster nut slot location in reference to the cap bolt ribs (2).
 - If the adjuster nut slots are aligned (1) as shown in illustration, no adjustment is required. Proceed to Step 13.
 - If the adjuster nut slots do NOT align, proceed to Step 12.

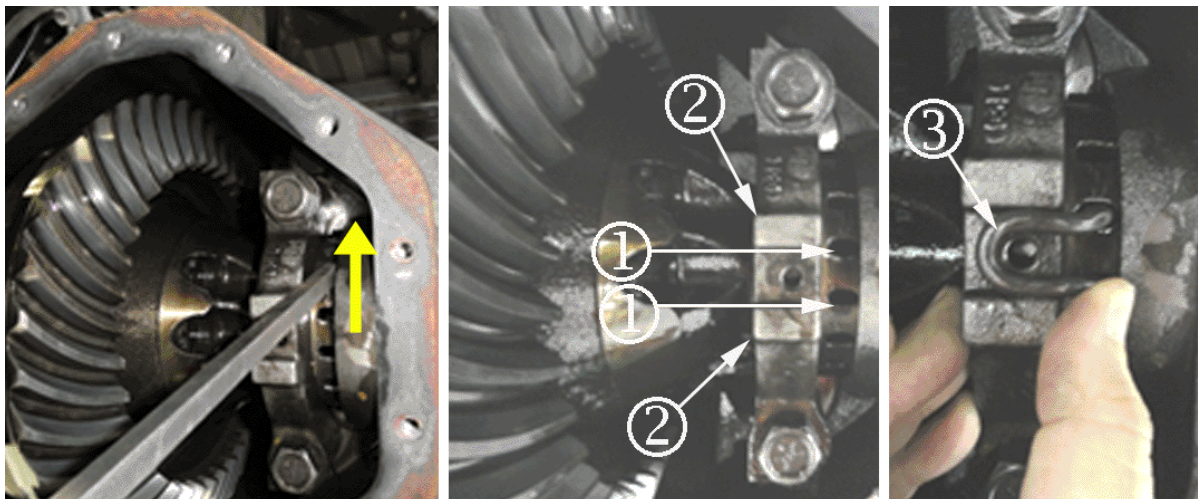
2790914

Caution: If indexing the adjuster is required, the adjustment direction is critical. The passenger side adjuster **MUST** be rotated in an upper direction to the nearest slot. If an upper direction is **NOT** used, bearing preload is lost.

- Using J-24429 spanner (or equivalent) in the adjuster nut slot (1), rotate the adjuster nut enough to center the clip between the cap bolt ribs. Only rotate the adjuster nut in an upward direction.

- Use a new adjuster clip (3) to verify alignment. The adjuster clip (3) must be seated between the cap bolt ribs (2) and into the adjuster nut slots as shown in illustration.
