GROUP Body	MODEL 2014MY Forte (YD)
	NUMBER PS396	DATE April 2015

SUBJECT: WATER LEAKING INTO TRUNK AND/OR REAR FLOORBOARD AREA

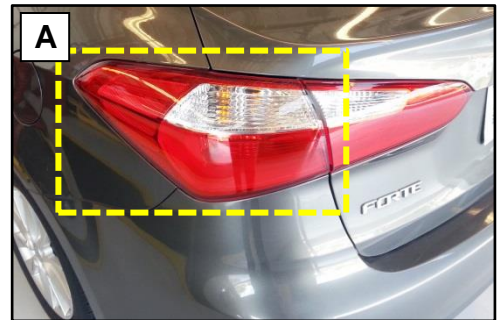
On some 2014MY Forte (YD) vehicles, produced prior to May 21, 2014, customers may complain of water leaking into the trunk and/or rear floorboard area, after a rainstorm or a carwash. This condition may be caused by improper sealing between the outer tail lamp (A) gasket and the body of the vehicle. To resolve this concern, replace the existing gaskets with the improved parts on both outer tail lamp assemblies. **NOTE: Do NOT order the complete outer tail lamp assembly to resolve this concern.**

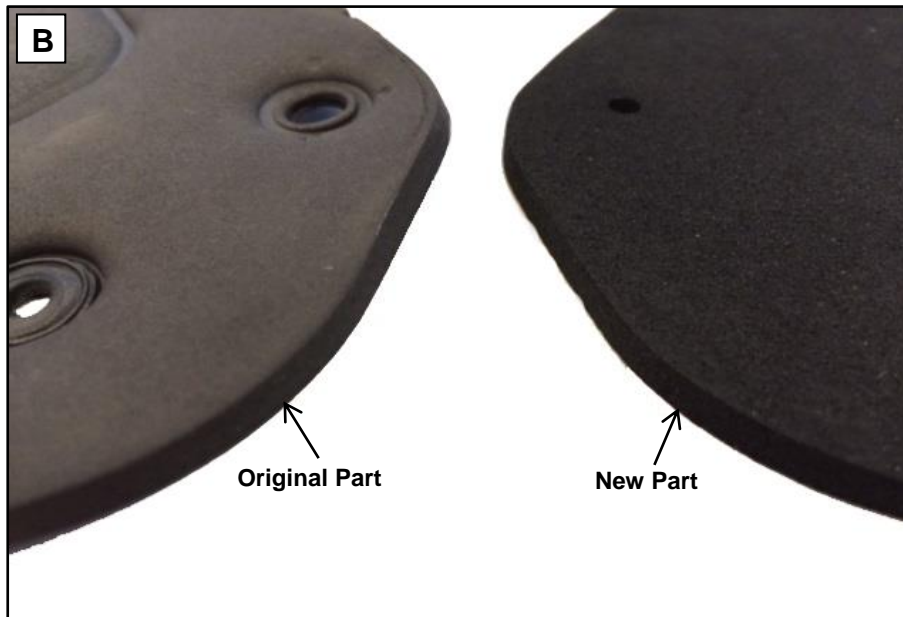
NOTE: The improved gasket for the outer tail lamps is made from a different, darker-colored material and is 1mm thicker than the original part (B).
