GROUP Electrical	MODEL 2015MY Soul EV (PS EV)
	NUMBER PS393	DATE April 2015

SUBJECT: SOUL EV (PS EV) – GMI FAULT ON AEROVIRONMENT™ DC FAST CHARGER (LEVEL 3)

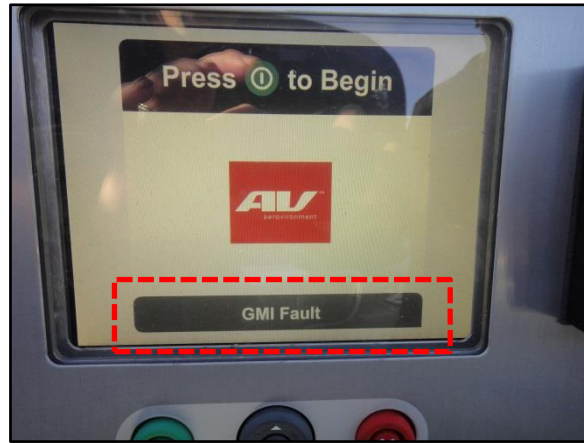
When encountering customer complaints of a Ground Monitor Interrupt (GMI) fault occurring ONLY when attempting to fast charge on an AeroVironment (AV) Level 3 charger, first verify the vehicle will successfully charge on a non-AeroVironment Level 3 Charger (ABB, Signet, etc.). If the GMI fault ONLY occurs when charging on the AeroVironment Level 3 charger, the Battery Management System (BMS) unit may require replacement. Contact Techline to receive additional diagnostic guidance to resolve this concern.
