GROUP <b>Chassis</b>	MODEL <b>2016MY Sorento (UMa)</b>
	NUMBER <b>PS390</b>	DATE <b>March 2015</b>

**SUBJECT:** SORENTO (UMa) – CREAKING NOISE FROM FRONT SUSPENSION

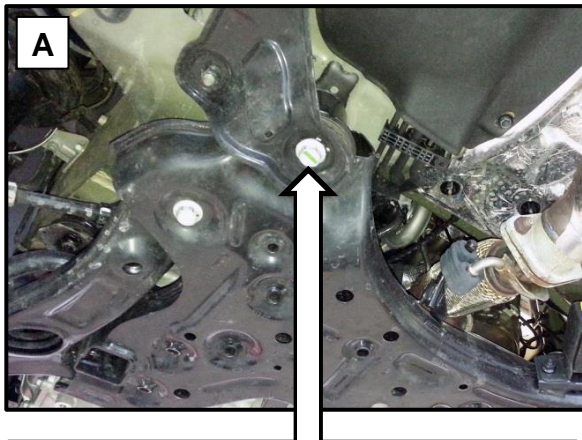
When diagnosing a customer complaint of a creaking or popping noise coming from the front suspension while accelerating or decelerating, inspect the two (2) rearmost sub-frame bolts (A) to verify the correct bolt was installed during assembly. The correct bolt should have a raised hexagonal crown and an irregularly-shaped flange (Fig B). If the incorrect bolt is found to be installed, remove and replace using P/N 62492 C5000.

**Tightening torque: 43.4 ~ 50.6 lb-ft (58.8 ~ 68.6 N·m)**
