PRODUCT CAMPAIGN BULLETIN

APPLICABILITY: 2003-2004 Baja
 2003-2004 Legacy and Outback
 2004-2005 Impreza, WRX, STI

SUBJECT: Takata Front Passenger Air Bag Inflator Replacement

NUMBER: WQR-53R
DATE: June 2, 2015
REVISED: September 25, 2015
NHTSA ID: 15V-323

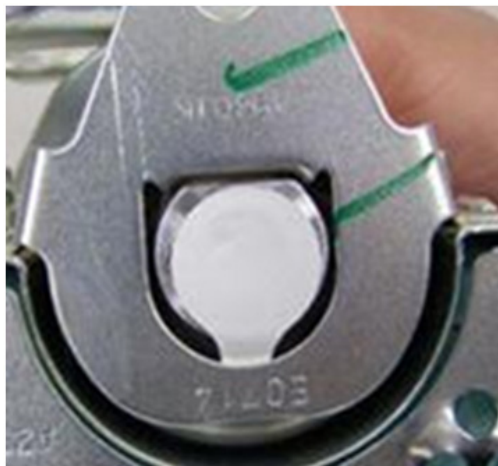
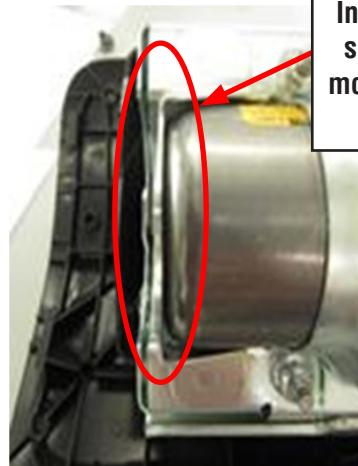
Inflator properly seated against mounting bracket (NO GAP)

STEP 9- Install the new inflator into the mounting bracket so the yellow taped end aligns with the removed stopper plate. Make sure the “D-shaped” portion of the inflator harness connector boss aligns with the “D-shaped” portion of the hole in the end of the mounting bracket as shown below. When properly installed, the end of the inflator will be seated tight against the mounting bracket. Do not peel the white harness connection dust cover at this time.

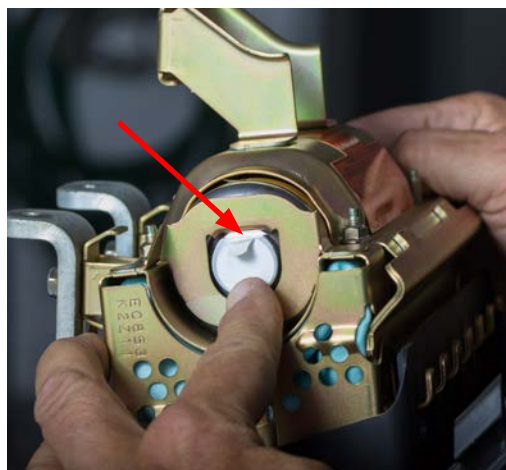
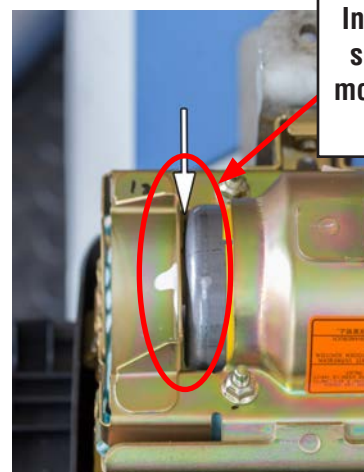
Inflator properly seated against mounting bracket (NO GAP)

STEP 9- Install the new inflator into the mounting bracket with the harness connector end going in first toward the mounting bracket. Make sure the “D-shaped” portion of the inflator harness connector boss aligns with the “D-shaped” portion of the hole in the end of the mounting bracket as shown below. When properly installed, the end of the inflator will be seated tight against the mounting bracket. Do not peel the white harness connection dust cover at this time.
