### ARTICLES CONTAINED IN THIS ISSUE

## 08 2015 MY LEGACY AND OUTBACK: JOURNEY TIME ALERT ON COMBINATION METER TELLTALE DISPLAY

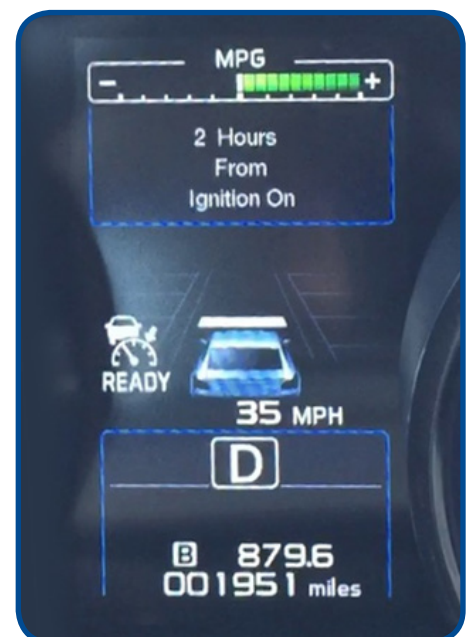
An added feature of the Combination Meter is an alert message (accompanied by a single “beep” sound) which will be displayed in the Telltale section above the odometer after 2 hours of driving have elapsed from ignition ON. The “beep” is the same sound heard when the low fuel lamp is first illuminated. This message is provided simply as a notification to make the driver aware they have been driving for 2 hours and it may be a good time to consider taking a break, checking fuel level, etc. Like other alerts shown on the Telltale display, it cannot be turned off or adjusted. This feature has been included on Subaru vehicles for several years, but unless the vehicle is driven for approximately 2 hours or more, many customers may have never experienced it.

Until the Owner's Manual is revised, information will be limited regarding this message.

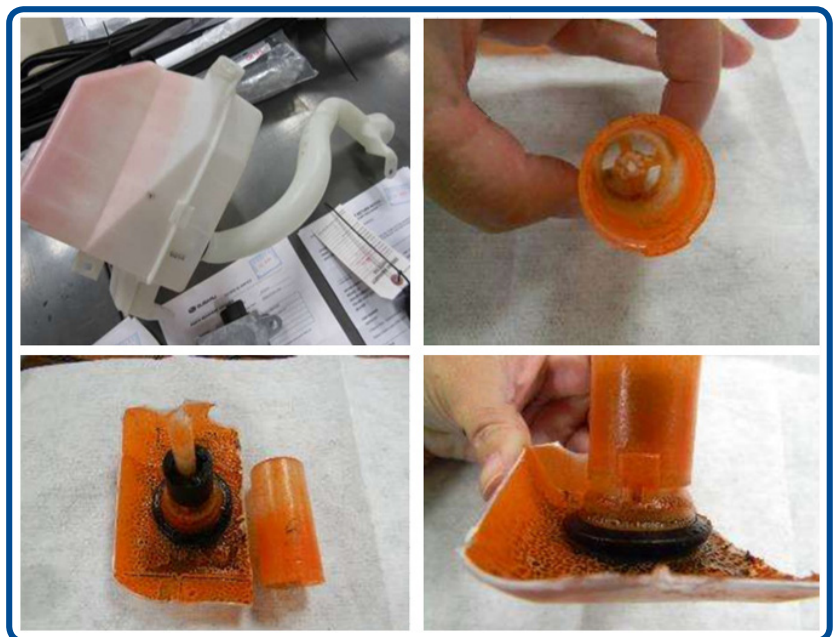
The Techline has received a limited number of inquiries regarding erratic illumination of the washer fluid level warning indicator lamp. An investigation involving parts collection along with a review of the corresponding repair order documentation was performed. The results concluded the root cause to be customer use of a popular, readily available water-dispersant windshield washer fluid / de-icer / bug remover which is orange in color. Fluid level sensors removed from the collected assemblies all showed an accumulation of an oily, orange-colored residue along with staining on the inside of the tanks. This residue was determined to be impeding proper operation of the sending unit float and switch components. Some photos of the collected parts with the residue are shown on the right. This type of damage is to be considered resultant from an outside influence and therefore not a matter for warranty.

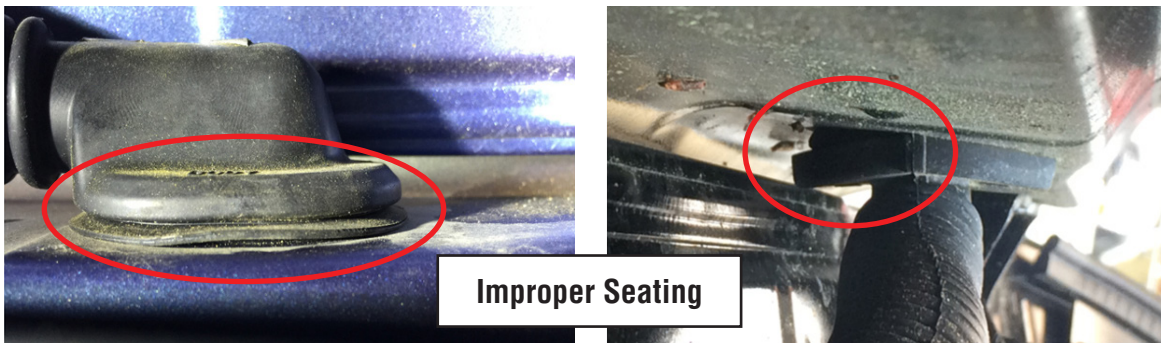
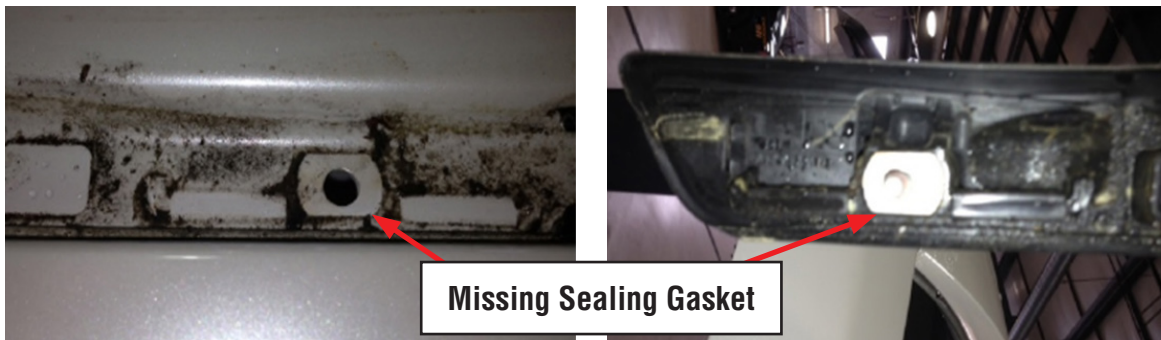
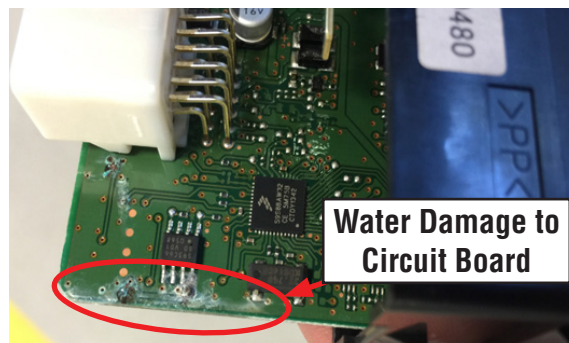
The Techline has received a number of calls regarding flashing TPMS warning lights. After initial diagnosis, if you are even able to communicate with the TPMS system, sometimes codes are stored, but most of the time there are none. If you encounter this condition, and for example, only 3 of 4 TPMS sensors are able to be registered, always check the TPMS control module for signs of water intrusion before replacing any parts. Also, always inspect the connectors and pins at the module carefully for corrosion if this condition is verified. Most cases have been traced back to the pass-through rubber harness cover / bellows between the body and the rear gate not being fully seated as shown in the photos below. The improper seating area has been primarily on the front side which can make it hard to see if not inspected carefully. There have also been isolated cases of a missing sealing gasket on the rear roof rail mounting stud. When either of these conditions occur, water can enter the vehicle, follow down the rear gate harness and drip directly onto the TPMS control module, eventually causing internal damage as seen in the bottom photo of a damaged circuit board. If you verify this concern, make sure to thoroughly clean and fully re-seat the pass through harness cover and re-check to verify any water leak has been repaired. To complete the repair, it will be necessary to replace the TPMS control module and re-register all the transmitters.

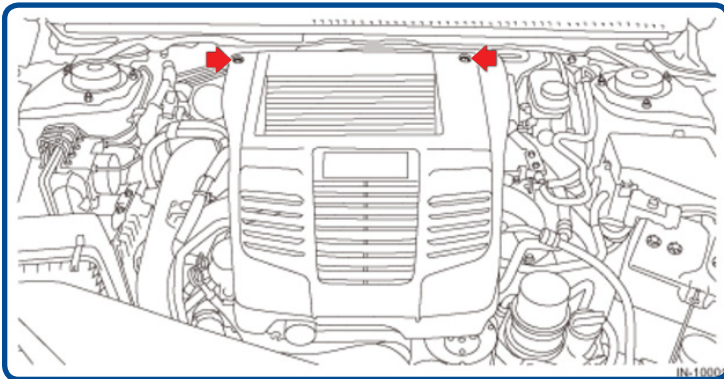
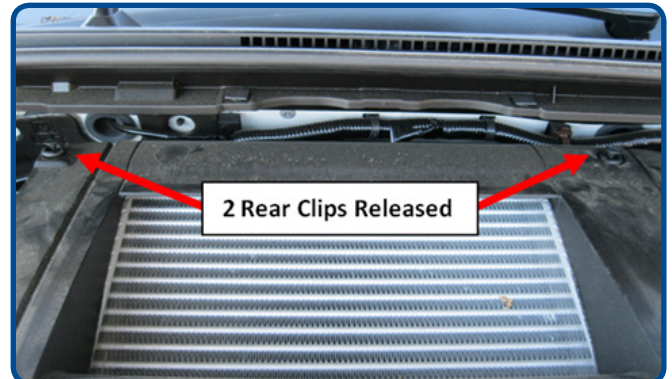
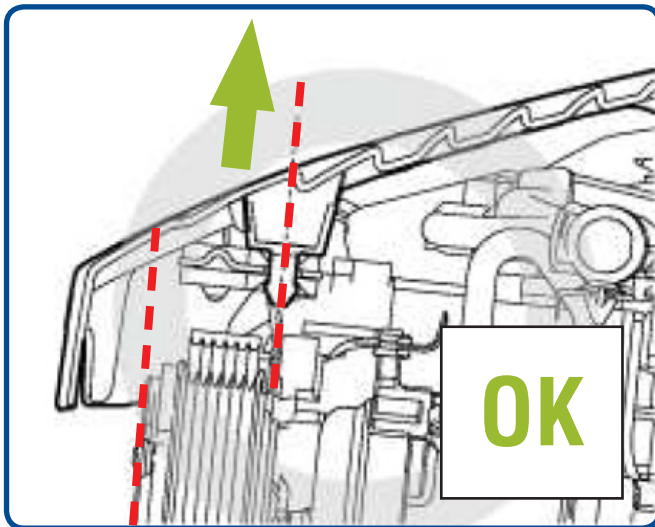
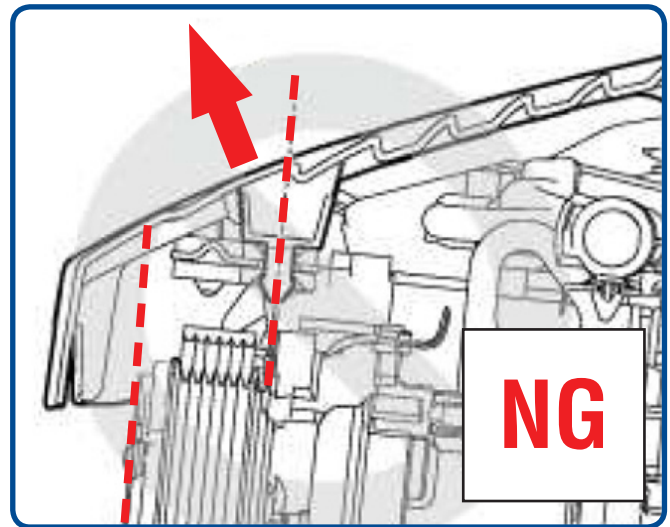
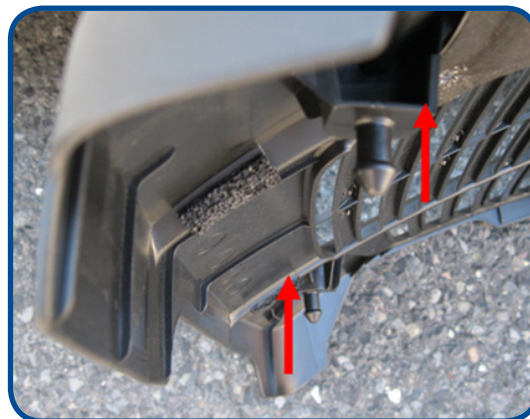
When removing the plastic engine cover on a 2015MY WRX, extra caution must be taken to release the two front pins from their rubber retaining grommets. The rear corners are secured with retaining clips. After removing the 2 clips, the cover must be **CAREFULLY** lifted **STRAIGHT UP** (parallel to the face of the A/C compressor pulley as shown in the illustrations below) to release the front pins otherwise, the cover will likely be damaged. Lifting the cover up at any other angle will usually break the pin portion(s) off the underside of the cover. This precaution is even more important to follow in colder temperatures. If the front pins are found to be sticking to the rubber grommets, sparingly apply a **very small** amount of non-silicone lubricant to the pins to make any future removal easier.

**REMINDER: NEVER** apply silicone lubricants or sprays onto or near any electrical connections or components.
