SERVICE BULLETIN

APPLICABILITY: 2015-16MY Legacy and Outback Models

NUMBER: 12-192-15R

SUBJECT: Windshield Cracking Concerns

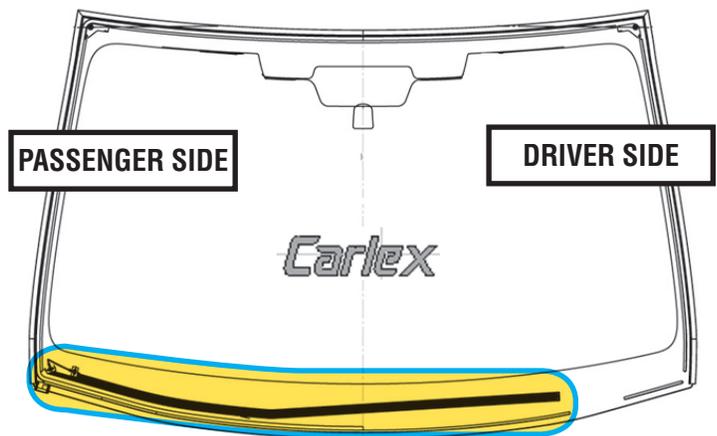
IMPORTANT: The information in this bulletin is only applicable to certain windshield glass manufactured by CARLEX and equipped with the windshield wiper deicer feature (part of the All-Weather Package) on vehicles within the specified VIN ranges. The affected windshields can develop cracks when impacted in the printed black area of the highlighted wiper deicer area shown in the illustration below.

IMPORTANT NOTE: The illustration to the right shows the windshield as viewed from **OUTSIDE** the vehicle.

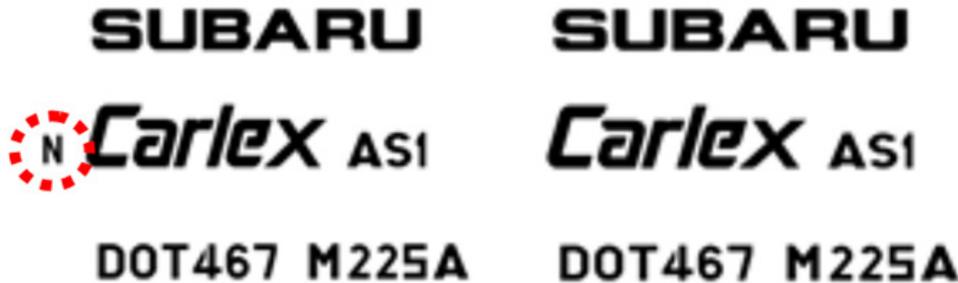
Fig. 1

The original windshields (before production change) can be easily identified by the identification markings found in the lower left, driver’s side corner shown in Figure 1 below.

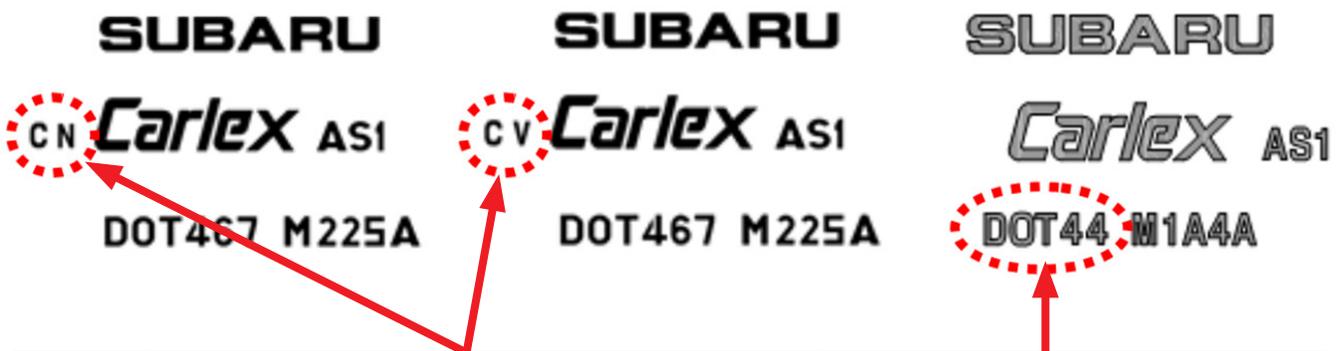
The enhanced production parts and replacement part windshields are identified by the additional identification markings (CN, CV, DOT44) as shown in Figure 2 below. Windshields with these markings are NOT eligible for replacement under the warranty extension.

Fig. 2	These 2 production markings can be found on production or replacement part windshields.	This marking is found on replacement part windshields only.
--------	---	---

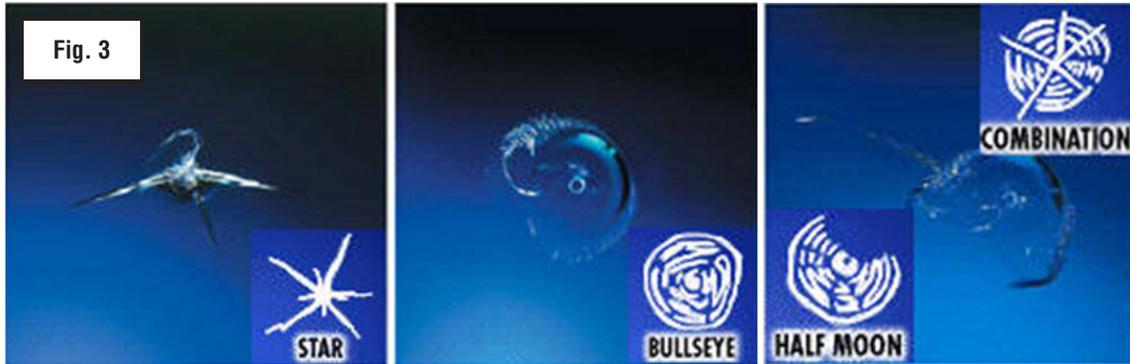
Confirm the windshield is actually cracked and the crack does not originate from a bulls eye, star, or combination impact (refer to the images in Figure 3 below). **These types of damage would only be covered by this warranty extension if the windshield is identified as having the above outlined condition and the damage originates in the affected wiper deicer area. DO NOT submit an Authorization Request for a windshield replacement which will be covered by the warranty extension outlined in this Service Bulletin.**

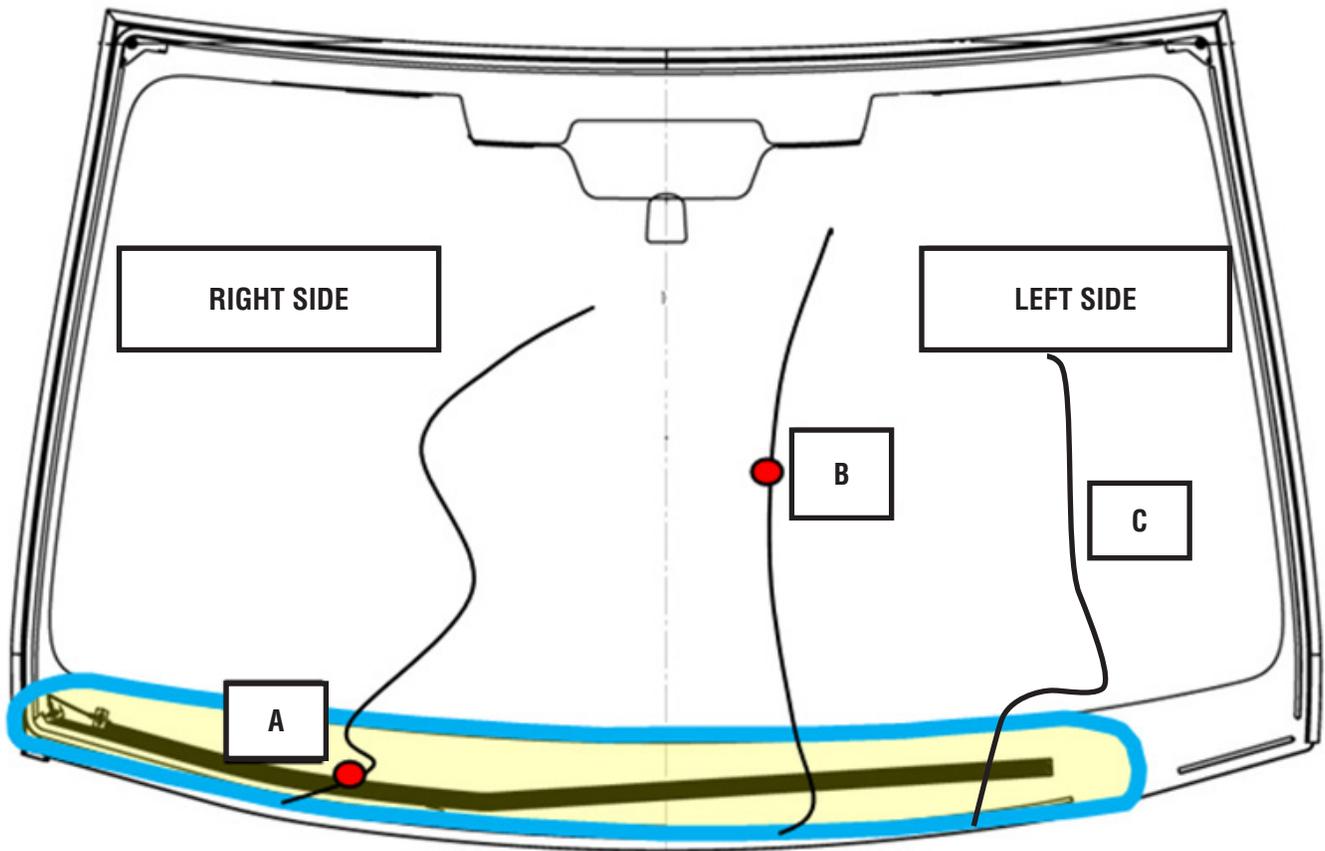
- If an impact point is found within the affected deicer area (as shown by "A" in the illustration below), proceed with windshield replacement under the terms of this warranty extension.
- If the impact point is found outside of the affected area (as shown by "B" in the illustration below), this bulletin and warranty coverage do not apply.
- If an impact point cannot be identified and the crack passes through the affected area (as shown by "C" in the illustration at the top of the next page), proceed with windshield replacement under the terms of this warranty extension.

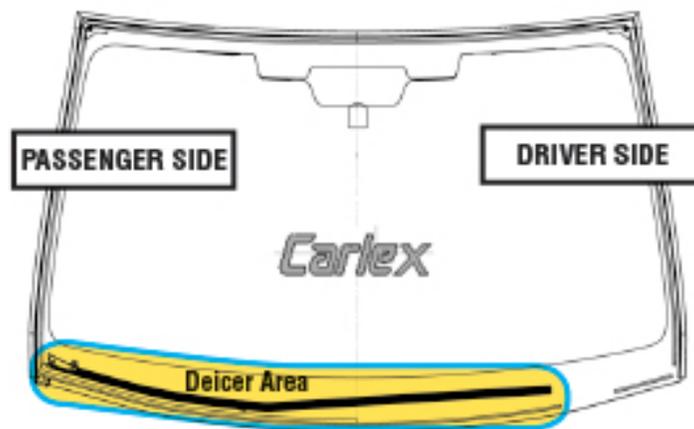
During the windshield glass manufacturing process certain compounds used to adhere the deicer to the lower portion of the windshield created a condition where the glass became more susceptible to cracking following a minor wound to the glass due to some outside force such as a stone impact. When this occurs the damage to the glass generally appears very minor or may even be invisible but the glass may crack as a result. If the crack originates or passes through the deicer (lower) area of the windshield then this condition may be the cause. (Please refer to the diagram below.) If the impact is severe enough to cause glass penetration, starring, or other severe damage, it is not caused by this condition since such an impact would also result in damage to the windshield even at its normally expected strength. Damage to other areas of the windshield, regardless of the cause, do not result from a manufacturing defect and consequently are not eligible for coverage either under your vehicle’s original limited warranty or under the extended warranty described in this letter. In addition, only genuine Subaru original or replacement windshields are eligible for warranty coverage.

NOTE: The illustration shows the windshield as viewed from the **OUTSIDE** of the vehicle.
