ARTICLES CONTAINED IN THIS ISSUE

QUALITY DRIVEN® SERVICE

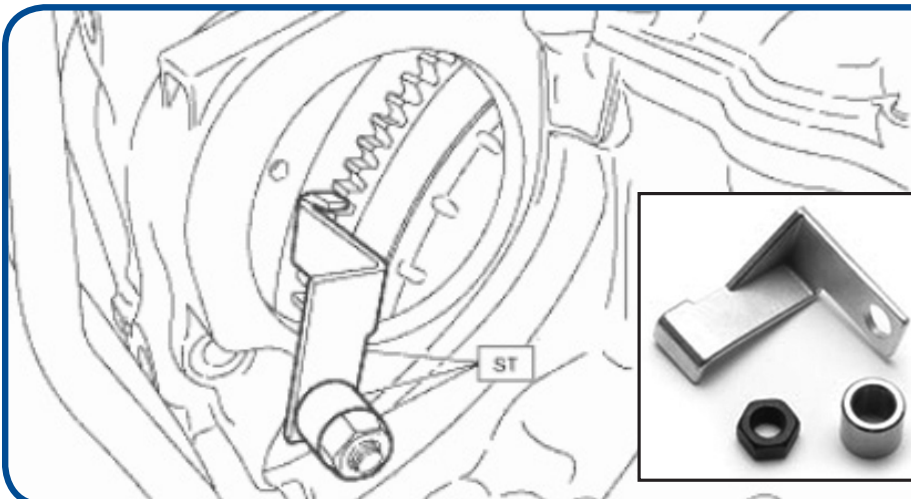
498277200 STOPPER SET

Please be advised it is necessary to leave the supplied stopper bracket in place while installing a remanufactured or new transmission assembly to the engine. The stopper is to be removed after the engine mounting bolts have been properly tightened. Always refer to the suitable Service Manual for proper procedure.

For repairs when the stopper is not already attached, special tool **498277200** must be used for the removal and installation of transmission assemblies. Failure to follow instructions may result in permanent damage to the torque converter or transmission assembly. Damages resulting from improper installation are not a matter for warranty.

- Used for removing and installing transmission assembly to engine.
- Used for preventing the torque converter from coming dislodged from the transmission.

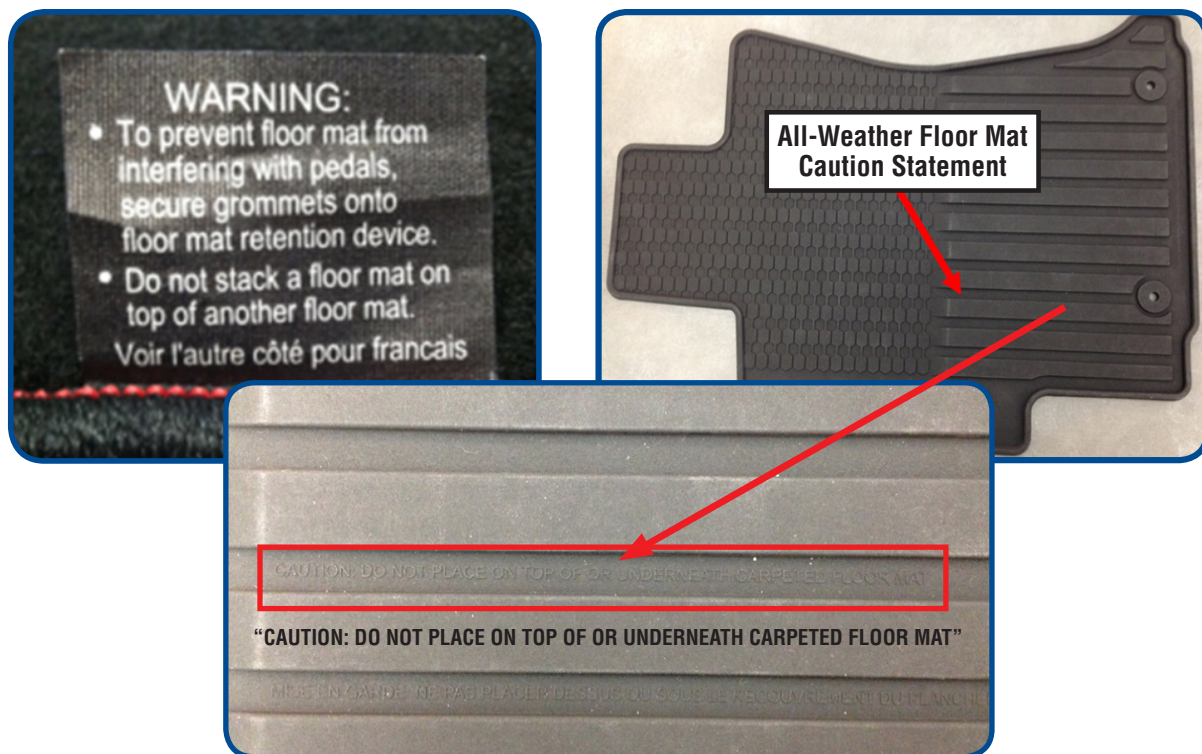
When installing Genuine Subaru Accessory floor mats, they **MUST** be installed directly on top of the vehicle's carpet and **NEVER** "stacked" on top of an existing floor mat. Stacking floor mats can be dangerous. If not properly secured, a "loose" floor mat can work its way forward enough to interfere with proper operation of the brake and accelerator pedals. Genuine Subaru accessory floor mats have grommets or reinforced holes designed to attach to a retention device which keeps them secured in the proper position, away from the vehicle's pedals. Examples of the consumer warning statements used on Genuine Subaru floor mats are shown in the photos below.

- Subaru of America, Inc. (SOA) does not endorse the use of any floor mats other than those developed and supplied by SOA's Parts and Accessories Group.
- **NEVER** double-stack floor mats in any new, used or SSLP loaner vehicle.
- **Whenever a vehicle is in for service, all Retailer personnel entering a customer vehicle should inspect the condition of the floor mats and retention hooks and notify customers in writing of any concerns identified.**

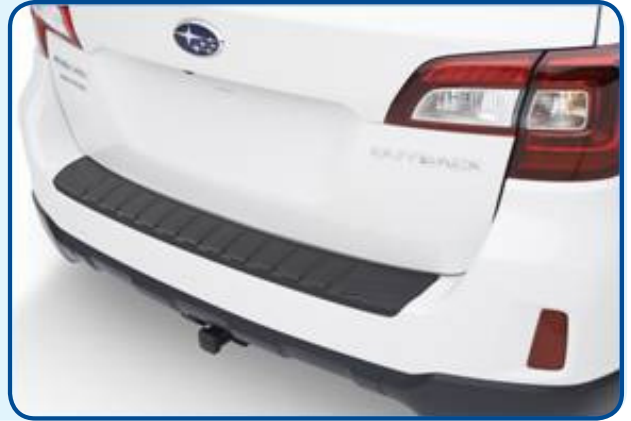
Bumper Cover Installation Tips & Best Practices

As a result of a warranty claim investigation, it was noted that the accessory Bumper Cover may not have been installed correctly. Proper alignment, pressure, procedure or even cleaning may not have been followed. As a result, we have listed key points when installing a Subaru Genuine Bumper Protector. A detailed installation video is linked below.

1. Clean vehicle surface and part
2. Vehicle surface and part temperature should be between 60-110F
3. Part aligned properly
4. Tape liners pulled in correct order and correct pressure applied

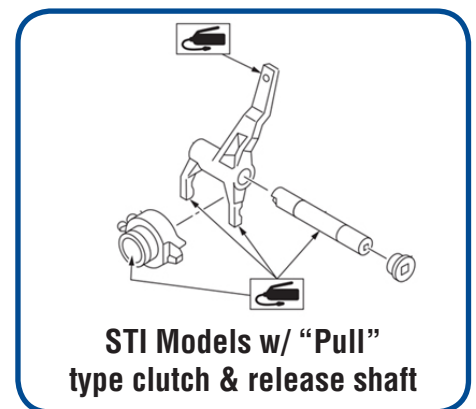
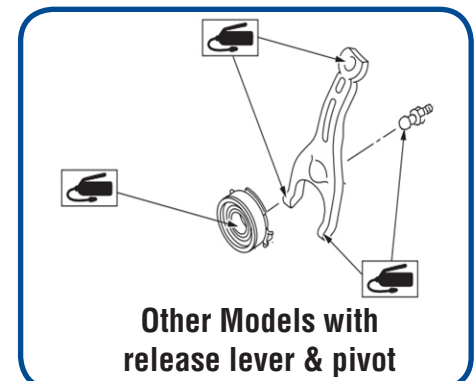
To avoid customer concerns of a creaking, squeaking or clicking sound possibly accompanied by increased pedal effort (stiffness) when operating the clutch pedal after performing a clutch-related repair, it is important to remember to always thoroughly clean and re-lubricate the clutch release components. Where applicable, the release lever, shaft, pivot, release bearing contact points on both the release lever and pressure plate along with the input shaft splines should all be properly lubricated and checked for smooth operation before re-installing the transmission assembly. It is also important to apply the grease sparingly, especially on the input shaft splines to avoid any grease contamination of the clutch disc friction material.

In addition, if you receive a customer concern of a squeaking or creaking sound when operating the clutch pedal, review TSB 12-190-15 to make sure the source of the sound is properly identified and addressed on the first repair visit. As always, when attempting to identify the location of an unusual sound, chassis ears or a similar tool can be helpful in isolating the source.

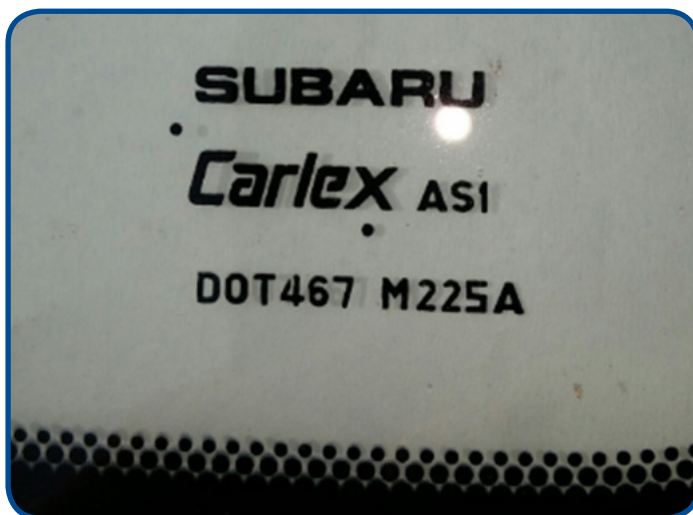
When completing a Glass Authorization Request going forward, you will notice there is an additional required photo that must be submitted with the Authorization Request. The new Required File Type is named, "Glass Identification Marking", see Illustration 1 .

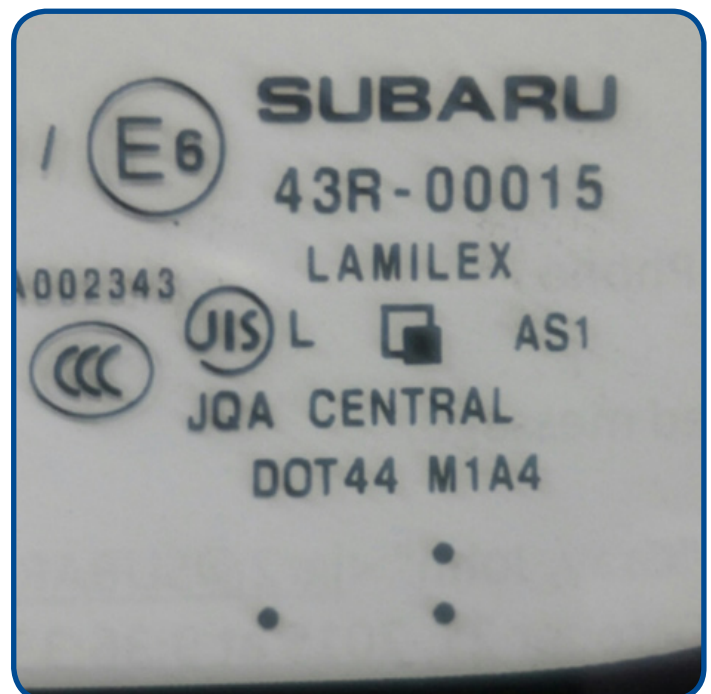
The Glass Identification Marking is located in the lower left corner of the windshield. See Illustration 2 for examples of what is required.
