Service Bulletin

PRELIMINARY INFORMATION

Subject: Tick Noise And/or Misfires On AFM Cylinders 1 4 6 And/or 7

With a V8 Engine and AFM (Active Fuel Management):

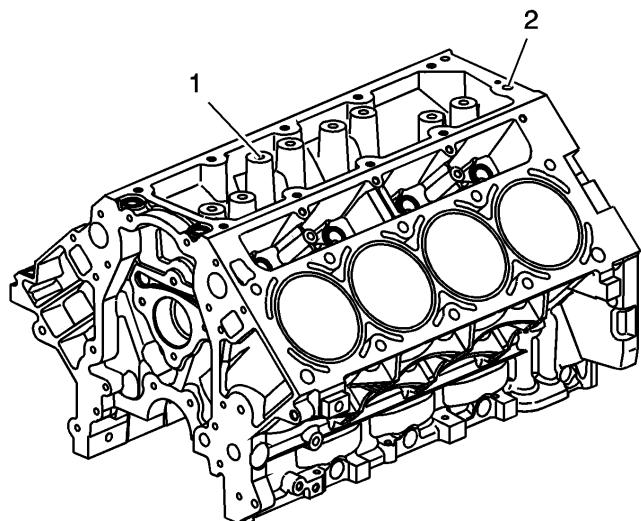
Clean out the related lifter control oil passages (item 1 below) while the old lifters are removed. Generally, it is only necessary to blow through the passages with shop air but if a lot of debris is noted, it may also be necessary to flush the passages out with brake cleaner. The oil should be changed after doing this since the cylinder heads will be off to replace the lifters anyhow.
