# Service Bulletin

**Subject:** Spark EV (BEV) 1ET35 Drive Unit and Component Restriction

**Models:** 2014 - 2015 Chevrolet Spark EV (BEV)  
Equipped with 1ET35 Transaxle (RPO MME)

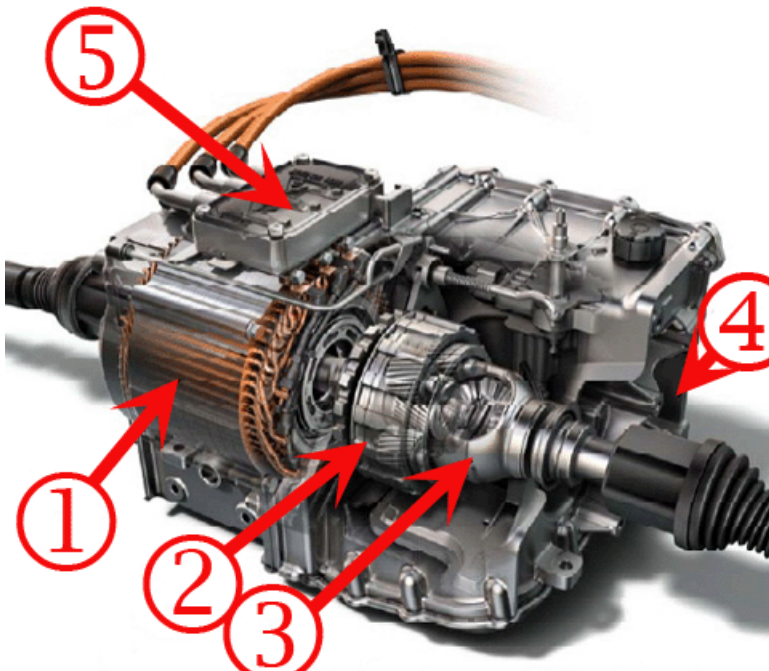
1. Drive Motor generator
2. Planetary Gears
3. Differential
4. Auxiliary Fluid Pump

## 5. 3-Phase Cable Connections

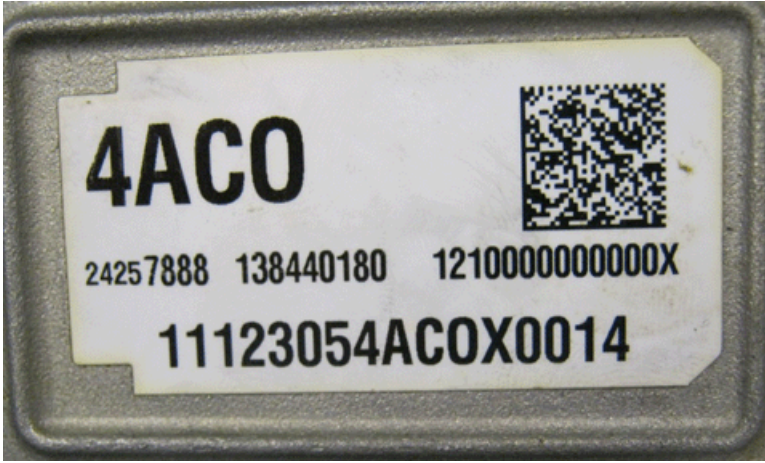
The Drive Unit Tag Number must be supplied to TAC when calling for a Drive Unit Assembly
