Truck Bed Tonneau Cover - Hinge Cover Lifting

Vehicle Exterior

2016 Tacoma

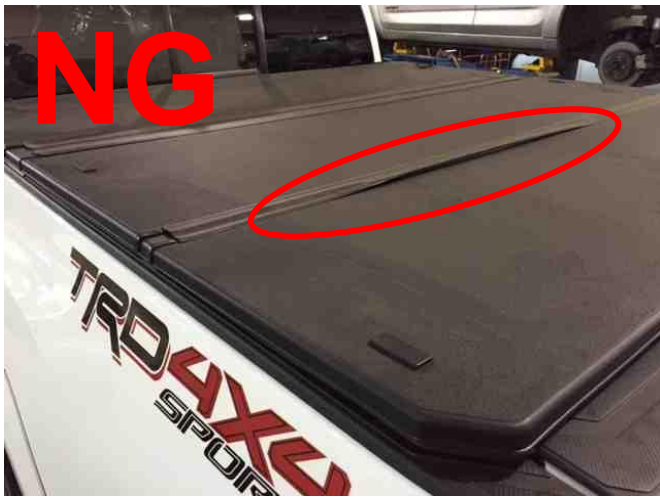
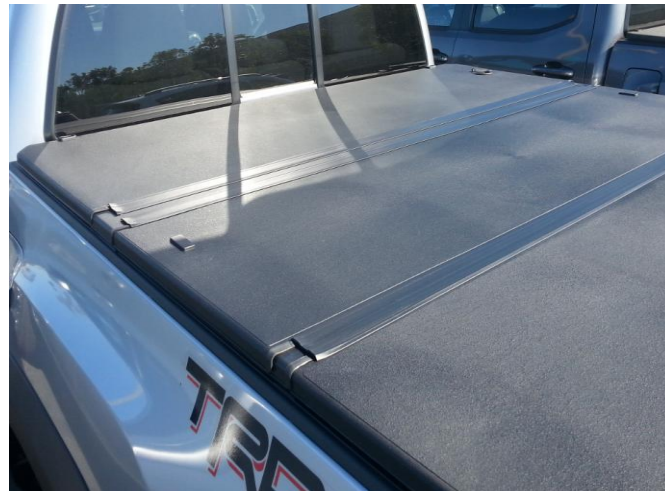
Some vehicles equipped with the bed tonneau cover may exhibit a condition in which hinge cover(s) are not flat when in the closed position.

Gap from hinge cover to tonneau cover should be no more than 0 -1mm.
