Program Bulletin

CUSTOMER SATISFACTION PROGRAM

SUBJECT: Navigation Radio Loss of Customer Settings

MODELS: 2010 Buick LaCrosse
2010 Cadillac SRX
2010 Chevrolet Equinox
2010 GMC Terrain
2011 Buick LaCrosse, Regal
2011 Cadillac SRX
2011 Chevrolet Cruze, Equinox
2011 GMC Terrain

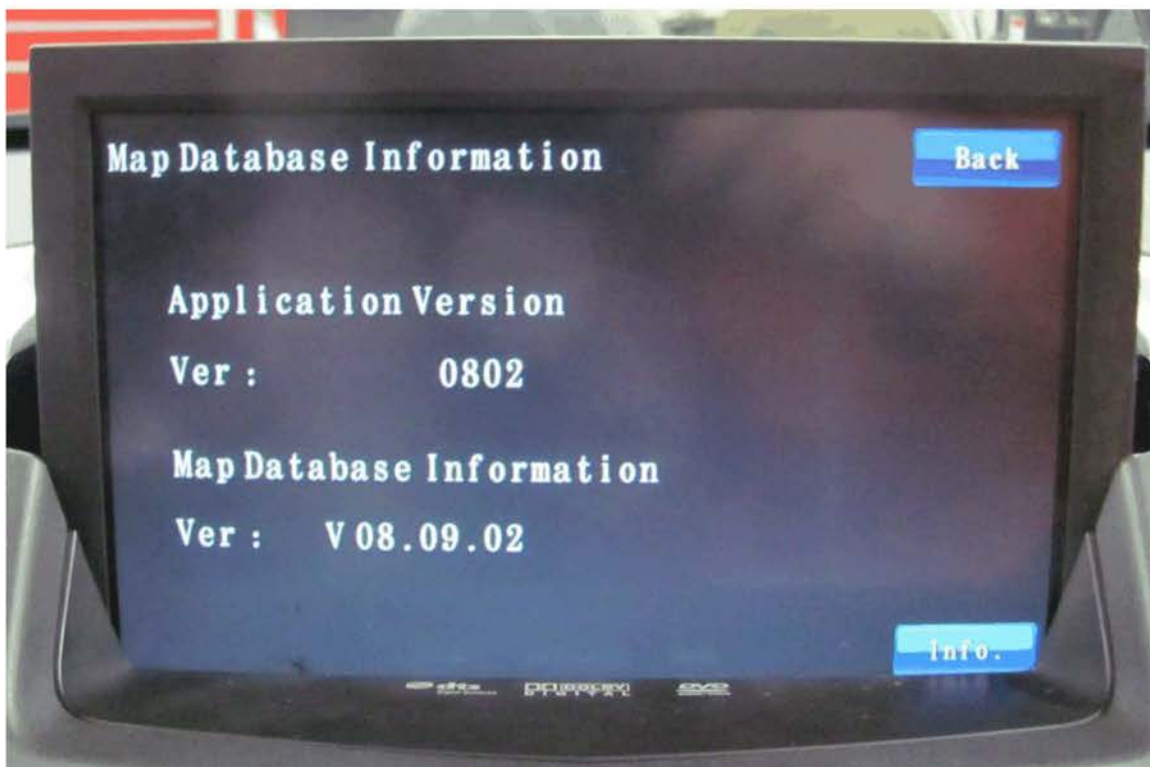
4068017

To determine the radio control module software version, navigate to the Map Database Information screen using the radio. Use the following navigation path: CONFIG>NAV>Map Database Information. Refer to the Application Version field on screen to determine the software version. Refer to photograph.

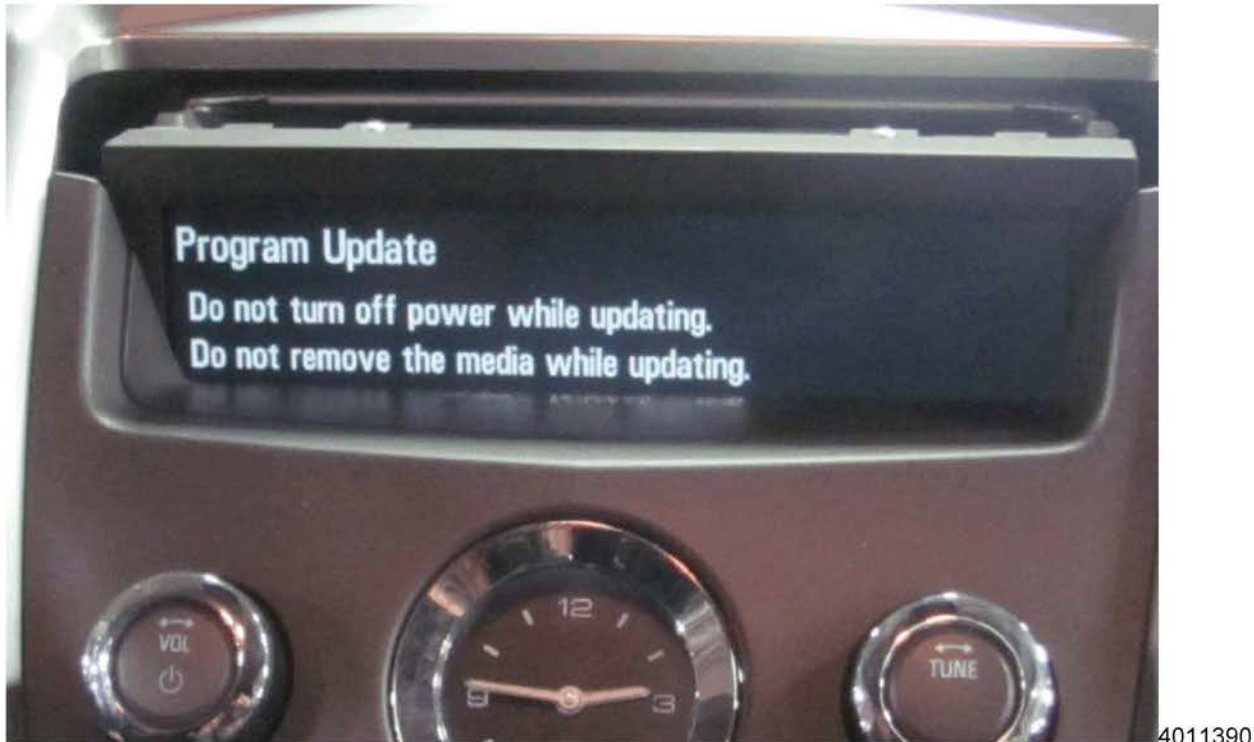
11. Insert the USB flash drive into the USB port of the vehicle. The radio will display the title "Program Update" along with warnings not to interrupt power or remove the media. A bar graph will form indicating progress and an "OK" button will appear. PRESS the appropriate radio button or area of the screen to activate the "OK" command and begin programming.

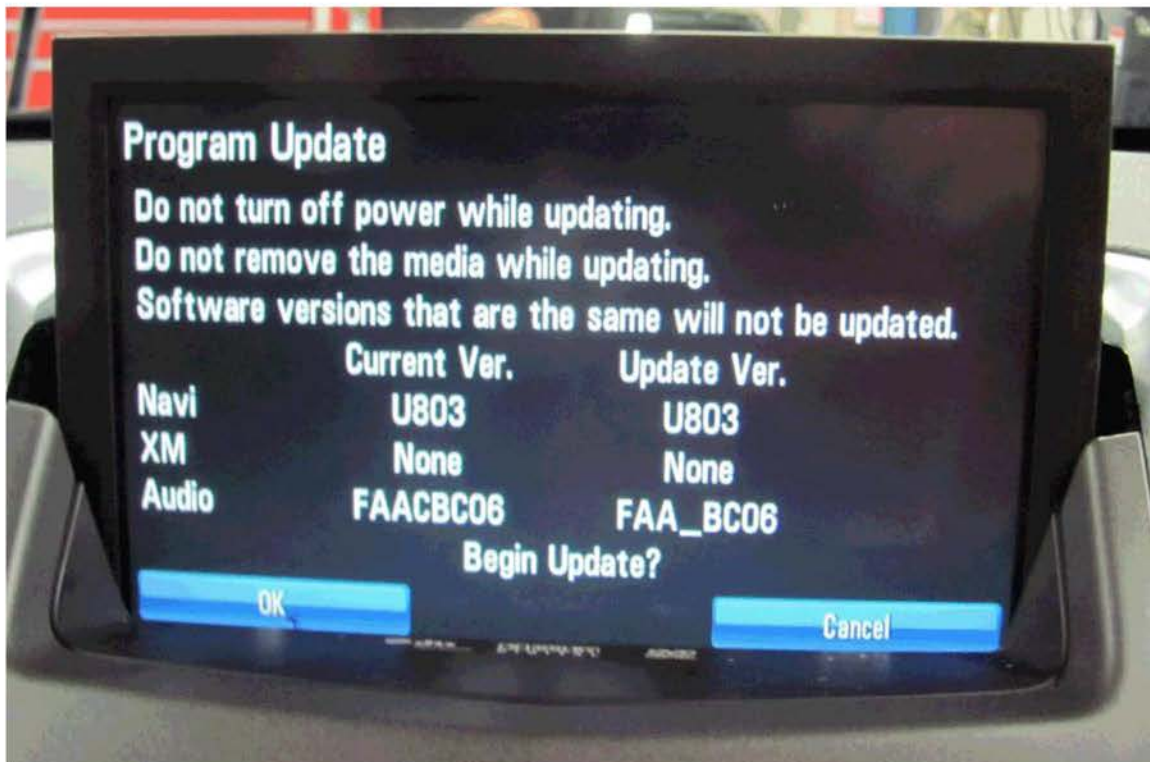
4068016

12. When the programming event has completed, the radio will display Download Complete.

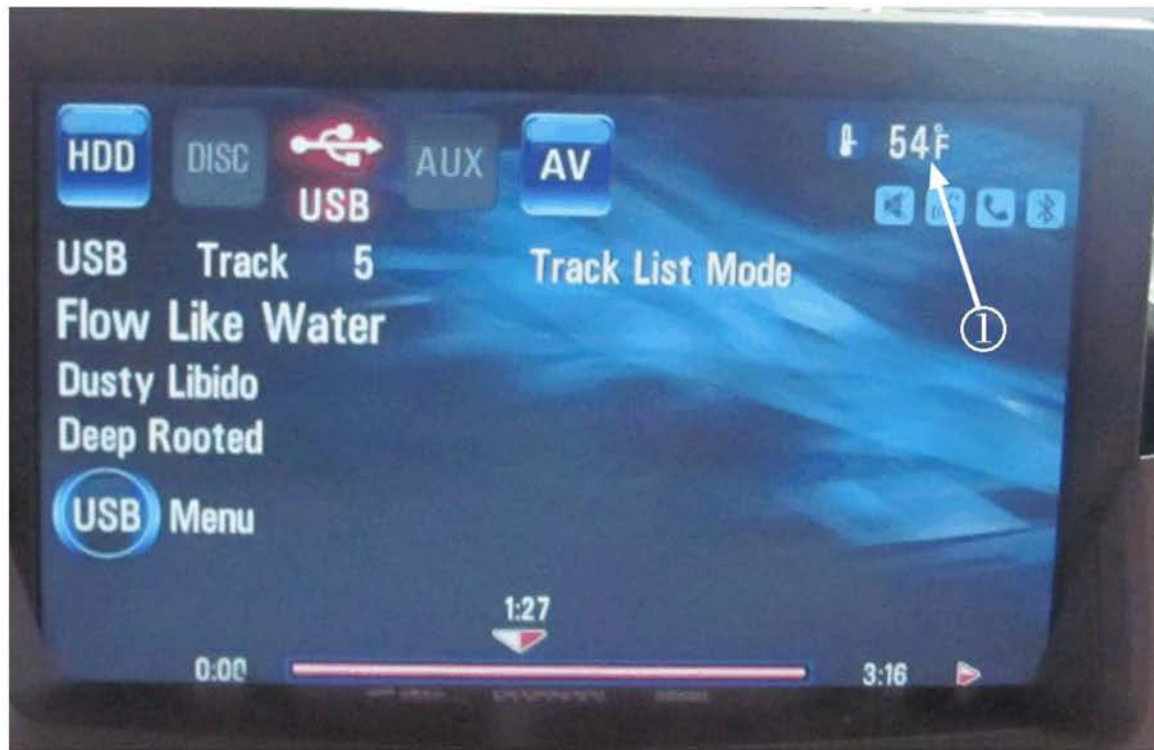
4011389

16. Determine if the temperature (1) is displayed on the radio and map screens.

- If the temperature (1) is displayed on the radio and map screens, no further action is required.
- If the temperature (1) is NOT displayed on the radio and map screens, a radio calibration MUST be performed. Proceed to step 17.
