**SUBJECT:** Service Update for Inventory and Customer Vehicles  
Incorrect Console Wiring  
Expires with Base Warranty

**MODELS:** 2015 Chevrolet Suburban, Tahoe  
2015 GMC Yukon, Yukon XL  
Equipped with Custom Front Floor Console without Cooler

Subject: 14768 – Service Update Bulletin  
Incorrect Console Wiring

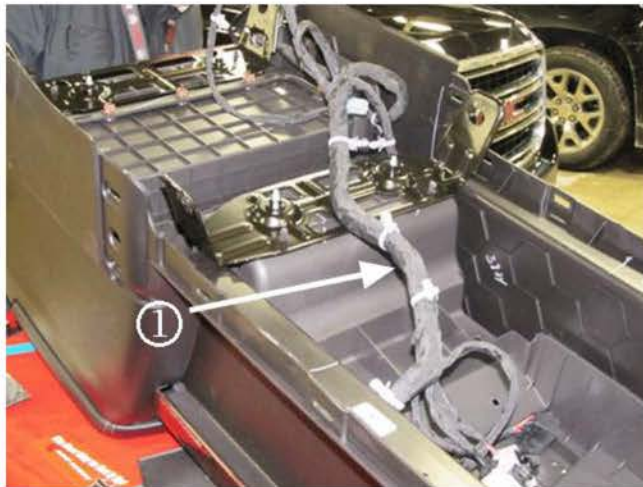
4065612

This bulletin provides a service procedure to replace the console-wiring harness on **certain** 2015 model year Chevrolet Suburban, Chevrolet Tahoe, GMC Yukon and GMC Yukon XL vehicles equipped with a custom front-floor console without cooler. These vehicles may have been built with an incorrect console-wiring harness which may cause the transfer case, child-door lock, window lock, heated-steering wheel, park assist and lane-departure switch indicators to not function. The heated seats function as intended, but because of the incorrect console harness, the battery-feed circuit to the heated-seat switches is protected by the wrong fuse and will not be properly protected if a short-circuit failure ever occurs.

**NOTE:** To help eliminate/minimize damage to the console molded tabs, use care when removing the original harness push fasteners.

1. Remove the front floor console wiring harness (1). Refer to *Front Floor Console Wiring Harness Replacement (Chevrolet / GMC)* in SI.
2. Install the new front floor console wiring harness. Refer to *Front Floor Console Wiring Harness Replacement (Chevrolet / GMC)* in SI.
