Reference	SSM72127
Models	Range Rover / L405 Range Rover Sport / L320 Range Rover Sport / L494
Title	Wheel and Tire Vibration.
Category	Chassis
Last modified	05-Jan-2015 00:00:00
Symptom	306000 Tyres/Wheels
Attachments	Water in tyres.JPG

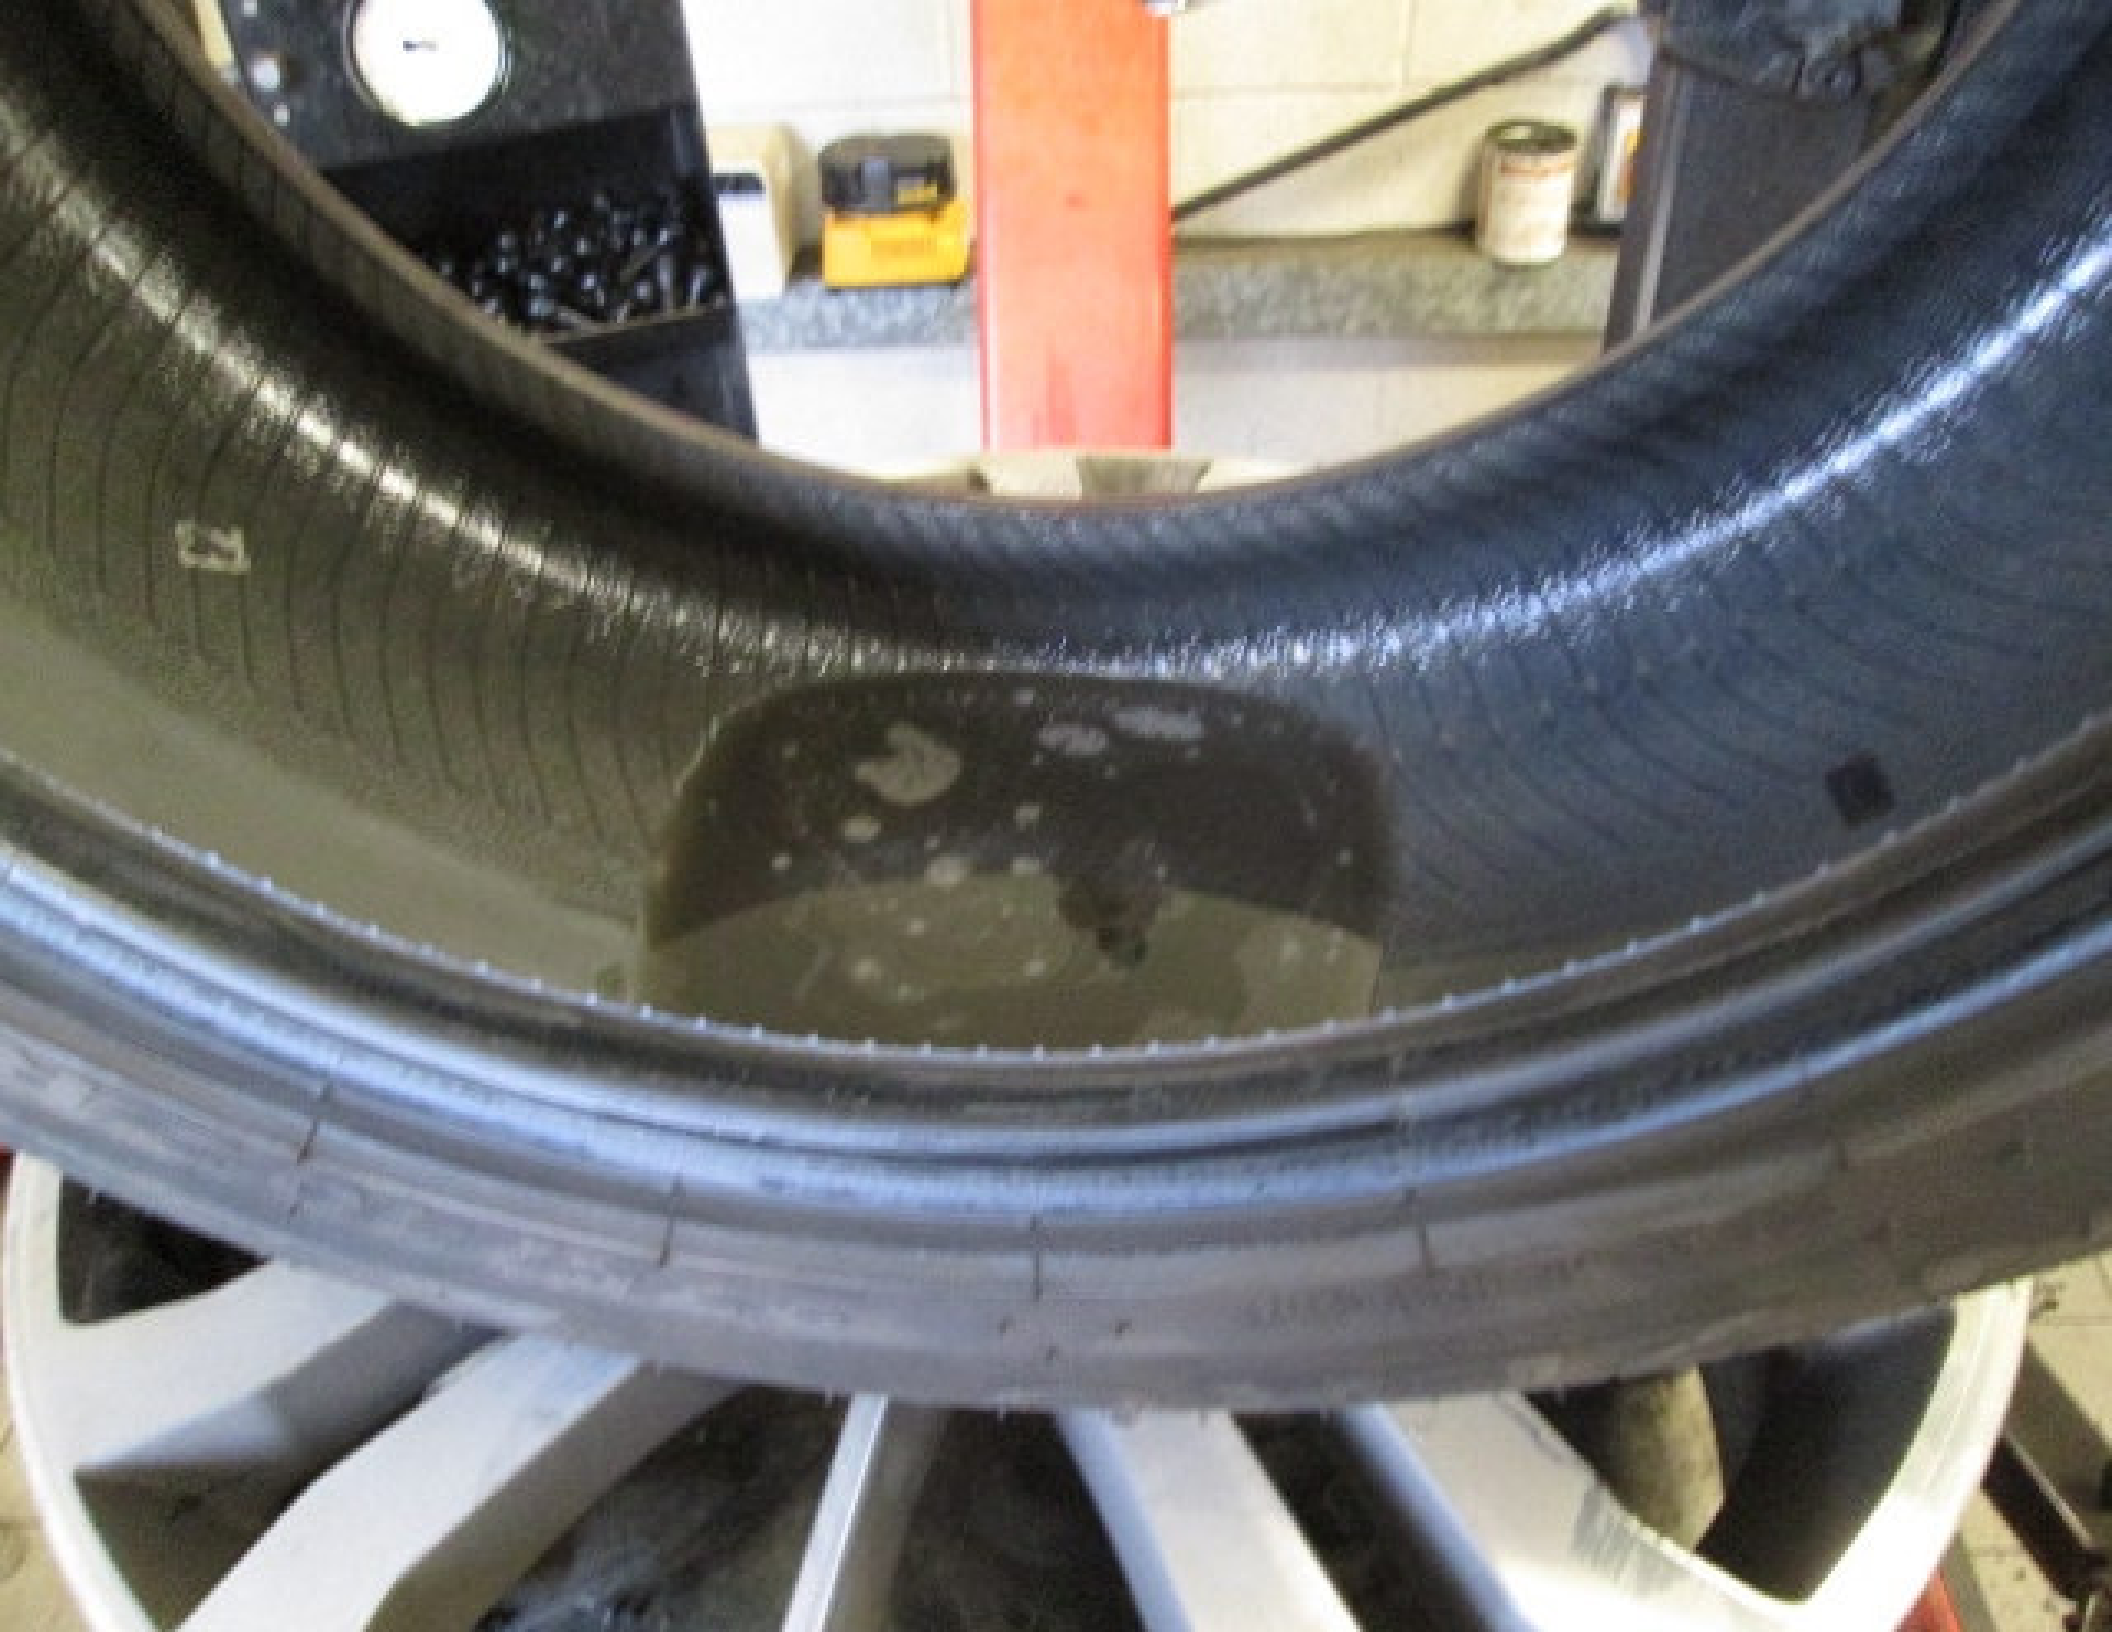
Wheel and tyre assemblies out of balance due to water inside the wheel and tyre assemblies. See attachment for example.

- Please record/estimate the amount of water within the tyres before rebalancing the wheel and tyre assemblies.
- Submit a Quality Concern Report including photos of the rim of the wheel, and side wall of the tyres.
