Reference	SSM72159
Models	LR4 / L319
Title	15MY LR4 with P2183-00 stored in the PCM
Category	Engine
Last modified	29-Jan-2015 00:00:00
Symptom	402000 Cooling System Concerns
Attachments	15MY L319 P2183 SSM Info (1).pdf

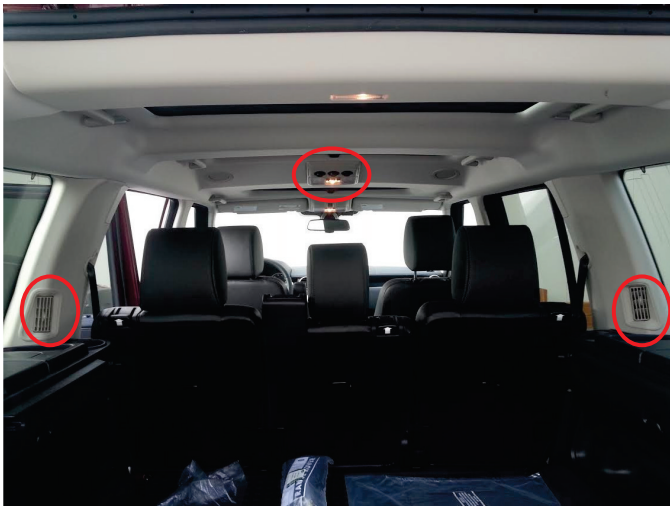
1. Is auxiliary climate control installed?

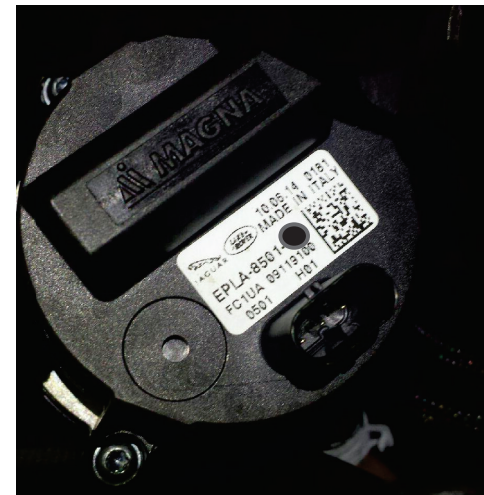
2. Does the aux coolant pump operate when the engine is running?

The pump should begin to run approx. 1 second after engine start and run continuously.

Verify this with by placing suitable listening equipment against the top surface of the pump from the top of the engine bay.

NOTE. Take the necessary care and precautions when using listening equipment in an engine bay with moving components.
