TECHNICAL BULLETIN  
LTB00744NAS1  
23 FEB 2015

**SECTION: 307-01**

**Rattling/Vibrating Noise From Underneath The Vehicle When Driving On An Uneven Road Surface**

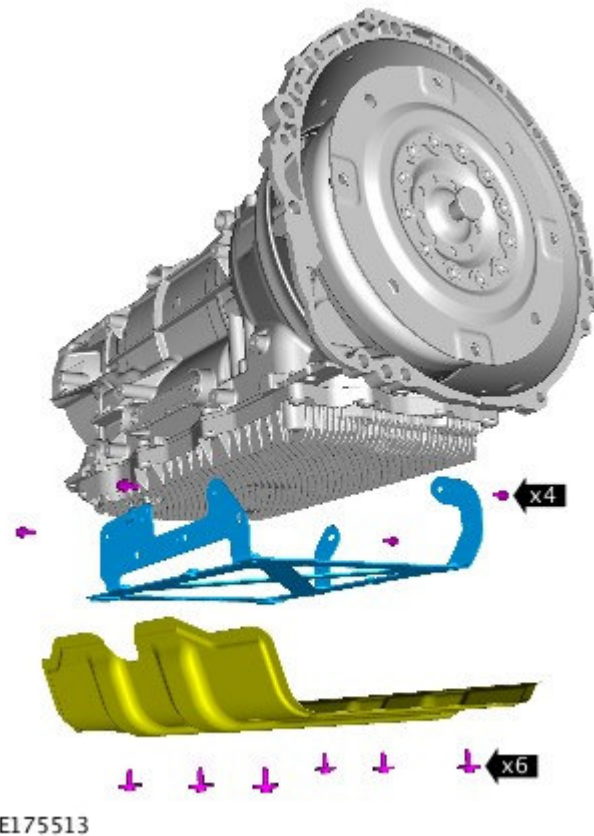
**Cause:** This may be caused by a cracked transmission heat shield mounting bracket.

2. Remove and discard the transmission heat shield mounting bracket.

3. Install the new transmission heat shield mounting bracket.

- Torque: 9 Nm
