TECHNICAL BULLETIN LTB00738NAS2 19 MAY 2015

Front Bumper Cover Cracking

Range Rover Evoque (LV)
Model Year: 2012 Onwards
VIN: CH000447 Onwards

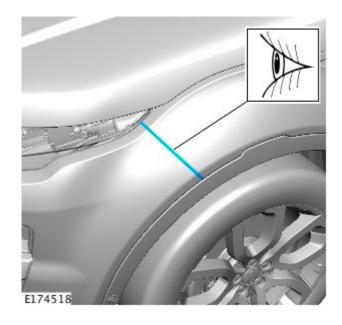
1. NOTE: left side shown; right side similar.

Situation: The front bumper cover may crack where it meets the front fender.

Cause: This may be due to stress applied to the bottom of the front bumper cover causing the top section of the front bumper cover to crack where it meets the front fender.

Area that can be affected.

2. Install a new front bumper cover (see TOPIx Workshop Manual, section 501-19).
