TECHNICAL BULLETIN
LTB00695NAS2
18 JUN 2015

SECTION: 205-00

Vibration in 7th/8th Gear at High Speed

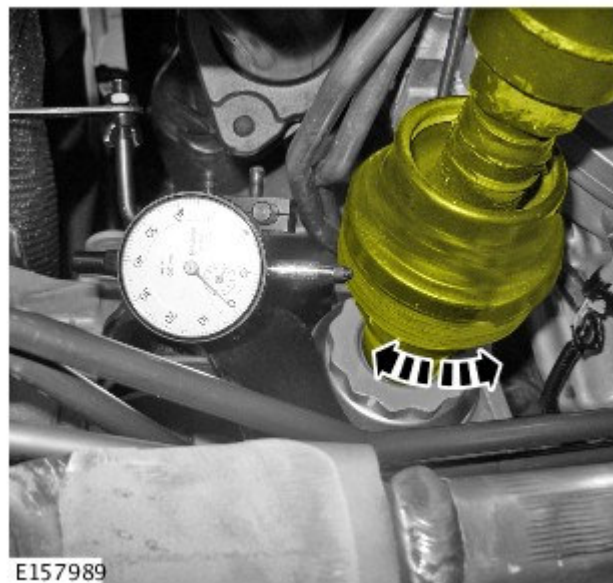
5. Hold one of the front wheels in position and rotate the other to measure the Total Indicator Reading (TIR) of the joint head.

- Record the TIR value.

Repeat Step 5, making adjustments as necessary, until Total Indicator Reading (TIR) is as close to zero as possible (must be less than 0.15mm TIR).
