### TECHNICAL BULLETIN LTB00625NAS2 08 APR 2015

'Knock' Sound From Front Suspension

Range Rover Sport (LW)

Model Year: 2014-2015

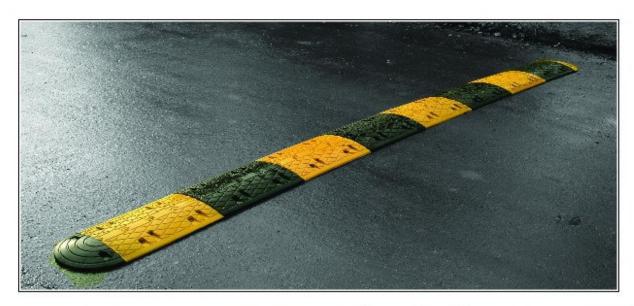
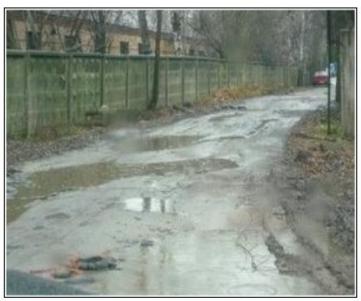
E162272

SYMPTOM: single 'knock' OR a series of isolated 'knocks':

- **Drive Cycle / Conditions:** single-wheel and dual-wheel inputs from speed bumps /damaged road surfaces or similar while traveling ONLY in a forward direction at speeds of up to 25mph (40kmh).
  - Action: perform the Service Instruction outlined below.

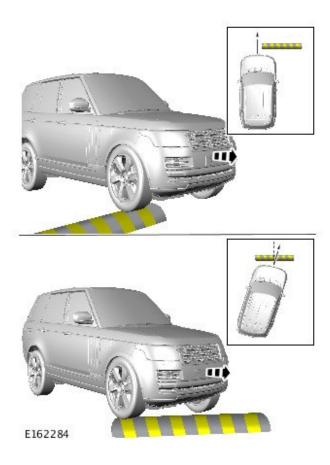
#### **SYMPTOM:** 'knock' noise:

- **Drive Cycle / Conditions:** noise occurs during single wheel inputs (one side only) at speeds up to 12mph (20kmh). Noise occurs when traveling in both forward AND reverse direction. Noise can also be heard during dual wheel input but to a lesser extent. Test both sides of the vehicle independently.
  - Action: refer to Technical Bulletin LTB00604NAS, Front Air Spring / Damper Hydraulic Fluid Leak.

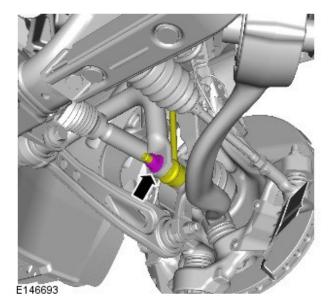
## 4. NOTE: a small amount of pivot is normal.

Check the front stabilizer bar links for visible play:

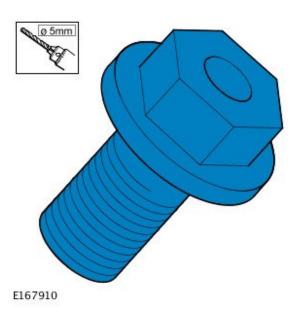
# 8. NOTE: View of the end of hydraulic valve block from front of vehicle.

Check the valve block-to-body stud clearance:

There should be 5mm clearance between the valve block body and the plastic body fastener that secures the fuel lines. • Where no or very little clearance exists, continue to the next step.

Remove the plastic body fastener and drill an axial hole 5mm diameter through the head; this will allow the body stud to pass through the head of the fixing.

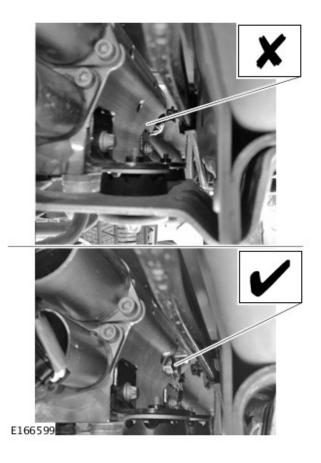
11. NOTE: Aero shield removal is required (see TOPIx Workshop Manual, section 204-06).

Identification off vehicle:

• If the vehicle is not fitted with the latest level (FPLA) valve block , install new valve block (see TOPIx Workshop Manual, Section 204-06) and then proceed to Step 14. If the vehicle is fitted with the latest level valve block then please proceed to Step 32.
