TECHNICAL BULLETIN
LTB00692NAS2
08 APR 2015

SECTION: 417-00

Front/Rear Lamp Condensation - Information Only

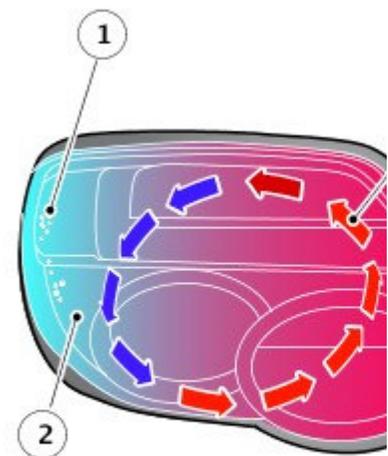
E170120

1. Condensation or moisture can be more noticeable during the months of spring and autumn when there is a likelihood of high humidity content in the air. It can occur when there is a temperature difference on either side of the lens surface. This can often occur in the evening and morning sunshine or when cold water makes contact with a warm lamp lens. When a lamp is warm in direct sunshine the surface area in direct sunlight will be approximately 10°C higher than the remainder of the lamp. When the lamp is cooled within the lamp and makes contact with the colder surfaces moisture can appear on the lens as water condenses out. Condensation may occur when washing a vehicle with cold water on a warm day or when the lamps are warm and vicarious to the same phenomena as with the formation of dew on the surface of a glass window pane.

2. The illustration shows the following.

1. Moisture formation
2. Cool surfaces
3. Air circulation
4. Warm surfaces

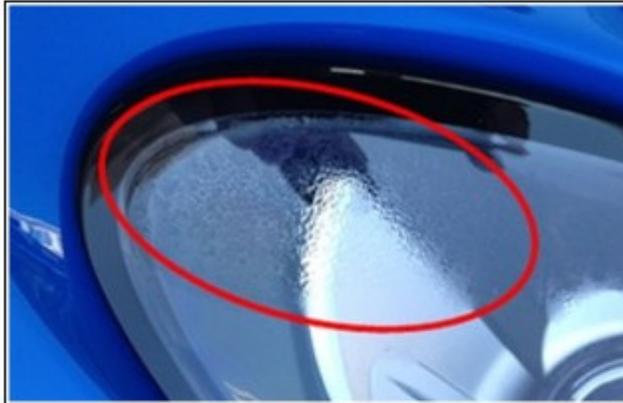
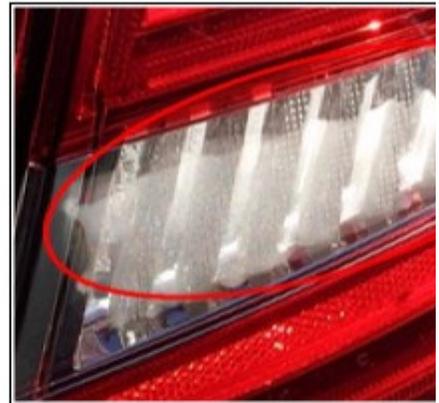
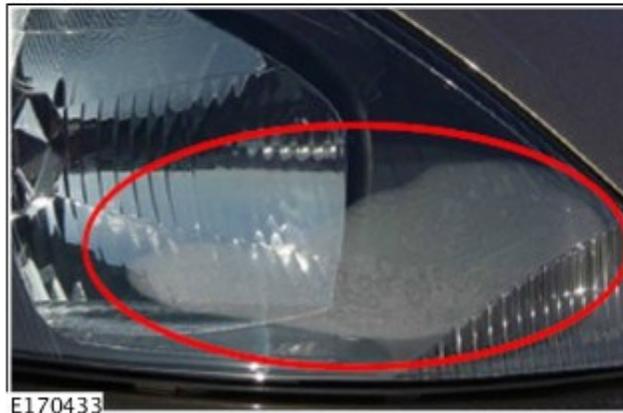
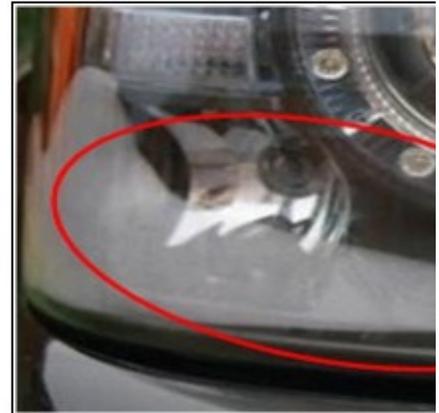
These are examples of normal exterior lamp condensation. This would NOT be covered by Warranty and the lamp is not replaced.

- 3.** No visible streaks, drip marks or droplets in the condensation mist.

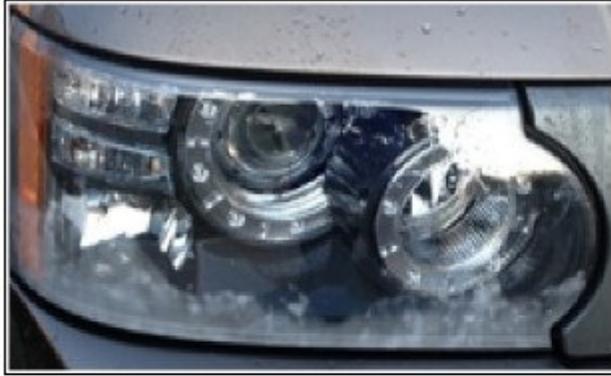
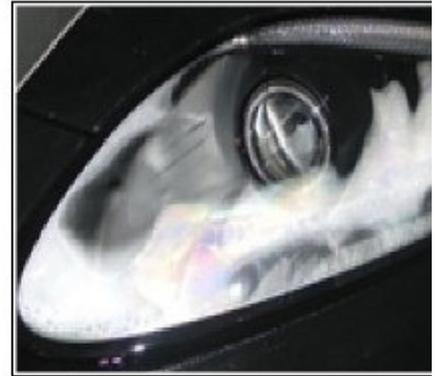
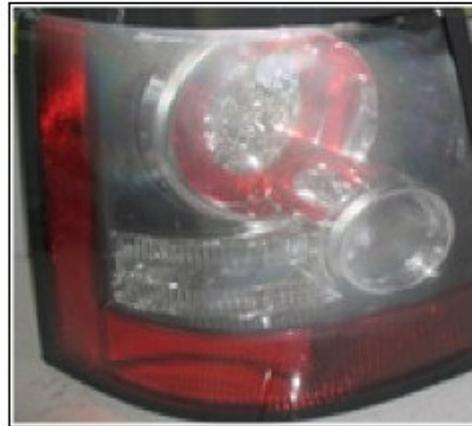
E170434

- 4.** Condensation mist that does not obstruct the view of the lamp interior.

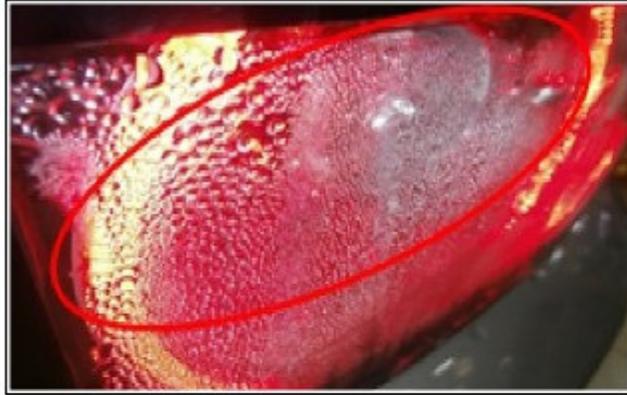
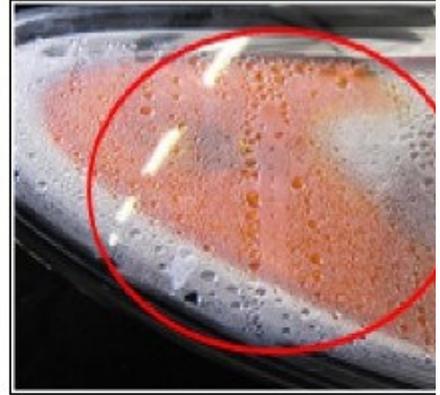
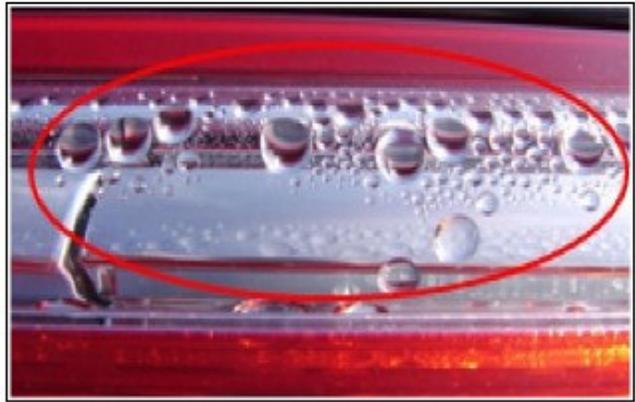
E170435

These are examples of abnormal exterior lamp condensation that may be covered by Warranty. Warranty may providing the lamp does not exhibit any visible signs of external damage.

- 5. Large water droplets.

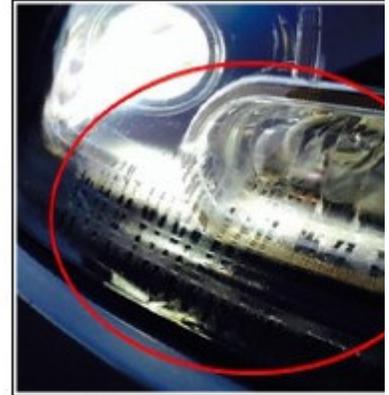
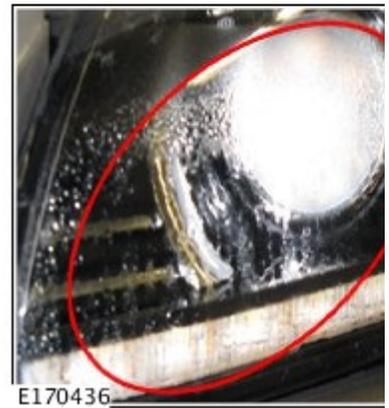
6. Drip marks or streaks in the condensation.

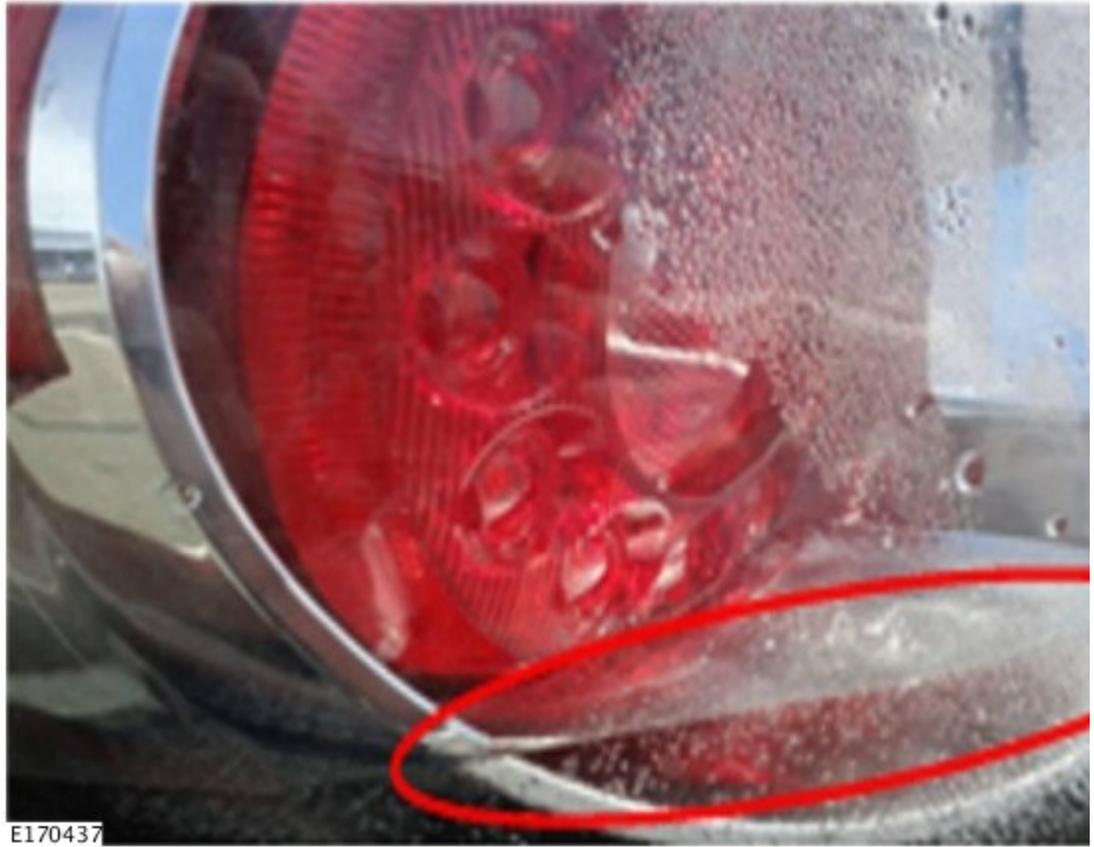
E170437

- 7. Standing water within the lamp.

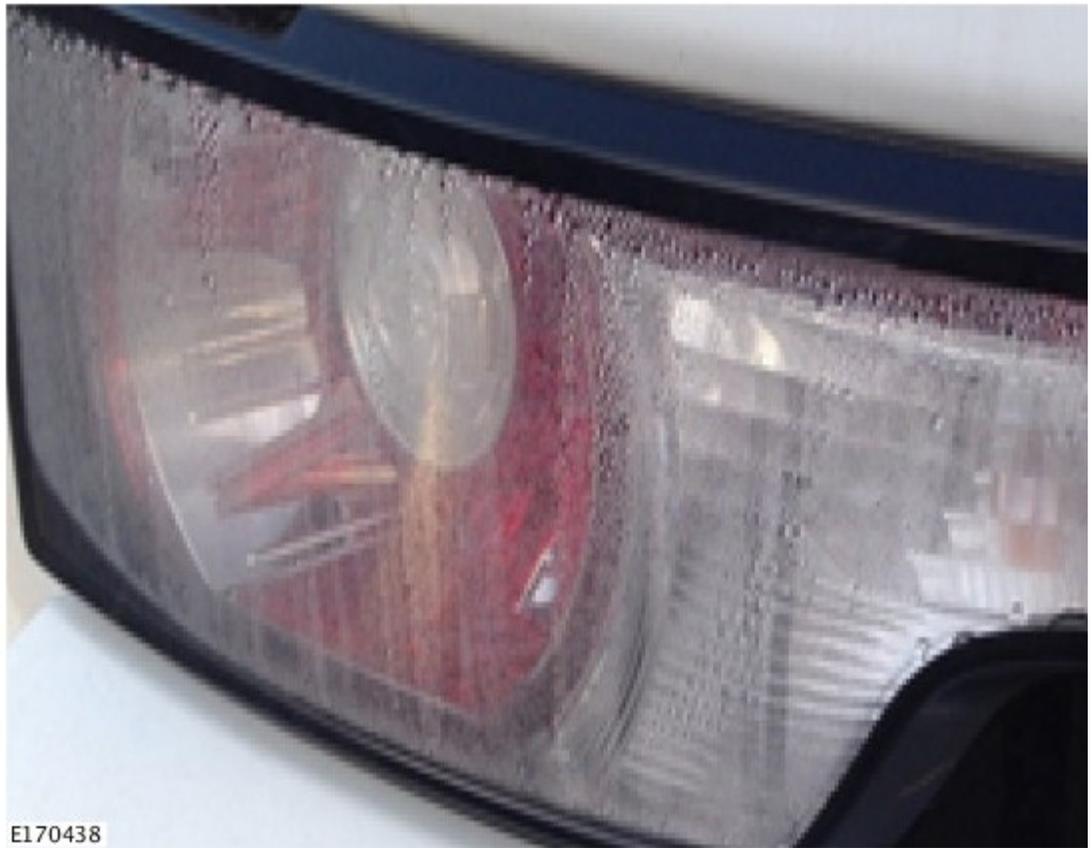
E170438

- 8. A thick mist covering the lens with water droplets.
