Reference	SSM72257
Models	Range Rover / L405
	Range Rover Sport / L494
Title	Differential Axle Tube Assembly Leak/Noise
Category	Driveline
Last modified	23-Apr-2015 00:00:00
Symptom	509000 Axle Concerns
Attachments	Front Axle Serial Number Points.pdf
	Half shaft information.pdf
	Needle Roller Bearing.pdf
Content	lssue:

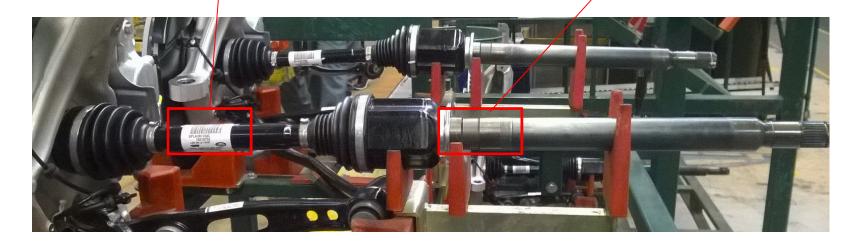
Picture of this bearing journal
