TECHNICAL BULLETIN
LTB00322NAS4
28 SEP 2015

SECTION: 501-08

Upper Windshield Finisher Loose

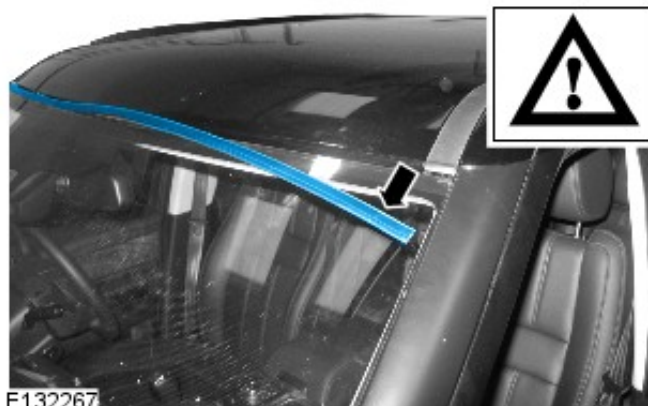
1 Check the upper windshield finisher that has become loose and or adrift for damage.

- If the finisher has no damage but is loose, continue to step 2.
- If the finisher is damaged and loose, remove and discard the finisher; continue to step 3.
