# TECHNICAL BULLETIN

## LTB00745NAS2

### **SECTION: 501-02**

## Hood Fouls The Front Door And/Or Front Fender

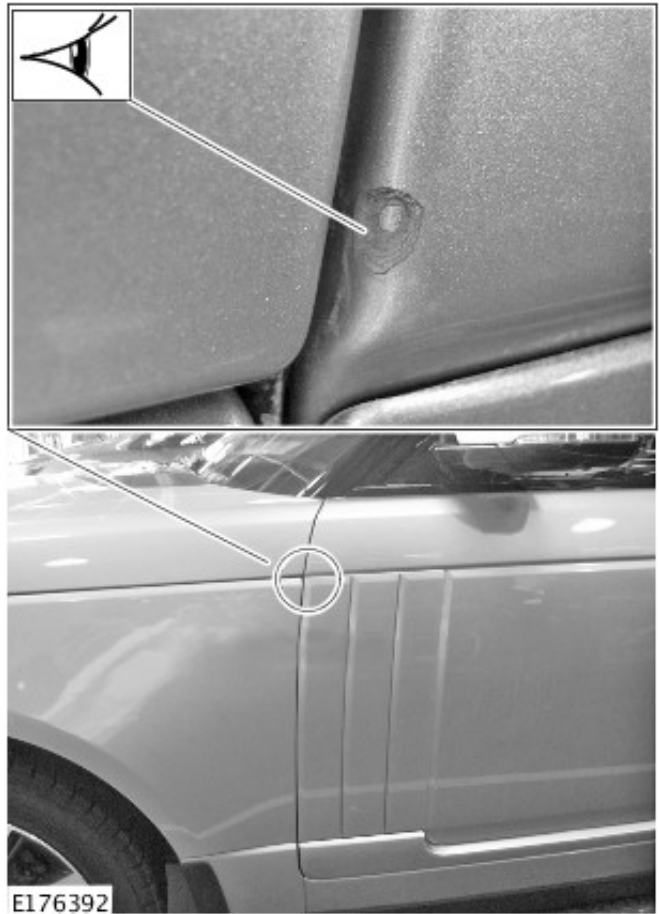
**Situation:** The hood may foul the front door and/or fender, causing the paint to be worn away.

**Cause:** This may be caused by softening of the engine compartment / hood seals, allowing the factory hood setting to move.

1 Check for signs of damage in the area shown.

**6** Repair and respray the damaged area where required.

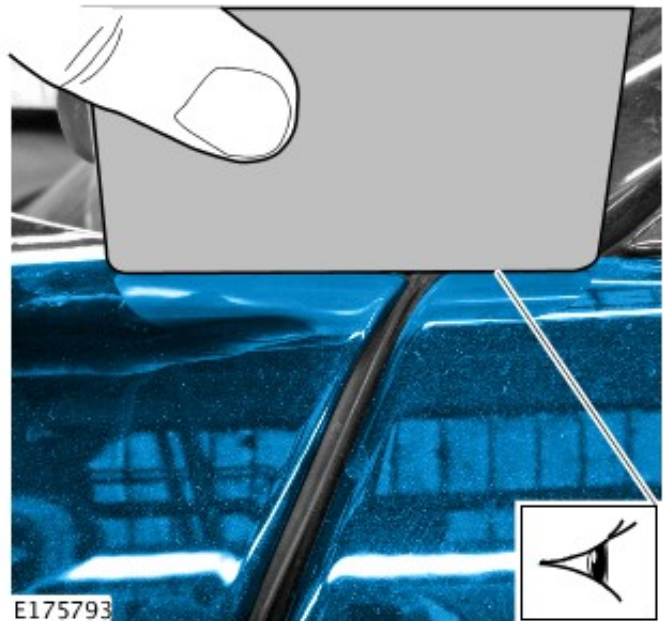
Check the alignment of the hood to door.
