TECHNICAL BULLETIN

LTB00814NAS1

SECTION: 501-02

Underhood Lower NVH Pads Freezing

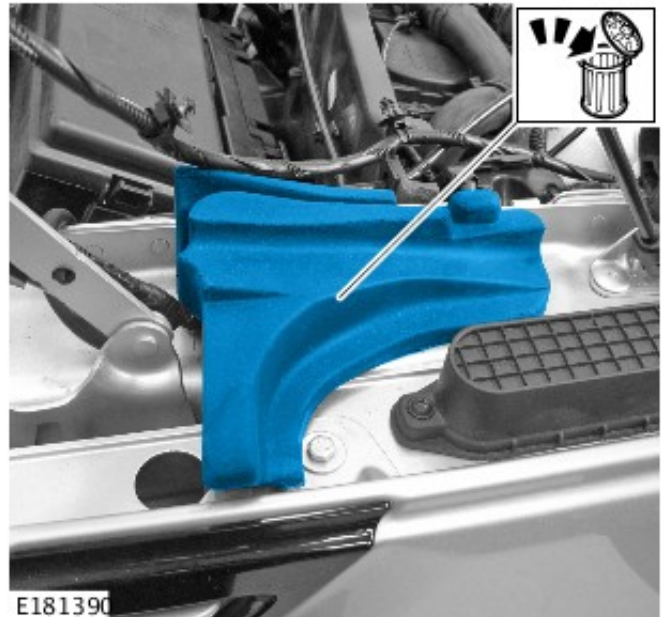
2

Situation: The underhood lower Noise Vibration Harshness (NVH) pad(s) may show signs of ripping, tearing, and/or has a poor finish.

Cause: This may be caused by ice build up between the foam surfaces and the hood causing penetration into the foam.

Remove and discard the underhood lower right-hand Noise Vibration Harshness (NVH) pad.
