**April 13, 2015**

00317-01777 Version 3

**Excessive Vibration Between 30 and 65 MPH**Supersedes 14-078, dated December 20, 2014, to revise the information highlighted in **yellow****AFFECTED VEHICLES**

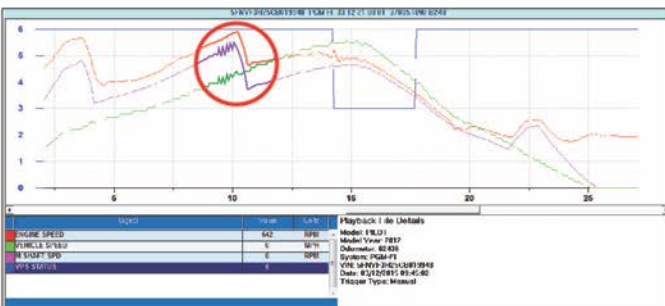
#### POSSIBLE TORQUE CONVERTER ISSUES

- The customer indicated the vibration occurred under braking or hard acceleration.
- The engine is not in valve pause when the vibration occurs.
- The snapshots 1 and 2 indicate fluctuations in the main shaft but the engine speed is steady – review the job aid *Torque Converter Clutch Shudder and Vibration*.

Refer to the Job Aid.

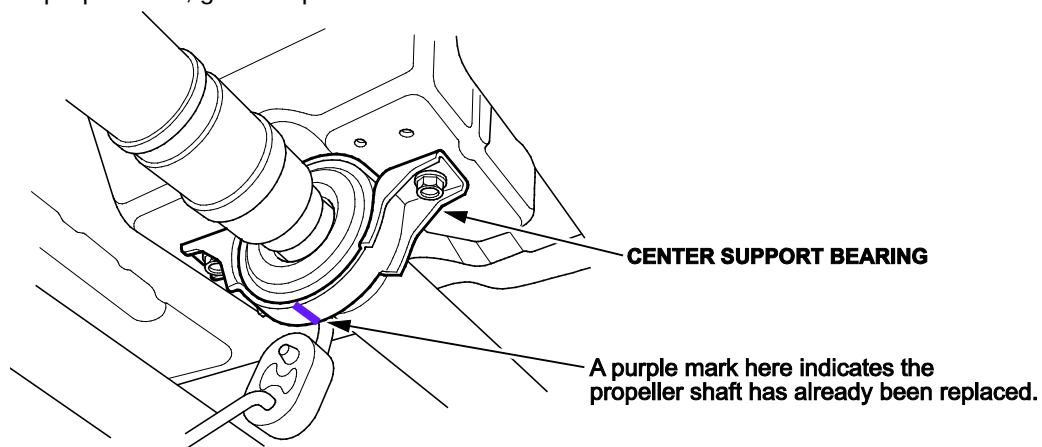
1. Raise and support the vehicle.
2. Check that the propeller shaft has not already been replaced. Check if there is a purple mark on the center support bearing as shown below.
  - If there is a purple mark on the center support bearing, the propeller shaft has already been replaced with a new part. Do not replace the propeller shaft again. If there is still a vibration, this bulletin does not apply. Continue with normal troubleshooting.
  - If there is no purple mark, go to step 3.
