April 14, 2015

01745 Version 1

## Transmission Slips or Shifts Hard When Cold

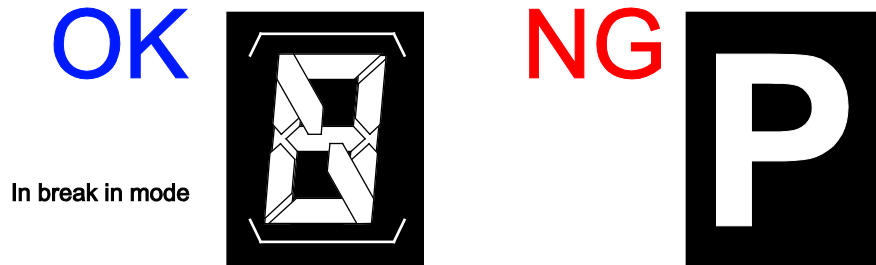
15. Make sure the Gear Position indicator has all of its segments showing.

NOTE: If all of the segments are not showing, you must exit the HDS, turn the ignition to OFF, and go back to step 3.

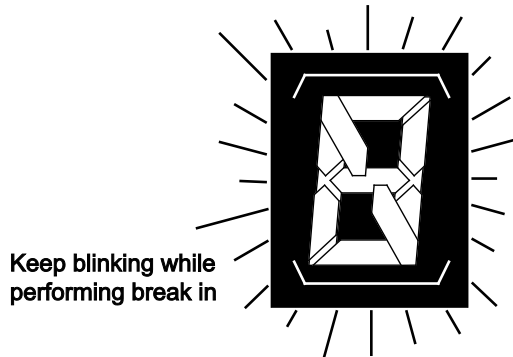
16. Start the engine. After about **10 seconds** the break-in procedure will automatically begin and the Gear Position indicator will start to blink. This procedure takes about **4 minutes**. During that time, engine fluctuation is normal. If you release the brake pedal or press down on the accelerator pedal, the procedure will stop and you will need to start over at step 3.
