| REFERENCE: | Nova Bus Manuals |
| RS N°: | MQR 7621-620 |

| SUBJECT: | Protective loom on the WHA electrical harness |
| JUSTIFICATION: | The protective loom on the WHA electrical harness may be damaged by the heat of the turbo. |

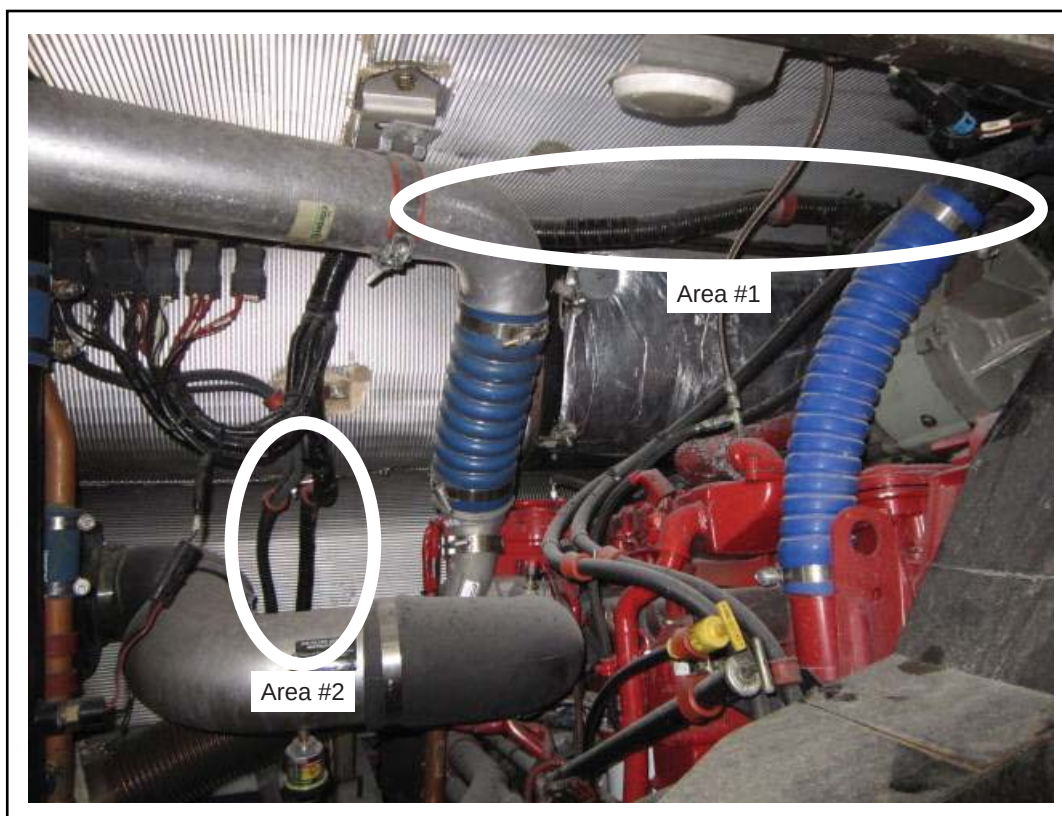
Figure 1 - Location to Look at on the WHA 61 Electrical Harness (View from Engine Radiator Side)

- 1.1. Open the rear engine access door.
- 1.2. Open the street side engine access door.
- 1.3. Open the transmission access door.
- 1.4. Open the engine access door under the rear passenger seat.
- 1.5. Remove the P-clamps on the WHA 61 electrical harness located in the two areas close to the engine turbo. See Figure 1. Retain the hardware.
- 1.6. Inspect the slit convoluted conduit in area #1. See Figure 1.

- 1.7. If damage is detected, go to the next step. If no damage is detected, go to step 1.10.
- 1.8. Remove the damaged convoluted conduit.
- 1.9. Install an appropriate length of new N28083-10 convoluted conduit to cover the entire damaged area. Tape the conduit in place with N74787 electrical tape. Install two turns of tape on every six inches (150 mm) along the convoluted conduit.

- 1.13. Inspect the slit convoluted conduit in area #2. See Figure 1.  
1.14. Repeat steps 1.7 to 1.12 for area #2.  
1.15. Close all four engine and transmission access doors.  
1.16. The vehicle may be returned to service. ❖
